SURVEY AND ANALYSIS OF BUILDING POUNDING DURING 1989 LOMA PRIETA EARTHQUAKE

¹KAZUHIKO KASAI, ²ANIL R. JAGIASI, and ³BRUCE F. MAISON

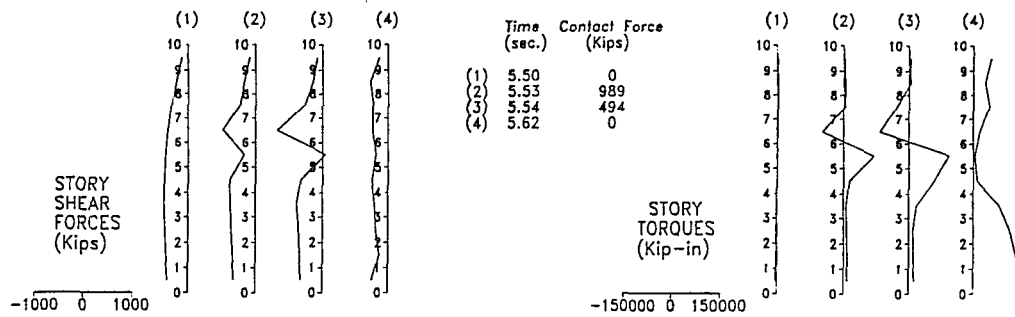
Fig. 3. X-direction Shear Force and Torque of 10-Story Building During the Most Severe Impact. (Pounding Against Retrofitted 5-Story Building)

Global Responses. Fig. 3 plots X-direction shear force and torque for the 10-story building during the most severe impact with the retrofitted 5-story building. Note that positive torque is denoted as counter-clockwise direction. Before pounding the shear force and torque distribution varies smoothly along height. Pounding creates impact forces at the pounding level, making the shear and torque distribution highly non-uniform. Fig. 4 plots X-shear and torque time histories of 10-story building. Analysis results assuming no pounding are also shown for comparison. The sharp changes in shear and torque occur due to the impact forces at the pounding level. The plots indicate at least 5 major impacts during the earthquake, as well as much higher shear and torques compared to no-pounding case. Note, however, that except for the instances of pounding the shear and torque histories are similar to those of the no-pounding case.

It should be noted that the stress when suppressing the twisting effect, is smoothly distributed over the story height (Fig. 6). Thus, the twisting promoted the irregular distribution of the shear stresses. As shown earlier in Fig. 3, at the instance of pounding the negative torque developed above the pounding level increased the negative shear stress therein, and the positive torque below the pounding level decreased the negative shear stress therein. Note, however, that when the 5-story building is non-retrofitted, the above mentioned effect of torque is not significant in spite of the large positive torque developed (Fig. 3). This is because such large positive torque did not occur at the same time as the large negative story shear. The significant increase in the story shear directly resulted in extremely large masonry elastic stresses of about 300 psi, 4 times the suggested failure stress.

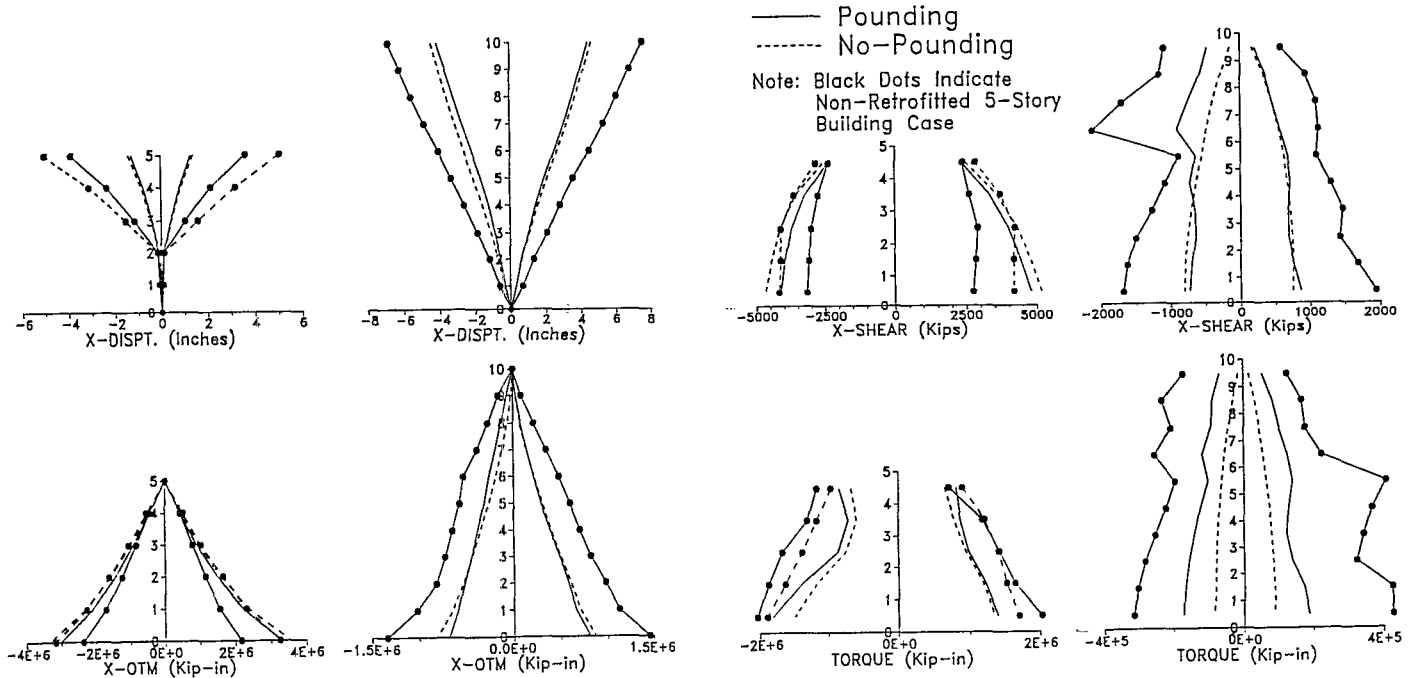
Fig. 5. Envelopes of X-Displacement, X-Shear, X-Overturning Moment, and Torque of 10 and 5-Story Buildings.

Fig. 5 plots the envelopes of the story X-displacement, X-shear, X-overturning moment, and torque of the buildings. Pounding and no-pounding cases are plotted considering either of the situations where the 5-story building is retrofitted or non-retrofitted. When 5-story building is retrofitted, pounding leads to slightly less maximum story displacements of both buildings compared with no-pounding case. However, when 5-story building is non-retrofitted, pounding produces displacements 30% less for the 5-story building and 70% more for the 10-story building compared with no-pounding case. Note that no-pounding displacements of the non-retrofitted 5-story building are about 3.6 times that of the retrofitted building.

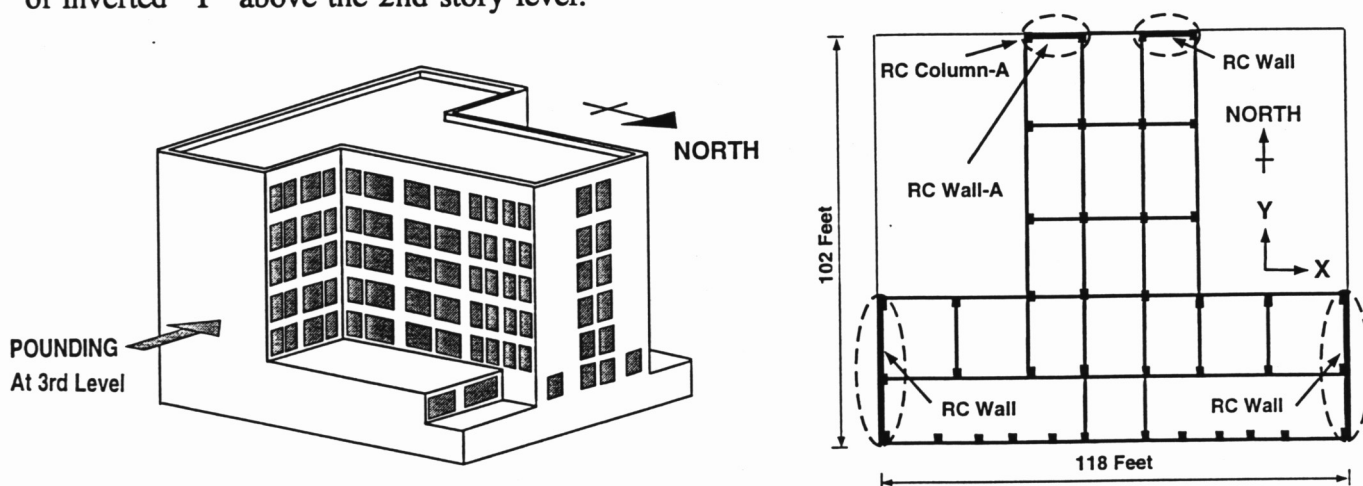
Fig. 7. Isometric View and Typical Floor Framing Plan of 7-Story Building.

Buildings and Analytical Modeling. This case study investigates a 7-story building located in Oakland. The building is on a street corner and is adjacent to a relatively wide 3-story building. There is another 7-story building at the far corner of the street. Both 7 story buildings pounded at the both sides of 3-story building, as evidenced by the local contact damage at the 3rd level of the buildings. The 7-story building at the west side (Fig. 7) has suffered the most severe structural and non-structural damage, and its pounding response will be discussed herein. The 7-story building consists of moment resisting reinforced concrete frames and reinforced concrete shear walls at many locations. The concrete columns have the spiral reinforcements with small pitch, and they are believed to be ductile. Fig. 7 shows isometric view from north-east as well as typical floor framing plan showing the columns, walls, and beams. The building has a rectangular base plan and two setbacks in the plan towards north. One minor setback exists at mezzanine level and another major setback at the second floor level (named as 2nd story level), as a result of which the building takes the form of inverted "T" above the 2nd story level.

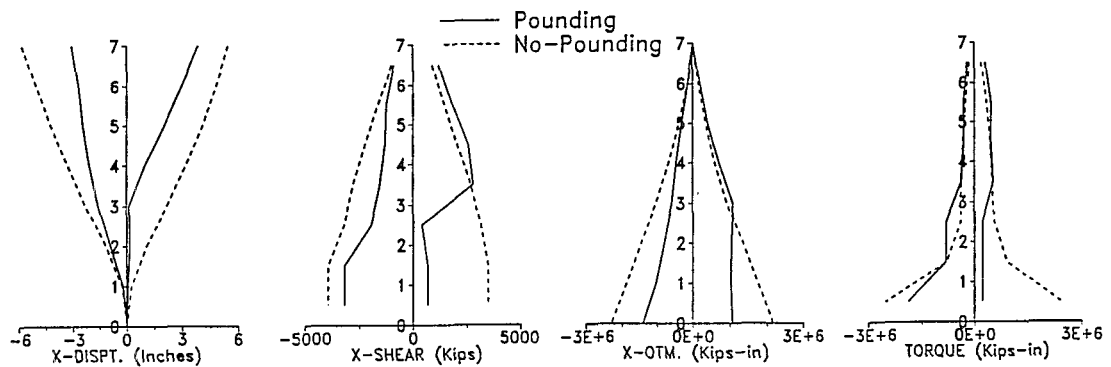
Fig. 9. Envelops of X-Displacement, X-Shear, X-Overturning Moment, and Torque of 7-Story Building.

Global Responses. Fig. 9 plots the envelop of X-direction gross responses along with the torque for the 7-story building for both the pounding and no-pounding cases. Pounding slightly amplifies positive shear and overturning moment above the pounding level, and significantly reduces them below the level. Pounding also reduces both negative shear and overturning moment throughout the story height. Positive torque acting in the counter-clockwise direction is significantly reduced below pounding level due to the impact force imposing clockwise torque to the lower levels.
