DAMAGE TO DAIKAI SUBWAY STATION DURING THE 1995 HYOGOKEN-NUNBU EARTHQUAKE AND ITS INVESTIGATION

N. YOSHIDA, and S. NAKAMURA

Engineering Research Institute, Sato Kogyo Co., Ltd.
Nihonbashi-honcho 4-12-20, Chuo-ku, Tokyo 103, Japan

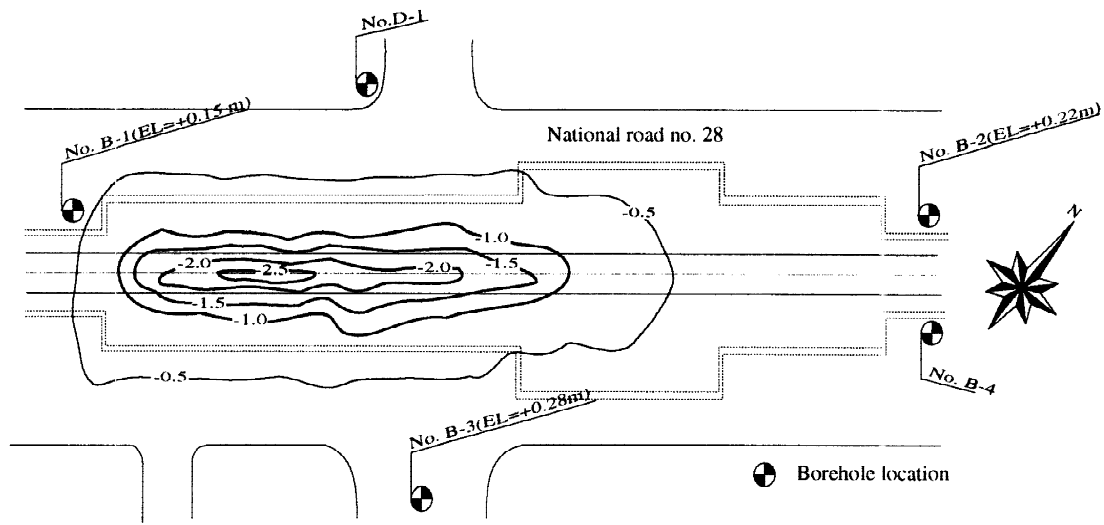
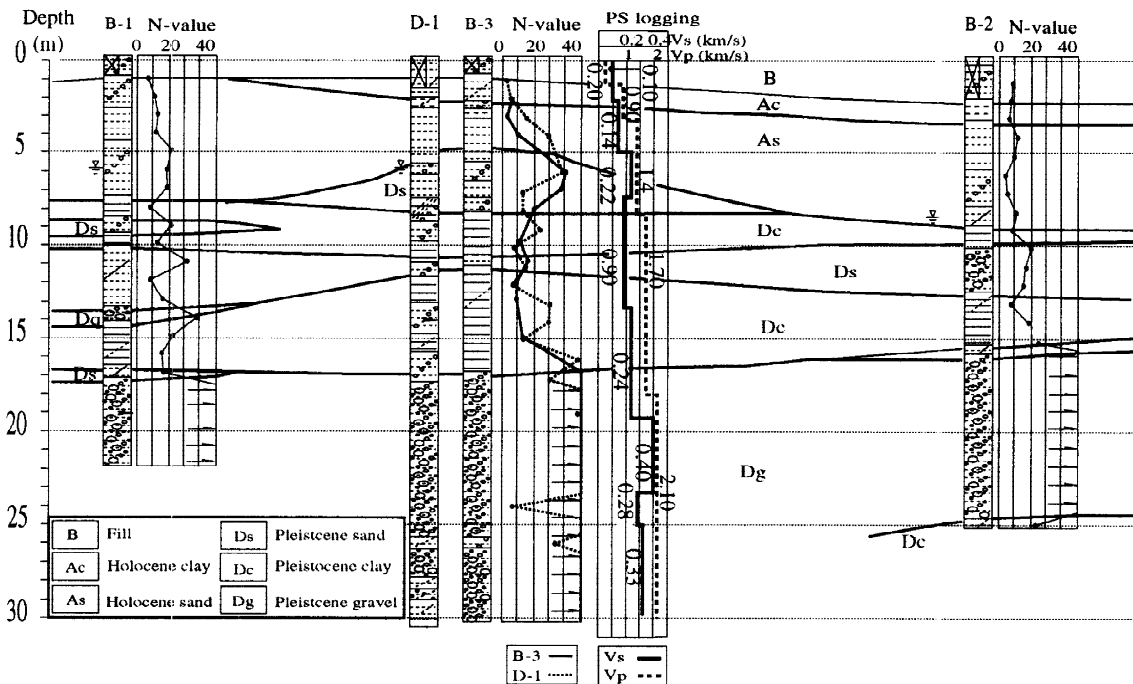
Fig. 5 Settlement of the ground surface (numeral in (a)) and soil profile based on the borehole investigation after the earthquake. Boring No.4 is fill whose SPT-N value is shown in Fig. 6.

(a) Plan and contours of the settlement of the ground surface

(b) Soil profiles

Figure 8 shows schematic diagrams of the damage in the longitudinal direction. The ground of the National road no. 28 for a distance 90 m long and 23 m wide gradually settled up to more than 2.5 m maximum. The contour lines of the settlement of the road surface are shown in Fig. 5, which was measured on January 28. Referring to Figs.2 and 8, the station can be divided into 3 zones in the longitudinal direction along the station depending on the structural system: zones composed of columns 1-23, columns 24-29, and columns 30-35, which are designated zone A, B and C, respectively, hereafter. Zones A and C are a one story box frame structure whereas zone B has utility rooms adjacent to the platform as well as the B2 floor (concourse).

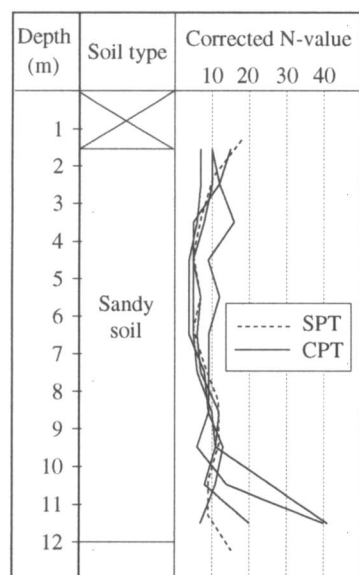
Standard penetration and cone penetration tests were made near the structure in order to determine the properties of the fill material. Decomposed granite soil was used as the fill material. Fig. 6 compares SPT N-values with N value computed from the cone penetration tests. The N value of the fill is about 10 at all depths except near the bottom. Figure 7 shows strain dependent characteristics of undisturbed samples of the fill material obtained from dynamic deformation tests. The test was made under the isotropic initial stress states with confining pressures of 49 and 98kN/m², and an anisotropic initial stress state with principal stresses of 49 and 29.4 kN/m².

Fig. 6 SPT-N value of fill materials. SPT was conducted at No.4 site in Fig. 5.

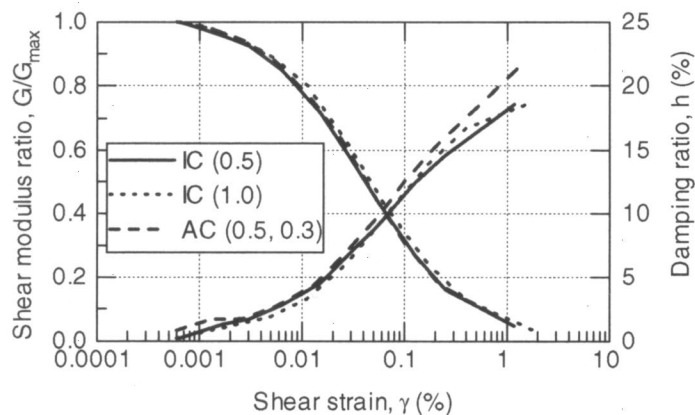
Fig. 7 Strain dependent characteristics of shear modulus and damping ratio obtained from dynamic deformation test on undisturbed samples, where IC denotes isotropically consolidated sample, AC denotes unisotropically consolidated sample, and numbers in the parenthesis are initial effective confining pressure in kgf/cm^2 .

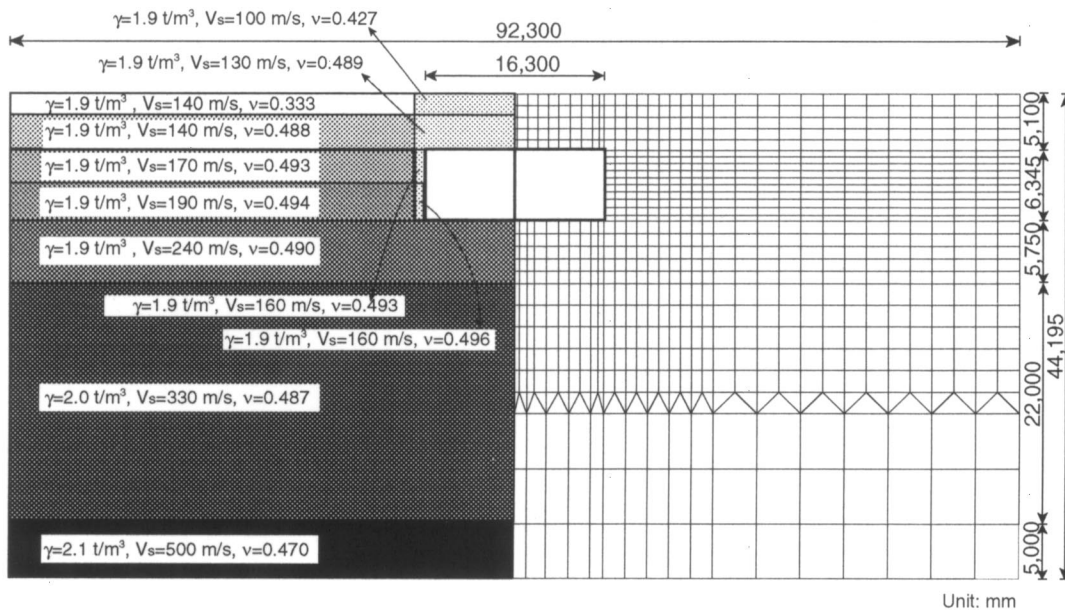
Fig. 10 Soil-structure system used in the dynamic response analysis.

Soil-structure model used in the first step analysis is shown in Fig. 10. Energy transmitting boundary and viscous boundary are used along the lateral and base boundaries, respectively. Ground is assumed to be horizontally layered and the depth of base whose shear wave velocity is 500 m/s is about 40 m. Material property used in the analysis, such as unit weight, initial Poisson's ratio and shear wave velocity, is also shown in Fig. 10. Empirical equation proposed by Yasuda and Yamaguchi (1985) are used as strain dependent characteristics of shear modulus and damping ratio of the subsoil except fill; those shown in Fig. 7 is used for fill material. Structural members are modeled to elastic beam elements considering rigid zone. The rigidity of each member is evaluated by considered the property of both concrete and reinforced bar.

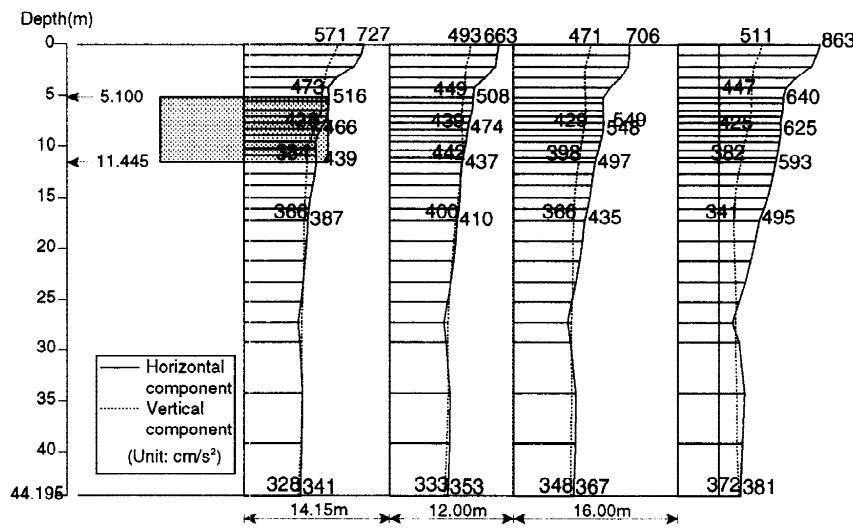
Fig. 11 Peak acceleration distributions

Peak acceleration distributions in both horizontal and vertical directions are shown in Fig. 11 at a length of 14.15, 26.15 and 42.15 meters from the center of structure. Acceleration at the ground surface is more than 400 cm/s^2 , which correspond to the JMA seismic intensity 7 around this area. The relationship between

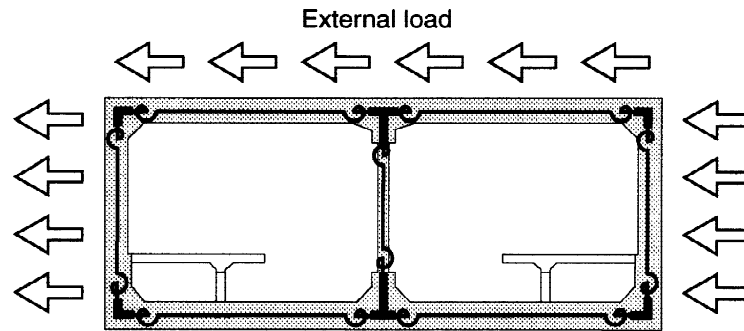
Fig. 13 structure system used in the static nonlinear analysis.

Nonlinear static analysis was carried out. One story box frame is modeled as shown in Fig. 13. Each member is modeled into a beam element. Moment resisting joint is employed at the ends of each member, which is modeled to be a rotational spring. The spring is modeled to tri-linear model, whose three lines corresponds to the behavior until crack, until yield and from yield to ultimate state, respectively. These behavior were calculated based on the total axial force and dynamic response force. Shear force and axial force obtained by the dynamic response analysis were applied to the location where it occurred as the external loads. Here, forces when the bending moment at the center column first exceed the ultimate moment are employed. They are divided into fifty and applied incrementally. These overburden soil load and static earth pressure are considered in the initial state.
