## **DAMAGE DETECTION BY MODAL TESTING**

H.G.L. Prion and M. Rezai K.

Department of Civil Engineering, The University of British Columbia  
2324 Main Mall, Vancouver, B.C., Canada, V6T 1Z4

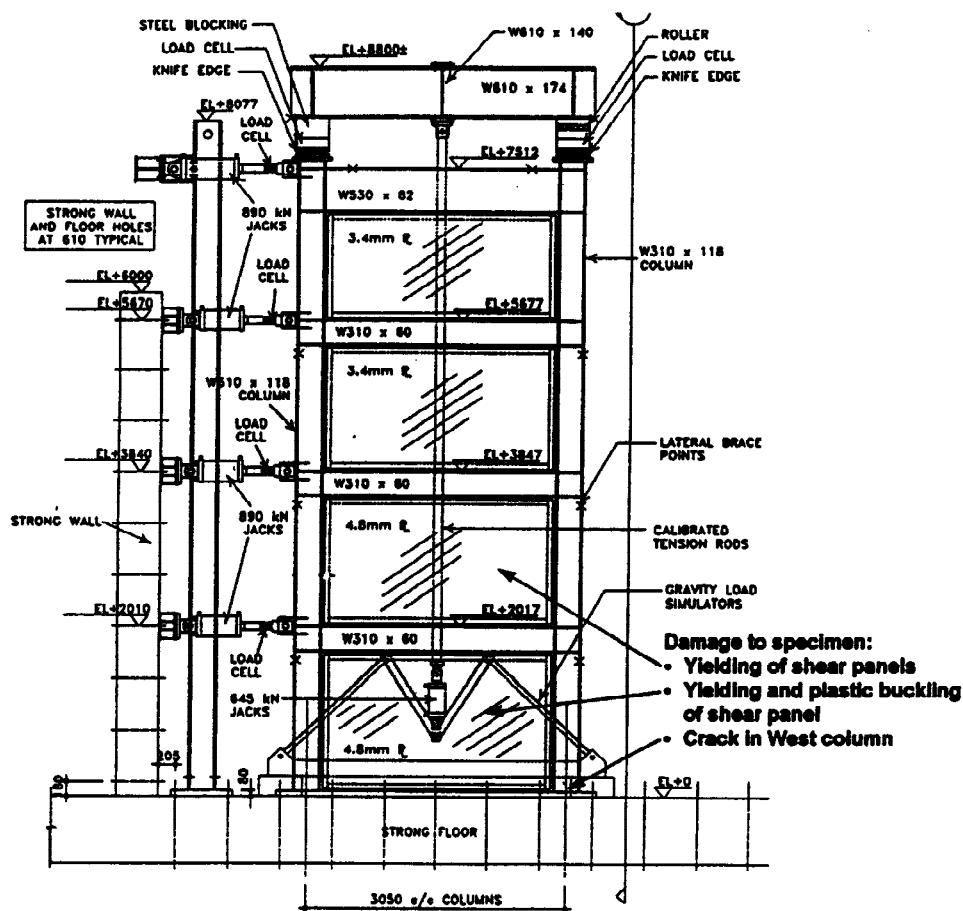
The test specimen was a 50% scale model representing one bay of the lower four storeys of an office building. The first storey was 1.93 m high with the upper top three storeys each 1.83 m. The columns, which consisted of W310×118 wide flange sections of grade 300W steel, were kept constant throughout the frame. Medium depth wide flange beams, W310×60, were used for the bottom three storeys while a deep stiff beam, W530×82, was used above the top storey to anchor the tension field forces generated in the shear plate. The thicknesses of the shear wall infill panels were 4.54 mm, 4.65 mm, 3.35 mm and 3.40 mm in panels 1 to 4 from the bottom storey to the top storey, respectively. All the beam to column connections were fully welded to create fixed moment connections. The shear panels were continuously welded to the surrounding beams and columns by means of a fish plate connection detail. Figure 1 shows the frame specimen in the loading apparatus.

Figure 1: Steel plate shear wall test specimen (Driver *et al.*, 1995)

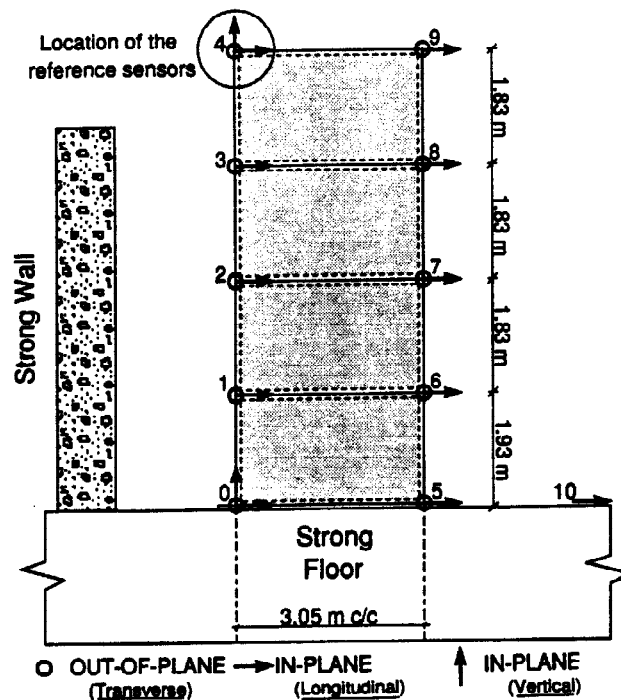
Eight strong motion accelerometers were used for the measurement of motions, which required four setups for the ambient vibration tests. Figure 6 shows the location and direction of the ambient vibration measurements along the height of the shear wall frame. Three reference sensors were used during the ambient vibration test, in the longitudinal, transverse and vertical directions. The remaining five accelerometers were moved to different locations for each test setup. Since the reference sensors were to be used to normalize the entire data set, having them located at a position of large relative motion was important. Furthermore, their location was assigned based on the approximate mode shapes of the structure and to ensure that the structure would exhibit motion at that particular location for all the natural frequencies of interest. The top left corner of the specimen was selected as the location for the reference sensors, as shown in figure 6. The data was collected for a total of eleven stations (numbered 0 to 10 in figure 6) in the longitudinal, transverse and vertical directions. Sensor 10 was attached to the floor about 3m away from the specimen to measure the free field vibrations. At each station, the calibrations of the accelerometers were verified before each test.

Figure 6: Sensor locations on test frame

Impact tests were performed by an impulse hammer that was instrumented with an integral piezoelectric force sensor to measure the applied force. Two sets of hammer impacts were applied on the specimen at two different locations (locations 2 and 4 in figure 6) and only in the longitudinal direction. Four consecutive hammer blows were struck at each location with interval of approximately 16 seconds for a total of 64 seconds. The impacts at the top storey of the frame were applied to excite the frame mainly in the first mode, while impacts at the second storey were meant to induce some energy for the second mode of vibration.
