## **SAFETY OF DAMS DURING HYOGOKEN-NAMBU EARTHQUAKE ON JANUARY 17, 1995 IN JAPAN**

**AKIRA NAKAMURA, ISAO NAGAYAMA,  
TAKASHI SASAKI and TOMOYA IWASHITA**

Dam Department, Public Works Research Institute (PWRI), Ministry of Construction, Japan

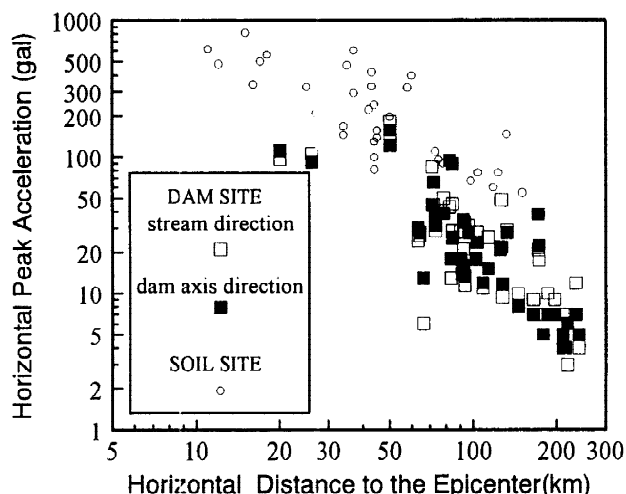
Figure 7 Attenuation of peak accelerations with distance to the epicenter (Horizontal acceleration)

**Attenuation of Peak Acceleration** - The attenuation of the horizontal peak accelerations observed at the dam foundations during the earthquake is shown in Figure 7, and that of the vertical peak accelerations in Figure 8. These values include the values obtained at the gallery under the embankment dam or at the lowest gallery in the concrete dam. Figures 7 and 8 show peak accelerations measured at dam sites and those at soil sites. In Figure 7, the data with white squares show peak accelerations at dam sites in the stream direction, the black squares show those in the dam axis direction, and the white circles show those of soil sites (Committee on Measures for Bridge Damage for Hyogoken-Nambu Earthquake, 1995). Figure 8 compares peak vertical accelerations between dam sites (black squares) and soil sites (white circles). The foundations of dams consist of hard rock before Tertiary period (40 dam sites: pre-Tertiary period; 5 dam sites: Tertiary period), whereas soil sites are of alluvial or diluvial deposits. Figures 7 and 8 indicate that the peak accelerations at the dam sites were substantially smaller than those at the soil sites. The maximum observed horizontal peak acceleration at a dam foundation was 183 gal. This site is located about 47 km from the epicenter, and about 10 km from the earthquake source faults which have caused the main shock. The attenuation of horizontal peak accelerations at dam sites with distance from the earthquake source faults is shown in Figure 9. The maximum acceleration during the earthquake at a rock foundation was estimated to be about 220 gal from Figure 9 (Committee on Evaluation of Earthquake Resistance of Dams, 1995).

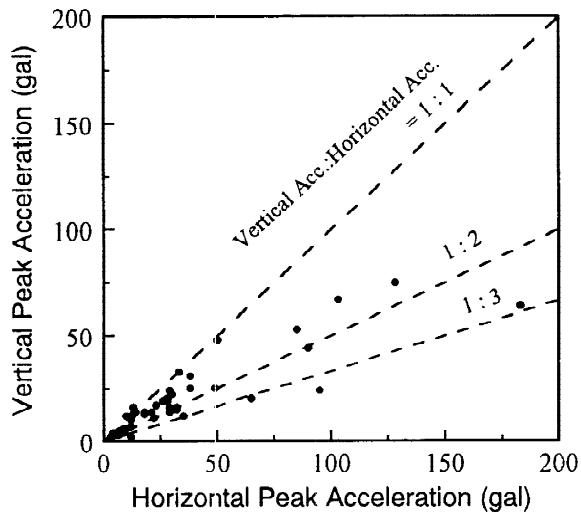
Figure 10 Relationship between horizontal peak accelerations and vertical peak accelerations

- The relationship between the vertical peak accelerations and the horizontal peak accelerations at dam foundations is shown in Figure 10. The ratio of the vertical to the horizontal peak accelerations is 1/3 to 1/1. The figure shows that the larger the horizontal acceleration is, the smaller the ratio is.

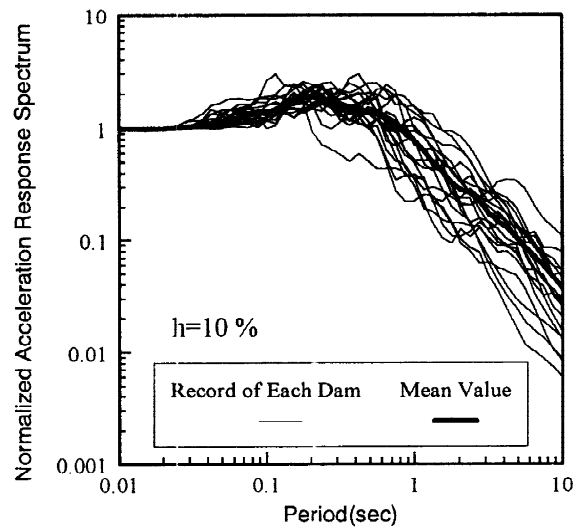
Figure 11 Acceleration response spectrum at dam foundations (Damping ratio  $h=10\%$ )

The response spectrum of accelerations recorded at 25 dam foundations is shown in Figure 11. The spectrum is normalized so that the maximum acceleration is 1. The mean value of the spectrum is about 2 for the period between 0.1 and 0.6 seconds. For periods larger than 0.6 seconds, the value decreases rapidly.

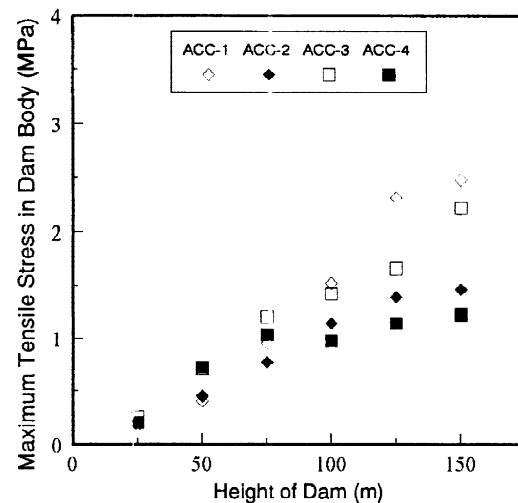
Figure 14 Maximum tensile stress in dam body with height of dam

**Results of Analysis** - The maximum dynamic tensile stress calculated in the dam body is shown in Figure 14. The stress increases in proportion to the height of the dam, but even the stress in the 150 m-high dam is less than 2.5 MPa. It is supposed that concrete gravity dams can withstand such dynamic stress. The maximum shear force along the contact plane between the dam and the foundation was also analyzed and the force was found to be less than the shear resistance along the contact plane. Concrete gravity dams thus have resistance against sliding.

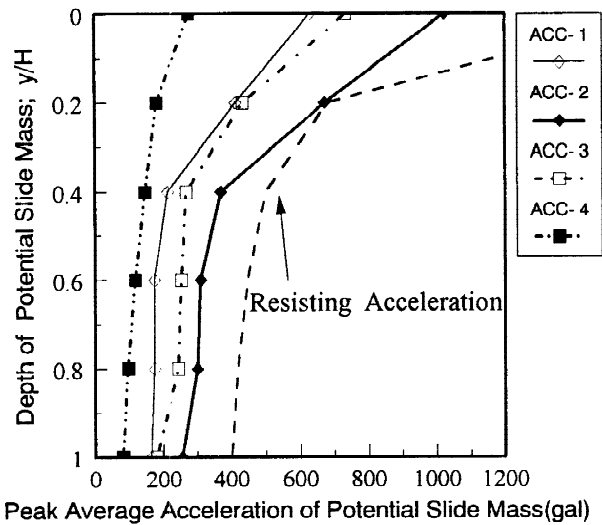
Figure 18 Peak average acceleration of potential slide mass with depth of potential slide mass for 110m-high dam

**Results of Analysis** - The analysis showed that the margin of safety of the 110 m-high dam is the smallest. The peak average acceleration of the slide mass for a given  $y/H$  (see Figure 15) is shown in Figure 18 with the resisting acceleration. Resisting acceleration is defined as the acceleration that would cause the potential slide mass to begin to slide, and is calculated from stability analysis using the physical properties of materials shown in Table 4. At the upper part of the dam, the peak average acceleration during the earthquake is very large, but the values are within the resisting acceleration for any  $y/H$ , so the rockfill dam is safe against sliding.
