DISTRIBUTION OF STRUCTURAL DAMAGE AROUND THE MUKOGAWA RIVER BASIN
SUFFERED FROM THE GREAT HANSHIN (HYOGOKEN NANBU)
EARTHQUAKE OF JANUARY 17, 1995

Hisanori MORIMOTO, Tadatoshi FURUKAWA and Kensuke BABA

Department of Architectural Engineering, Osaka University,
2-1, Yamada-Oka, Suita, Osaka 565 JAPAN

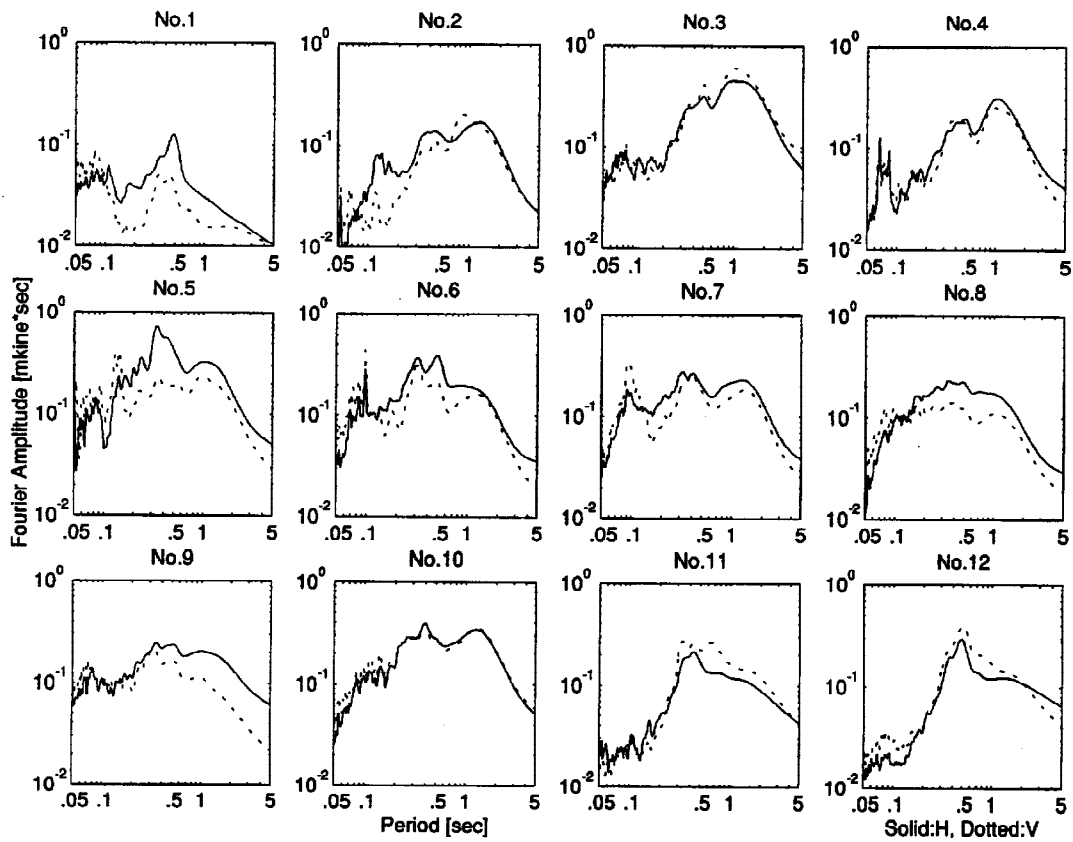
To research the spectral variations across the middle reaches of the Mukogawa river basin and its neighbor ground, the microtremor measurements were carried out during the calm nights of early August, a half year late the seismic hazard. The measuring instruments are prepared in two sets consisting of three velocity-sensitive transducers with the natural period of 1second respectively along the lateral and vertical directions, the portable amplifiers and the portable computers added in the A/D converters to digitalize the analog data in a 12-bits at the rate of 100Hz. The microscopic ground motions are caught on the twelve points at about 500meter intervals across the midstream of the Mukogawa River. The observation points are numbered from the west to the east across the midstream section and plotted in Fig.1. The measurement period is settled in 60seconds at every point and four or six segments during 20.48seconds are extracted from the recorded data without singular noises. The spectral amplitudes are analyzed through smoothing 20 times under the Hanning windows as well as averaging all the segments in the arithmetical manner, and the lateral amplitudes are especially regulated in the geometric average of the orthogonal components, as shown in Fig.3 including the lateral and vertical components. The sharp eminence is found around the period of 0.5sec at the site point No.1 of the rocky mountains with keeping the lower amplification level, which is adopted for the reference to the following spectra. The points No.2~4 are stationed on the alluvial fans beside the mountains, where the dominant properties are recognized around 0.5sec in company with the swelling at 1.0sec. The eminent disposition is extended broad from the period 0.1sec to 1.5sec with the top around 0.4sec at the site points No.5~7 arranged on the deposit formations in the western side of the Mukogawa River. The similar tendency is shown without the clear summits at the points No.8~10 over the deposits in the eastern riverside. Moreover, the remarkable prominence is exhibited at 0.5sec in the spectral characteristics from the point No.11~12 standing on the Itami terrace, the

trend of which is not a little common to the one at the rocky site No.1. The spectral site characteristics surface more remarkably in Fig.4 to drop out the source peculiarities by making the ratios between the reference spectra at No.1 and those at the following numbers.

Fig.3. Fourier spectral amplitudes through the micrometer measurement across the midstream of the Mukogawa River.

The solid lines correspond to the lateral components and the dotted lines to the vertical ones.

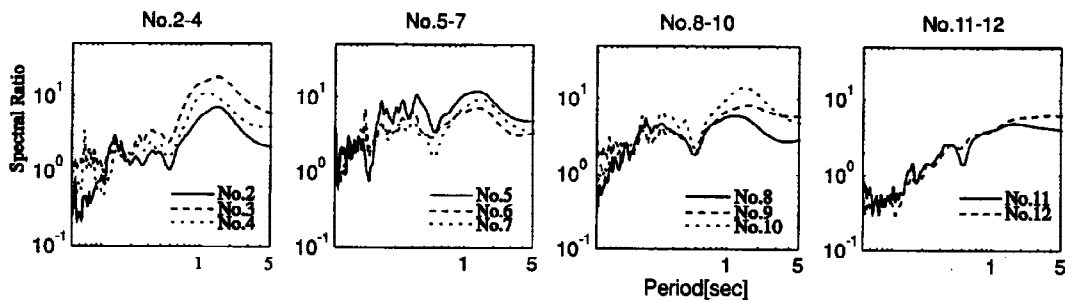
Fig.4 Spectral amplitudes ratios referred to the lateral components at the site No.1 around the Rokko Mountains.
