**STATE-OF-THE-ART SEISMIC EVALUATION OF REINFORCED  
CONCRETE BUILDINGS BASED ON BEAM-COLUMN JOINT CAPACITY.**

***PART 2: Application to Damaged Buildings During the January 17, 1995 Great Hanshin Earthquake***

Tomoaki AKIYAMA, Masaya HIROSAWA and Silvestre BERSO

Structural Investigation Division  
Tokyo Soil Research Co., Ltd.  
2-11-16 Higashigaoka, Meguro-ku, Tokyo 152, JAPAN

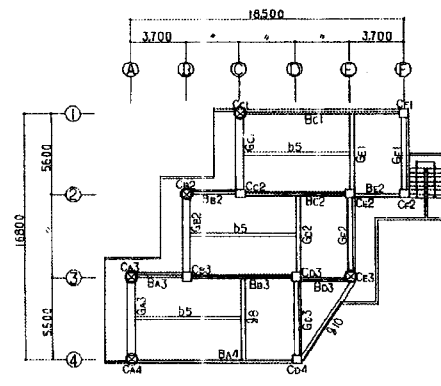
Fig.2. Framing plan of typical floor

**Building Description.** This eight-story apartment houses without basement built in 1985 has irregular shape in plan as shown in Fig.2. Basically one span in the North-South direction and two or three spans in East-West direction. There are infilled structural walls along the X-direction of the ground floor in Frames 3 and 4, but in Y-direction there are very few walls because of openings, hence, along this direction perfect moment resisting frame can be considered. Moreover, the story height of each story ranges from 2.7 m. or 2.8 m. and total height from the base to the top story is 22.35 m.
