# THE RESTORATION OF THE IKUTA SHRINE DESTROYED BY THE GREAT HANSHIN EARTHOUAKE USING ULTRA HIGH STRENGTH COMPOSITE COLUMN

TOSHIHARU HISATOKU<sup>1)</sup>, TERUO SEGAWA<sup>2)</sup>, TATSUO OKAMOTO<sup>2)</sup>
1)Takenaka Corporation, 8-21-1, Ginza, Chuo-ku, Tokyo, Japan
2)Structural Engineering Section, Building Design Department, Takenaka Corporation,
2-3-10, Nishi Hom-machi, Nishi-ku, Osaka, Japan

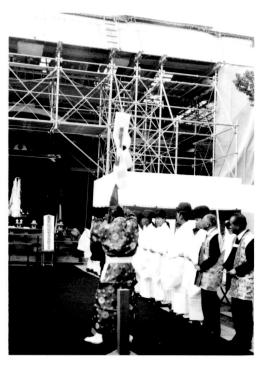
Photo. 3 Constructed CFT Collumns

The re-construction of the Hall of Worship started on March 1995. Photo.3 shows the constructed CFT columns on October 1995. Carved cast steel *Daito* are put on the columns. Jyotoshiki, the topping-off ceremony, was held on November 30 1995, as shown in Photo.4. The restoration of the IKUTA shrine will be finished in June 1996.
