## SEISMIC DAMAGE TO CIVIL ENGINEERING STRUCTURES BY THE 1994 FAR-OFF SANRIKU EARTHQUAKE

Y.SHIOI and N.SAKAJIRI

Department of Civil Engineering, Faculty of Engineering  
Hachinohe Institute of Technology ( HIT )  
88-1, Ohbiraki, Myou, Hachinohe, Aomori, Japan

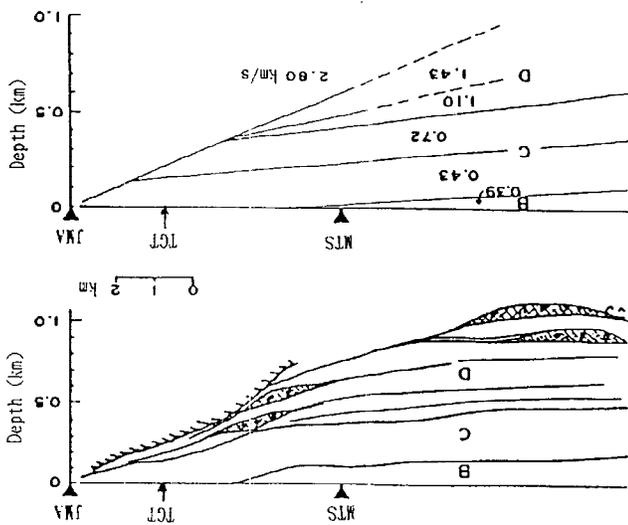
Fig.4 Geologic section & velocity structure of Hachinohe Port

Figure 4 shows the geologic column of both sites,where we can not find a bedrock under very thick sedimentary layers up to 80m. It is suggested that the phenomenon of liquefaction is strongly related to the existence of the thick or soft sedimentary layers which accumulate seismic energy and amplify the strain of upper layers (Shioi,1980). At observation point MTS in Fig.2, the predominant period of the ground is 2.5-3 second (Sakajiri and Sasatani,1994) and severe liquefaction is reported. Since the depth of the bedrock at TGT is presumed to be more than 200m, a fairly long period is considered. At 1st industrial port where sedimentary layers are relatively thin, a few small sand boils were found on some reclaimed grounds near the shore.

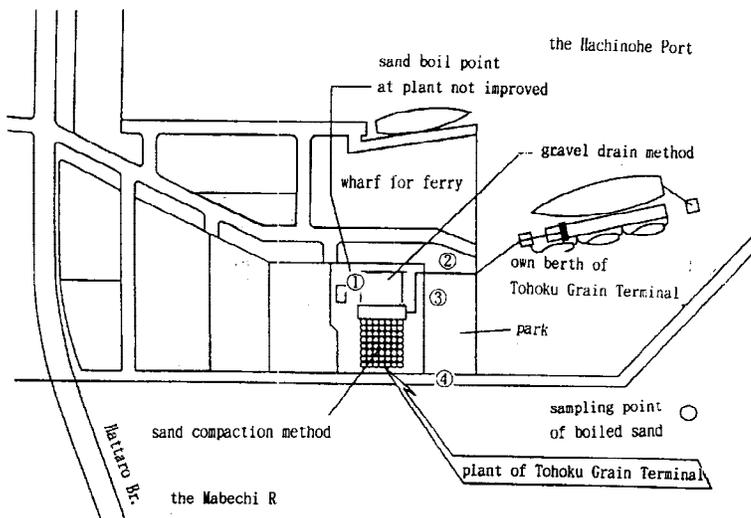
Fig.5 Disposition of No.3 wharf

Among the liquefaction phenomena at the 2nd port, several noteworthy facts were found at No.3 wharf. On the top of wharf, big silos and a plant of Tohoku Grain Terminal Co.Ltd.(TGT)(Photo.1) and a small park are situated along the Mabechi River(Fig.3). The ground of the silos and the plant was improved 10m below with sand compaction method in the 1st construction stage and with gravel drain method in the 2nd stage. The improved ground of the plant was quite sound except for a slight settlement (Photo.2), though a bit of boiled sand on the natural ground of the same area was observed. At the small park and its parking area neighboring to the plant a lot of boiled sand was found throughout the site (Photo.3), contrasting the other side of a fence. From a series of phenomena including other examples, it was confirmed that ground improvements with dewatering can be effective in preventing soil liquefaction or reducing its influence,

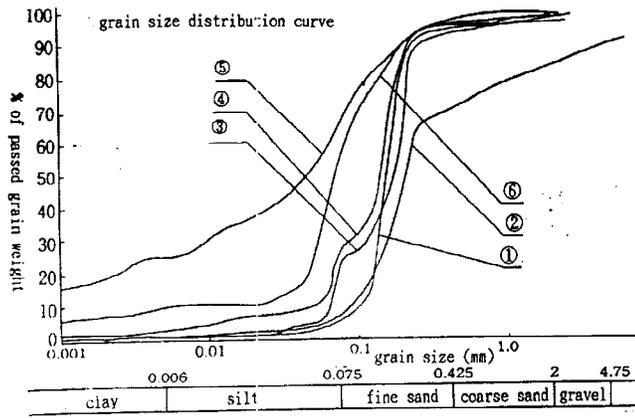
Fig.7 Grain size accumulation curve of boiled sands

In the liquefaction at Hachinohe Port, various kinds of soil were boiled, including small gravel, silt and well-graded soil,as shown in Fig.5. Although liquefied ground became a force to push the wharves, it caused no severe damage to the structures on flat ground. Most of the buildings on the liquefied area are still being used after some repairing. The conveyor viaduct (Fig.1) from the TGT plant to the unloading berth, with a top heavy structure, was sound during the two big earthquakes in spite of passing a severely liquefied park, and continued to supply feed to cattle in the cold winter. Though the energy to induce liquefaction was enormous, it appears that the acceleration of the force to act upon structures was not so strong.

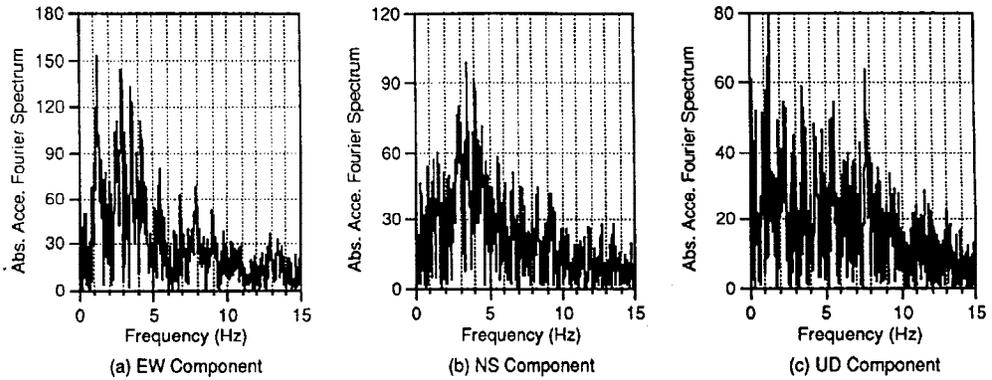
Fig.8 Fourier spectrum of the Sanriku Eq. at HIT

Damage due to the Sanriku Eq. was concentrated in Hachinohe City and distributed densely on the diluvium terrace, volcanic sediments on the peleozoic layer of limestone, clay stone, sandstone and chart. This earthquake was predominantly shorter in period than the Tokachi Earthquake with almost the same epicenter and the magnitude 7.9. Figure 6 (Takita et al,1995) shows the spectrum of acceleration on the peleozoic clay stone 20m below Hachinohe Institute of Technology. From Fig.6, the predominant period seems to be 0.3

second for the horizontal direction. But for the vertical direction, it is difficult to determine the predominant period since high acceleration was distributed up to 8 Hz. Therefore, we cannot neglect the influence of the vertical component of this earthquake motion in order to analyze the damage to structures. Photo.4 shows cracks in some intermediate columns of the city hall, with heavier loads than edge columns. Photo.5 shows a big shear crack in a column on the porch of a high school, sustaining the overhanged portion of the building. Figure 7 shows failure and rehabilitation of the bank of railway, where another type of failure, slope sliding, occurred due to the Tokachi Eq. and had been repaired.

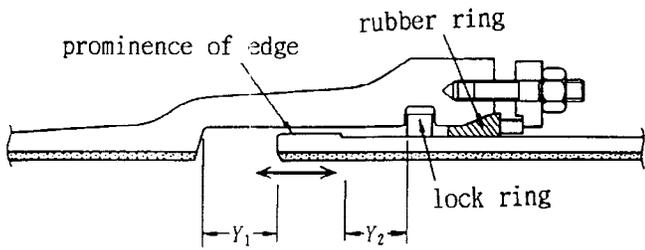
Fig.11 Detail structure of joint of seismic pipe

The water supply facilities in Hachinohe City were severely damaged by the Tokachi Eq. in 1968. Hachinohe Regional Water Works Enterprise (hereinafter HRWWE) has been making efforts to take seismic measures for their facilities based on this bitter experience. HRWWE devised an iron pipe with a new joint system shown in Fig. 7, called a "seismic pipe". The seismic pipes are used for the trunk lines in the network 124km long (Fig. 8) and received no damage from the 2 big earthquakes. HRWWE is building a loop circuit of the trunk line surrounding the center of the city. Furthermore, HRWWE took several seismic measures for purification and pumping stations such as strengthening of instruments, fixation of equipments and tool shelves, chemicals, protection of computers and so on.
