SEISMIC DAMAGE TO CIVIL ENGINEERING STRUCTURES BY THE 1994 FAR-OFF SANRIKU EARTHQUAKE

Y.SHIOI and N.SAKAJIRI

Department of Civil Engineering, Faculty of Engineering
Hachinohe Institute of Technology (HIT)
88-1, Ohbiraki, Myou, Hachinohe, Aomori, Japan

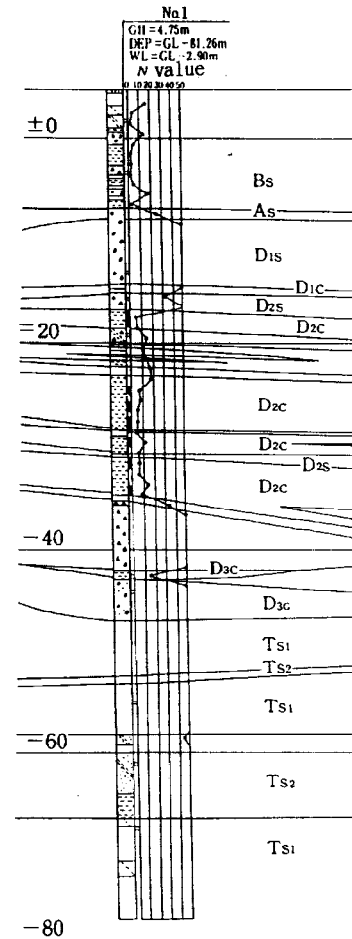
Fig.6 Geologic column at the top of No.3 wharf

Figure 4 shows the geologic column of both sites,where we can not find a bedrock under very thick sedimentary layers up to 80m. It is suggested that the phenomenon of liquefaction is strongly related to the existence of the thick or soft sedimentary layers which accumulate seismic energy and amplify the strain of upper layers (Shioi,1980). At observation point MTS in Fig.2, the predominant period of the ground is 2.5-3 second (Sakajiri and Sasatani,1994) and severe liquefaction is reported. Since the depth of the bedrock at TGT is presumed to be more than 200m, a fairly long period is considered. At 1st industrial port where sedimentary layers are relatively thin, a few small sand boils were found on some reclaimed grounds near the shore.

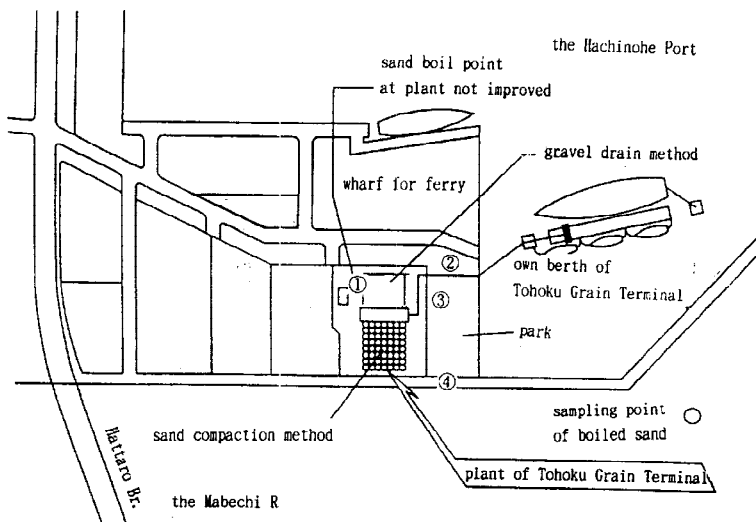
Fig.5 Disposition of No.3 wharf

Among the liquefaction phenomena at the 2nd port, several noteworthy facts were found at No.3 wharf. On the top of wharf, big silos and a plant of Tohoku Grain Terminal Co.Ltd.(TGT)(Photo.1) and a small park are situated along the Mabechi River(Fig.3). The ground of the silos and the plant was improved 10m below with sand compaction method in the 1st construction stage and with gravel drain method in the 2nd stage. The improved ground of the plant was quite sound except for a slight settlement (Photo.2), though a bit of boiled sand on the natural ground of the same area was observed. At the small park and its parking area neighboring to the plant a lot of boiled sand was found throughout the site (Photo.3), contrasting the other side of a fence. From a series of phenomena including other examples, it was confirmed that ground improvements with dewatering can be effective in preventing soil liquefaction or reducing its influence,
