PILE DAMAGE DURING 1995 HYOUGOKEN–NANBU EARTHQUAKE IN JAPAN

Hatsukasu MIZUNO, Masanori IIBA and Tsutomu HIRADE

Building Research Institute, Ministry of Construction, Japan
Tatehara1, Tsukuba City, Ibaraki Prefecture, 305 Japan

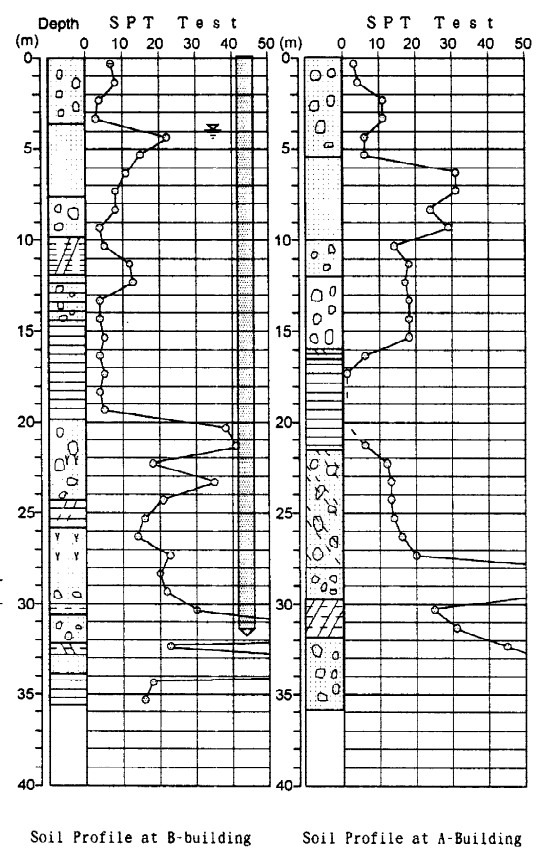
Fig.8 Soil profile at buildings A and B

Excavation of pile heads and non-destructive tests were performed at No.s 1, 2 and 3 points in Fig. 7. Pile heads had no damage, although boiled sands were observed along piles and around strap beams. Figure 8 depicts soil profiles at the building A and B. Figure 9 presents the result of non-destructive test at No. 1 point, the building A with finite difference simulation result based on wave propagation analysis. In consequence, the pile is considered to be cracked at a depth of G.L. –8 meters, and to be broken at a depth of G.L. –16 meters.

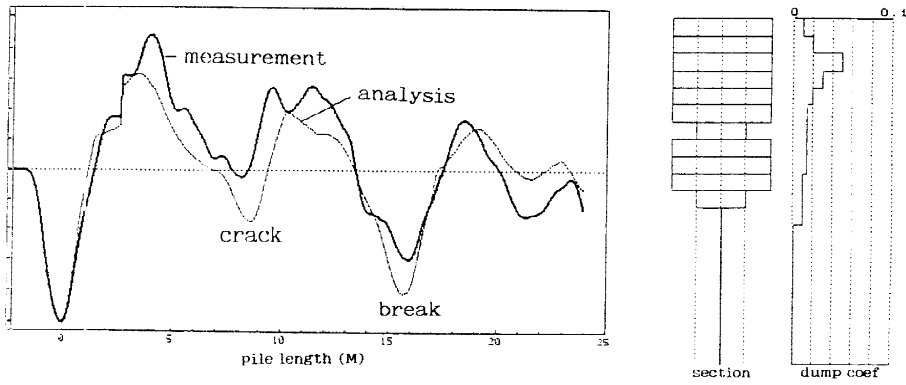
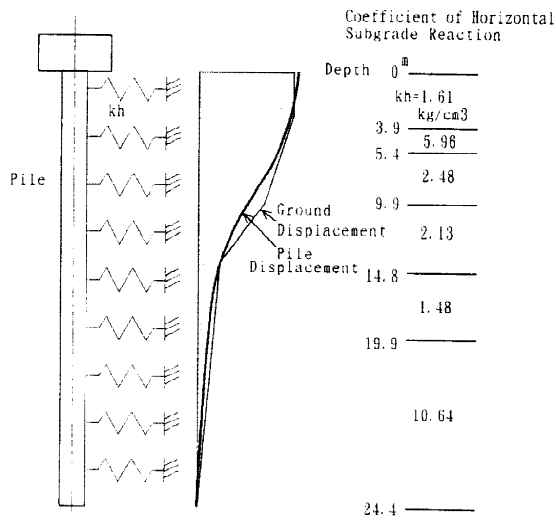
Fig.10 Analytical model

Effects of lateral soil flow on the pile are examined on an analytical model shown in Fig.10. A beam theory on Winkler supports is used in piles and horizontal soil reaction coefficients are evaluated from SPT test results in the model. Forced displacements due to lateral soil flow are applied to the pile head vicinities. Figure 11 presents plan views of foundations and piles of the building B. The analytical results are presented in Fig. 12.

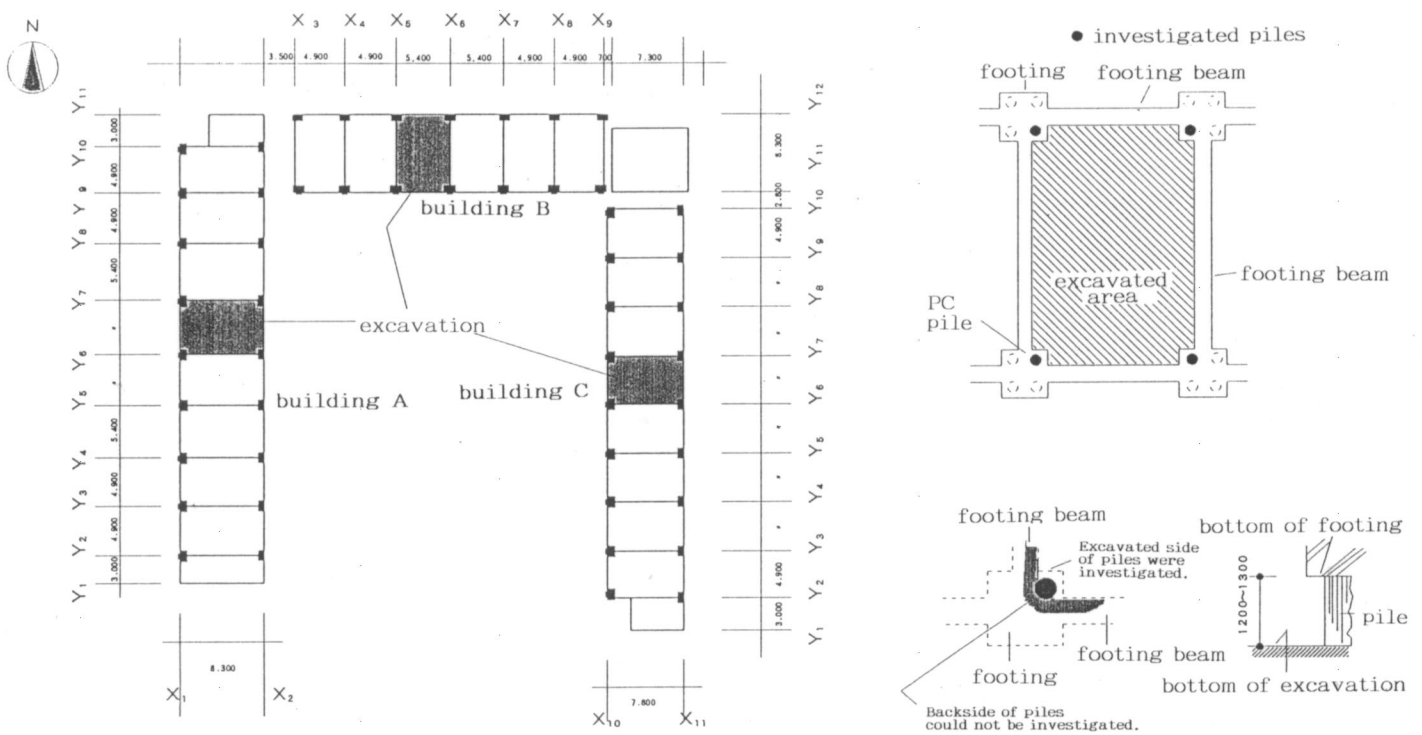
Fig.13 Site and excavation location, CASE C

Tree twelve-story apartment houses buildings A, B and C were located near to Takatori station on JR line, Suma-ku, Kobe City, and supported by precast prestressed concrete piles, as shown in Fig. 13. The buildings A, B and C tilted 10/1000 radian to the east, 38/1000 radian to the north and 9/1000 radian to the east, respectively. The building B was judged dangerous by a team of quick safety judgement just after the earthquake, and demolished. The others were
