PERFORMANCE OF SCHOOL BUILDINGS IN BINGÖL DURING THE 1 MAY 2003 EARTHQUAKE

**Turel GUR¹, Julio A. RAMIREZ¹, Mete A. SOZEN¹, A. Cihan PAY¹, Arvid M. JOHNSON¹
Antonio BOBET¹, Adolfo MATAMOROS², Ayhan IRFANOGLU³, Lili AKIN¹**

SUMMARY

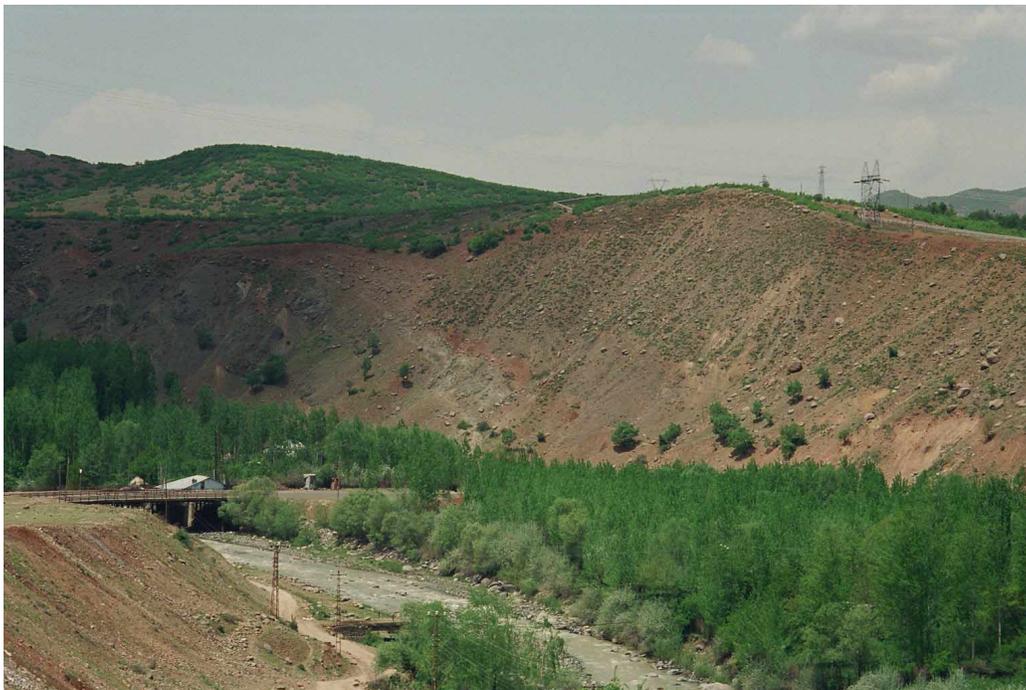
Figure 2. View southwest over the Capakçur River at western edge of Bingöl. Gravel in steep bank on right of view. Volcanic bedrock in shadow in steep bank on left of view. Contact slopes toward viewer.

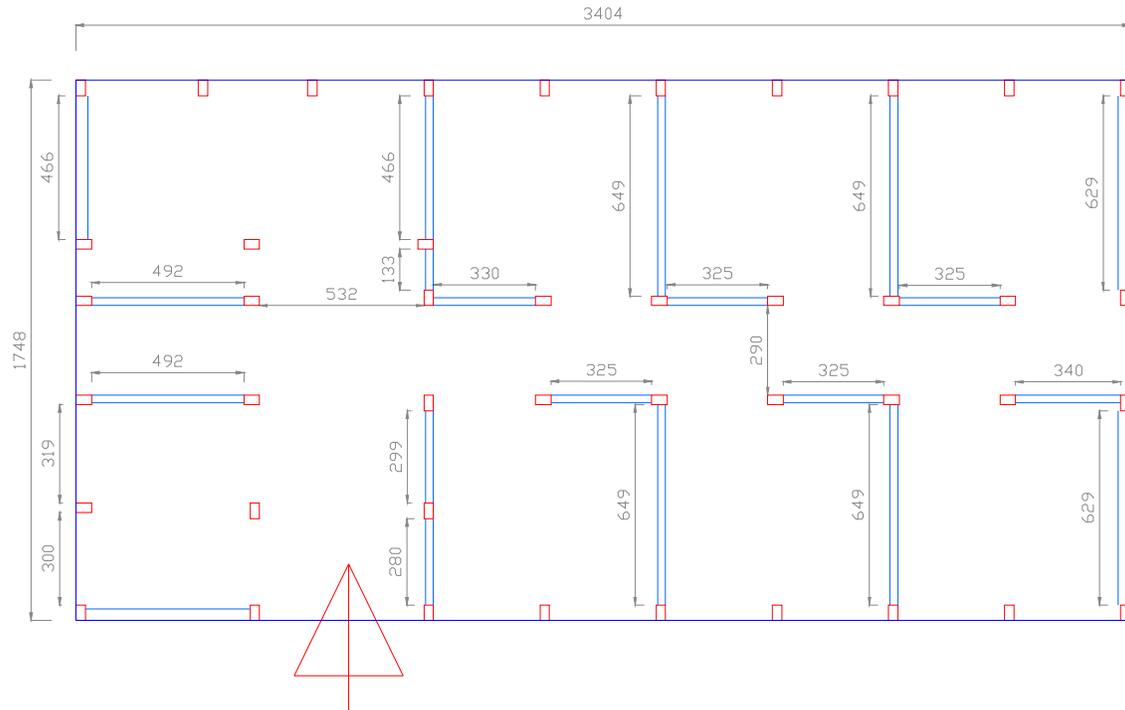
Of the 17 buildings in this category, 16 had the same column layout (Fig. 4 and 5). As the floor plan indicates, the lateral load resisting system in these buildings can be categorized as regular in plan. The majority of the columns were aligned in regular bays, and most of the beams framed into columns. The dimensions of the columns in the buildings were typically 0.3m x 0.5m. The orientation of the columns was the same in all buildings, with the exception of a corner column in building C-13-01. The locations of the masonry infill walls varied depending on the use of the space in these schools. The exterior masonry walls were typically thicker than the interior walls.

Figure 4. Typical school plan without shear walls. All the walls shown in the drawing refer to those occupying a full span. Walls with openings are excluded. All the columns have dimensions of 0.3m x 0.5m. The arrow indicates the entrance to the building. Dimensions are in cm.

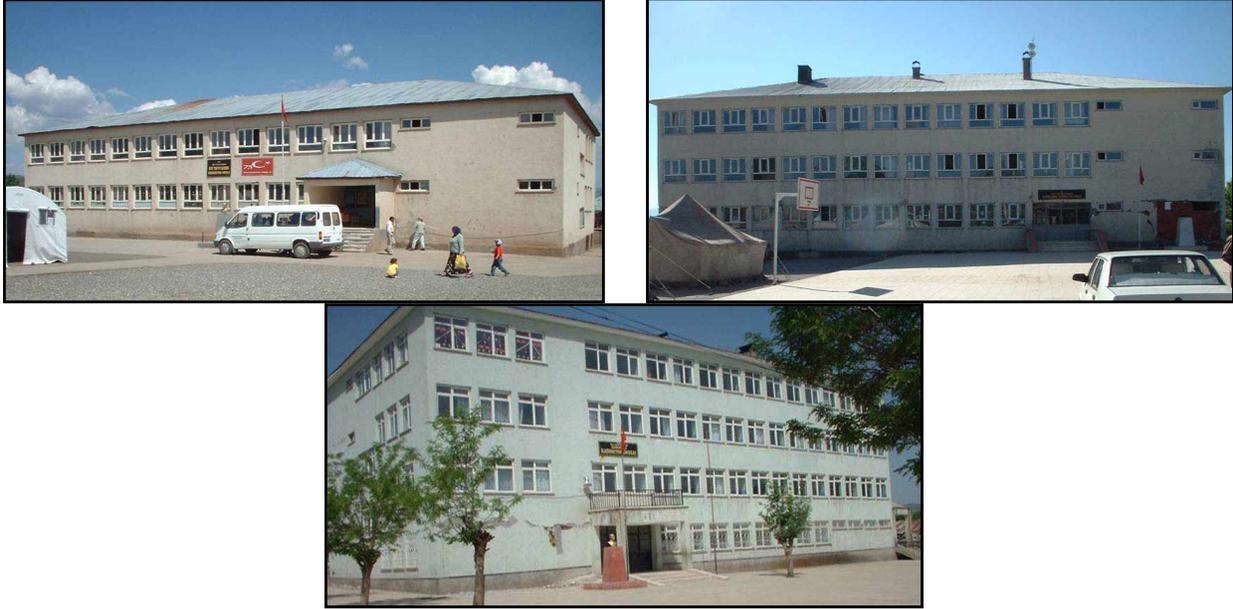
Figure 5. School buildings with typical floor plan without shear walls
