EARTHQUAKE DAMAGE OF WINDOW GLASS AND DOOR OF A HOTEL DAMAGED IN THE 1999 CHI-CHI TAIWAN EARTHQUAKE

SUMMARY

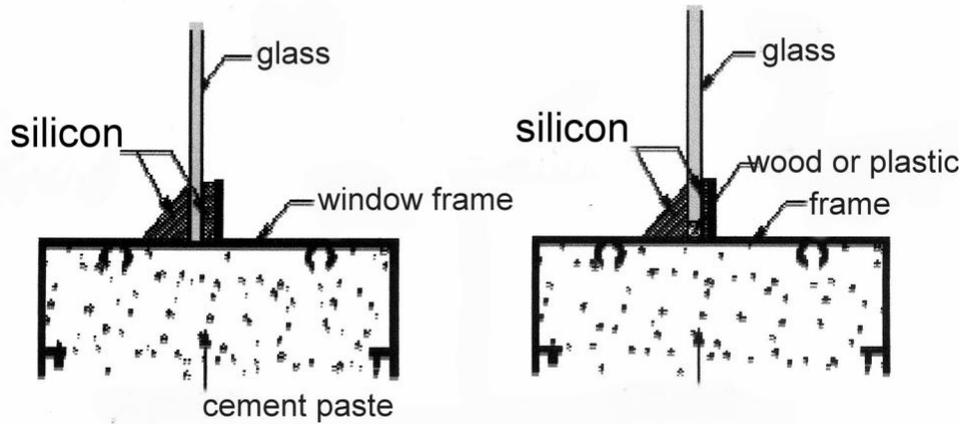
5mm thick ordinary glass was adapted in part of court skylights in this hotel, and it could be a great menace to human life if the sharp pieces falling down from top. Especially the glass of main entrance and surroundings was mostly designed as large area of fixed glass window adapted ordinary glass. We found that smaller area of unit glass(under 90cm*90cm)was directly fixed by Silicon(fig.7), but some area reached 1.5m² was barely fixed by Silicon.; As to larger area, some was broken by being compressed directly since it was fixed by layering, but the down edge of glass did not be separated by elastic gasket(fig.6). The figure.8 is the standard construction of fixed window glass.

fig.6. Frequently used glass-fixed construction _1 and 2

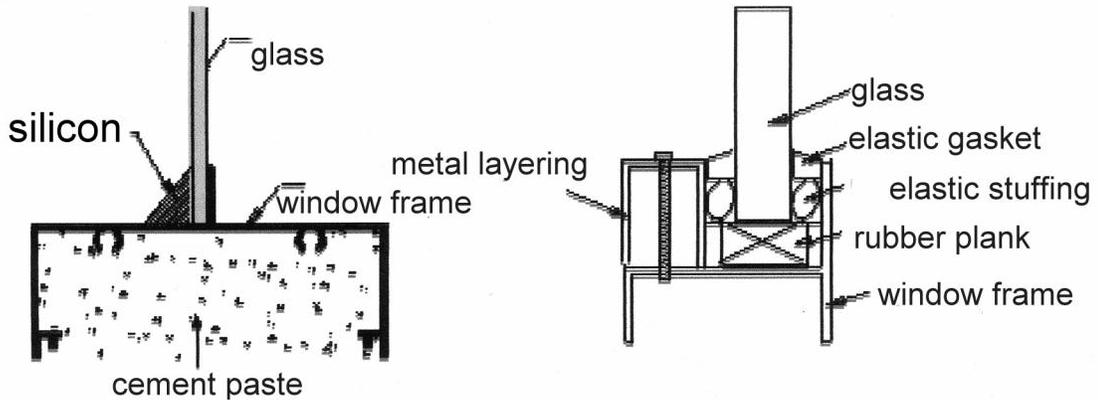
fig.7. Frequently used glass-fixed construction _3
