INNOVATIVE RESTORATION OF THE APAGNI ROMANESQUE CHURCH, DAMAGED BY THE 1997 MARCHE-UMBRIA EARTHQUAKE

M. INDIRLI¹, A. VISKOVIC², M. MUCCIARELLA³, C. FELEZ⁴

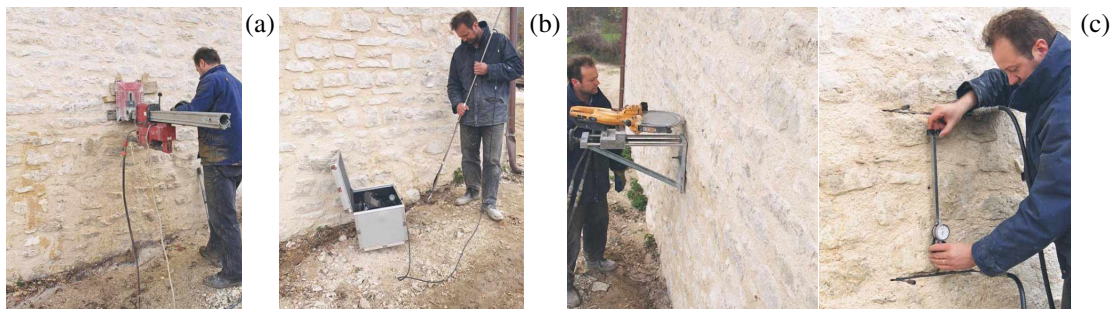
Fig. 9. Tests execution: (a) drillings, (b) survey with TV color probe, (c) flat jacks

The masonry structure of the raising walls is made by blocks of medium-large dimensions in the two external faces and a rubble fill core ("muratura a sacco") composed by smaller and less regular stones with discontinuities and cavities; the mortar is well distributed in the vertical faces, less accurate in the internal
