## **EFFECTS OF LOCAL GEOLOGY ON DAMAGE SEVERITY DURING BHUJ, INDIA EARTHQUAKE**

**J. P. NARAYAN<sup>1</sup> and M. L. SHARMA <sup>1</sup>**

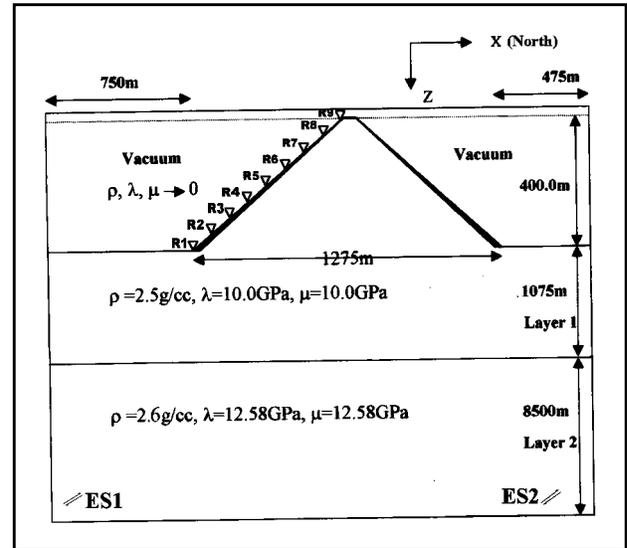
Fig. 5 Vertically exaggerated ridge model (After Narayan [9]).

Deep cracks up to the base of the weathered hill mass, displacement of boulders reveals strong surface wave generation. These observations corroborates with the simulated response computed by Narayan [9] of a weathered ridge model shown in figure 5. Slope, height, width of top and base of the considered ridge model are 32.6°, 400.0 m, 25.0 m and 1275.0 m, respectively. Weathering material properties and thickness below the recording stations are given in table 1 and 2. Ridge model was simulated using a point shear dislocation earthquake sources with focal mechanisms as dip = 90<sup>0</sup>, rake = 90<sup>0</sup> and Strike = 90<sup>0</sup> at focal depth of 9.475 km and at a distance of 0.89 km south of the ridge axis. The time step and

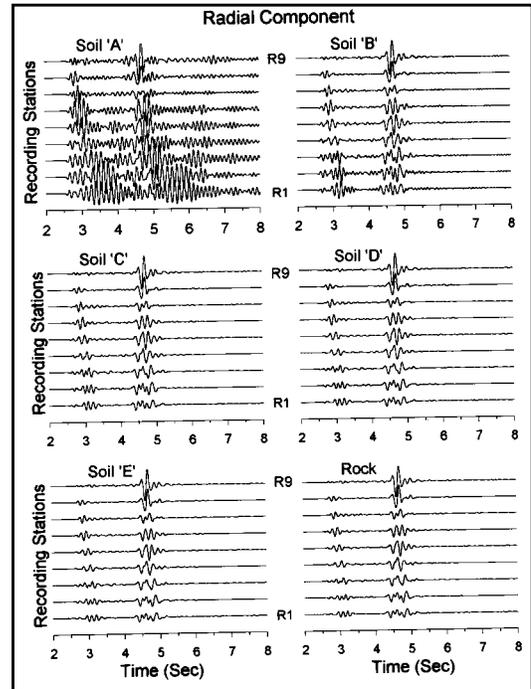
dominant frequency were taken as 0.0005 s and 5 Hz, respectively. Figure 6 shows the radial component of ground displacement for both weathered and non-weathered ridge cases. Surface waves were developed in both the weathered and non-weathered ridge cases, somewhere near the top of the ridge.

The amplitudes of surface waves are decreasing towards the top and base of the ridge except for soil 'A' where amplitude and duration of surface waves are very large and increasing towards the base of the ridge. We conclude that soft weathered materials of the Ram Dev Pir hill may have generated very large amplitude surface wave with longer duration, causing collapse of the temple and damage to hill mass itself in the form of deep ground cracks, shifting and breaking of large boulders.

*Fig.6 Radial component of the ground motion along the slope of ridge for different weathering-velocity.*
