**AN ANALYSIS OF FIRE SPRINKLER SYSTEM FAILURES DURING THE
NORTHRIDGE EARTHQUAKE AND COMPARISON WITH THE SEISMIC DESIGN
STANDARD FOR THESE SYSTEMS**

Philip D. LeGrone, P.E., CSP, CFPS¹

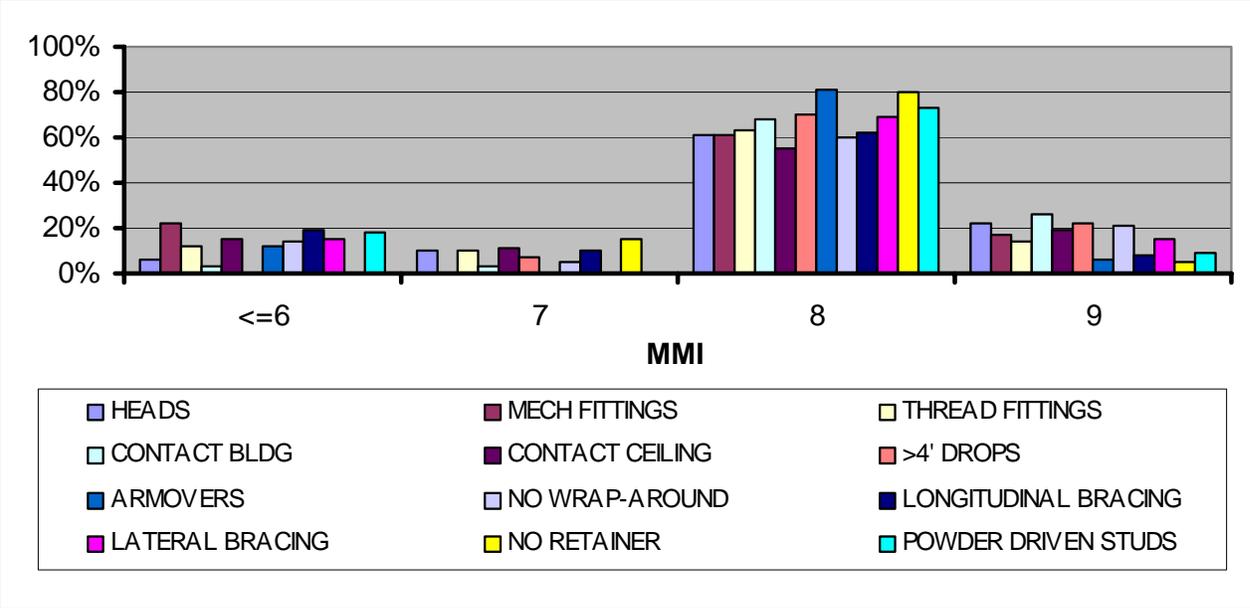
Figure 2
Percent of total data field entries at each MMI

This view of the data set highlights that the largest percentage of data entries for all data fields occurs at MMI 8. It also points out that this is true for essentially all of the data fields collected. Although this data set is too small to be considered statistically representative of the entire distribution of fire sprinkler

systems in the geographic area impacted by the earthquake it is clear from the data that there is an appreciable change in the failure rate at a damage level of MMI 8.

At MMI 9 there is a drop off in the percentage of entries, which is likely due less to better performance of systems and more to the smaller geographic area that experienced this level of intensity as displayed in Figure 1.

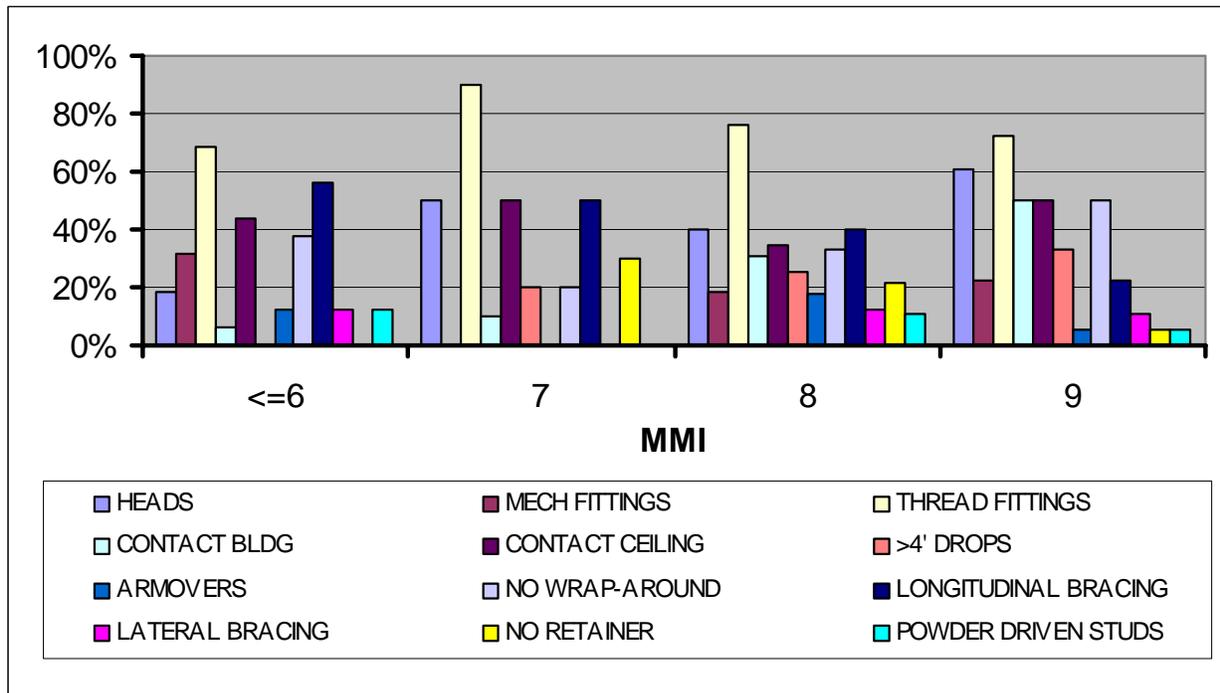
Figure 3
Percent of total data field entries at each MMI

Figure 3 provides some insight into the MMI at which each data field is populated as involved in the fire sprinkler system failure. This chart displays the percentage of facilities exposed to each MMI that had each data field populated. For example, at MMI 8 there were 75 facilities in the database of which 40% had damage to sprinkler heads populated.

Figure 3 highlights the relationship of certain data fields at various intensities to the failure of the fire sprinkler system. From a review of this figure the following three data fields are noted to be consistently populated at all intensities.

Newer sprinkler systems have a higher percentage of mechanical fittings, but threaded fittings are still quite common. Mechanical fittings is also one of the more frequently populated data fields as shown in Figure 3 at each earthquake intensity level. If a serious discrepancy between the two was noted in the data the issue would merit more in depth study into the reasons why. NFPA 13 does not treat threaded fittings any differently than mechanical fittings from a seismic design perspective.
