PERFORMANCE OF R/C AND MASONRY STRUCTURES DURING THE 2003 BINGOL EARTHQUAKE IN TURKEY

Necdet TORUNBALCI¹, OZKAN ISLER²

SUMMARY

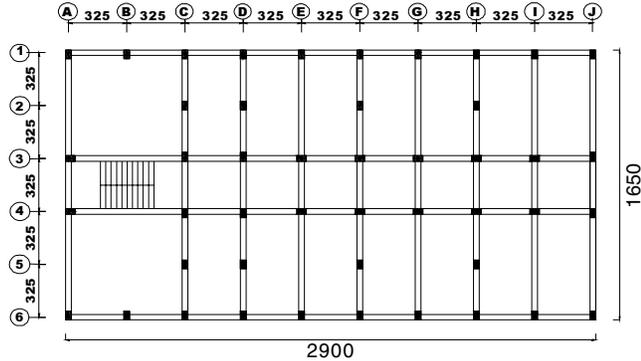
Fig. 9 Plan of the primary school building

The Primary School Building is a three-storey building with a ground storey and 2 regular stories constructed as reinforced concrete skeleton. Its dimensions in the plan are 16.50 x 29.50 m and the height of its stories are 3.50 m. The axis system of the columns is regular and the intervals of column axes are around 3.25 m and 6.50 m. Beam dimensions are 30/60 cm, column dimensions are 30/50 cm. The building is sitting on singular foundations. The ground of the buildings is alluvium-vegetable soil and the underground water level is at ground level.

Primary School Building collapsed through the complete fracturing of its columns, scattering of the concrete of its columns, heavy damage at its joints and the scraping of its reinforcements from the concrete. Although 1st and 2nd floors have not collapsed, these floors have been heavily damaged. The high vertical acceleration of the earthquake has caused the fracturing and the scattering of the columns at

the ground level. The columns, which have not collapsed but fractured from their joints, have been pushed horizontally and have punched the upper floor slabs, which have fallen on them. 1st floor slabs, which have fallen on the fractured ground floor columns have been punched by the ground floor columns also by the effect of excessive horizontal displacements. Upon the examinations, it has been noted that the pebbles in the concrete mix were 12-15 cm, and the stirrup distances were at the 40 cm level at some locations. The poor quality of the building concrete has also negatively affected the adherence. Because of the use of mild and smooth surfaced steel, the reinforcements have been scrapped from the concrete and have deformed tremendously.
