## **EXPERIMENTAL TEST ON A FULL SCALE REPAIRED R.C. STRUCTURAL WALL**

**Paolo RIVA<sup>1</sup>, Alberto MEDA<sup>2</sup> and Ezio GIURIANI<sup>3</sup>**

### **SUMMARY**

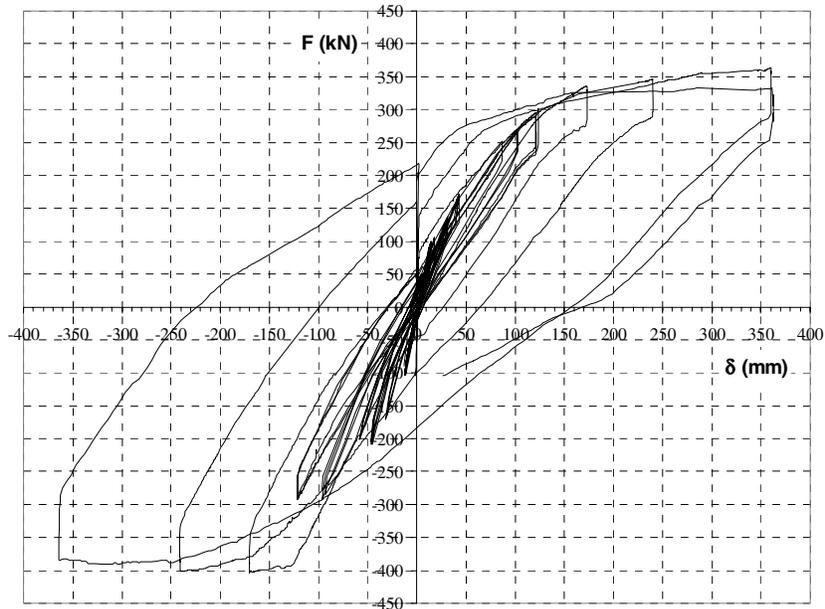
**Figure 5 - Force  $F$  versus end displacement  $\delta_y$  for the cycles after  $\delta_y$ .**

Figure 5 shows the force-versus-top displacement response of the wall up to collapse. The wall yielded at a displacement amplitude approximately equal to  $\delta_y = 120$  mm. Collapse occurred during the second cycle at  $3\delta_y = 360$  mm due to sliding shear failure. A stable structural response was observed up to collapse. In fact, no significant strength and/or stiffness degradation was observed during cycles following yield.

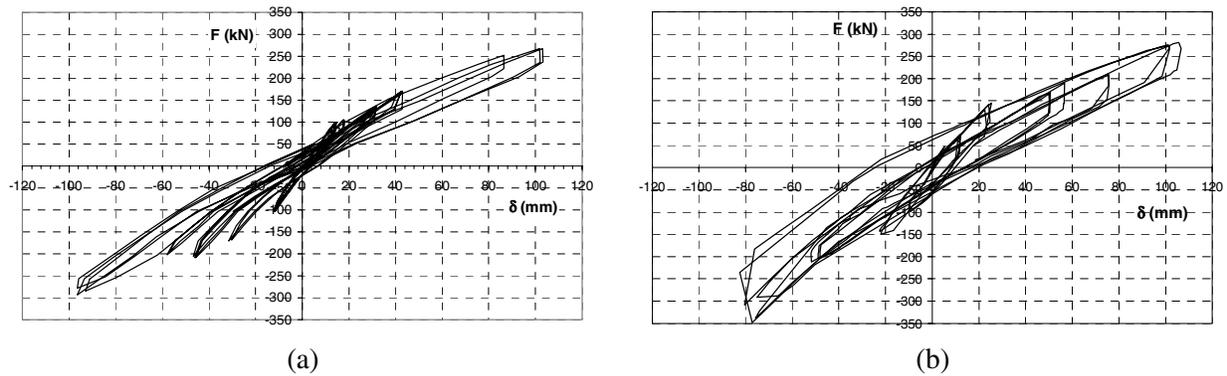
**Figure 10 – Comparison of the original (a) and repaired wall (b) response up to yielding.**

Figure 10 illustrates a comparison of the applied force-vs-end displacement response of the repaired and original walls. The repaired wall has a stiffness comparable to the original one, while a more pronounced hysteretic behaviour is evident.

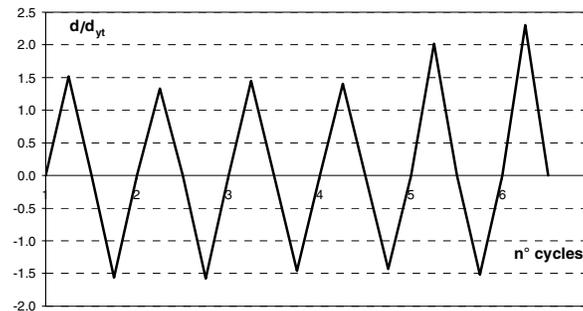
**Figure 12 – Loading history from yielding to failure.**

Figure 12 illustrates the loading history adopted during the test. In order to find the structural yield displacement, the load was initially increased until the intersection between two lines tangent to the load-displacement curve in the II stage (after cracking) and in the III stage (after yielding) could be determined in both loading directions. The yield displacement was found to be approximately equal to  $\delta_y \approx 135$  mm.

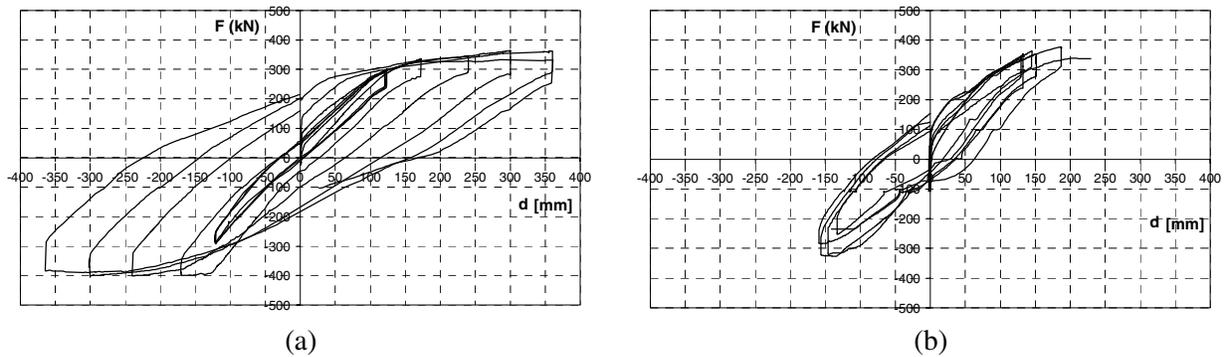
**Figure 14 – Comparison of the original (a) and repaired wall (b) response up to failure.**

It is furthermore observed that, while bending moment linearly decreases along the wall, shear action is constant next to the wall support (Figure 2). Hence, providing sliding shear overstrength only next to the base section, where the collapse of the original wall was observed, was not sufficient and somewhat detrimental. In fact, the added web reinforcement contributed to considerably increase the bending strength of the base section, moving the critical section closer to the end of the repaired part of the wall, where the mechanical couplers were present.
