# GEOLOGICAL CONDITIONS AND SOIL DEFORMATIONS IN THE JULY 17, 2007, CHUETSU OFF-SHORE EARTHQUAKE

KEYWORDS: Chuetsu Offshore Earthquake, sand dunes, crack patterns, infrared images

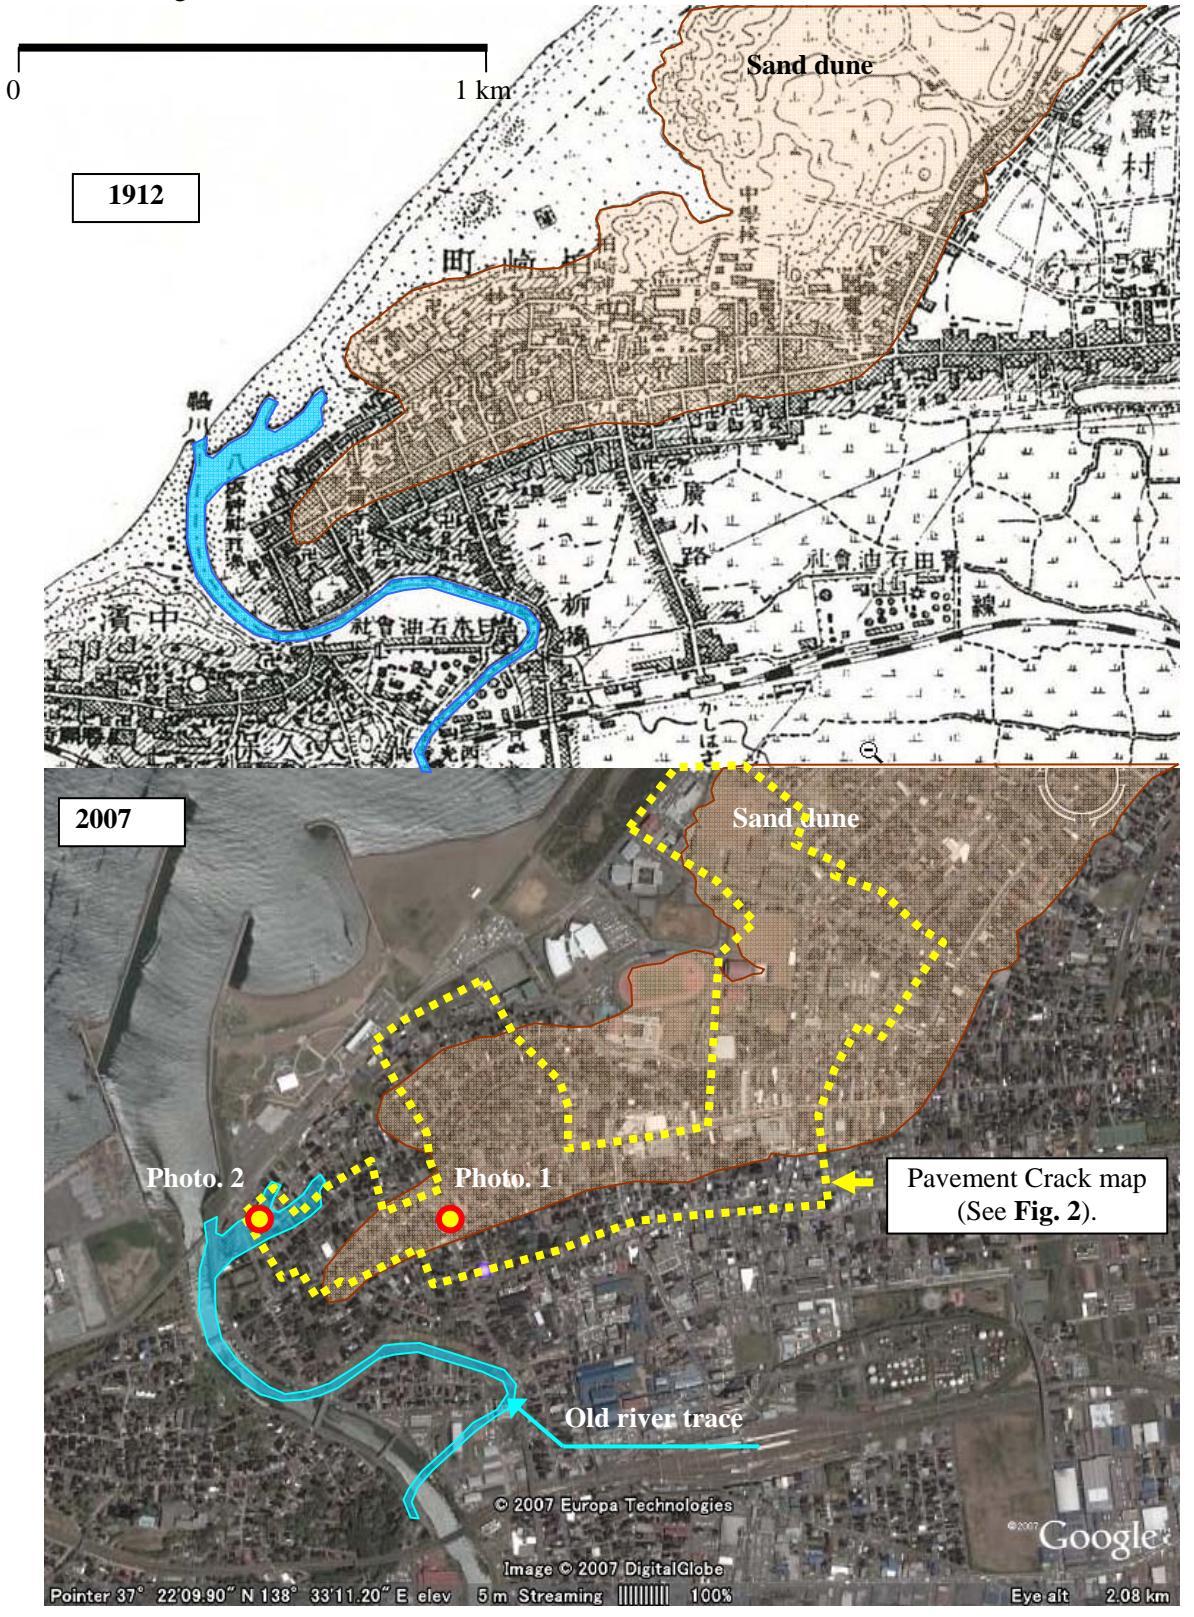
suspended matters that waters of these two rivers have carried over centuries have been deposited south-east behind the sand dunes. Fig. 1 shows that the old river trace of Ugawa had a meander near the south end of the sand dune and a lagoon at its mouth.

Figure 1. Satellite imagery in 2007 of Kashiwazaki (Google Earth) and a topographical map of the same area in 1912. Location of lower left corner of the satellite imagery: 37°21'38.87"N, 138°32'22.29"E
