## PERFORMANCE OF SEISMIC ISOLATED BUILDINGS DUE TO 2005 WEST OFF FUKUOKA EARTHQUAKE IN JAPAN

Keiko Morita<sup>1</sup> and Mineo Takayama<sup>2</sup>

**KEYWORDS:** Seismic Isolated Buildings, Response Behavior, 2005 West Off Fukuoka Earthquake

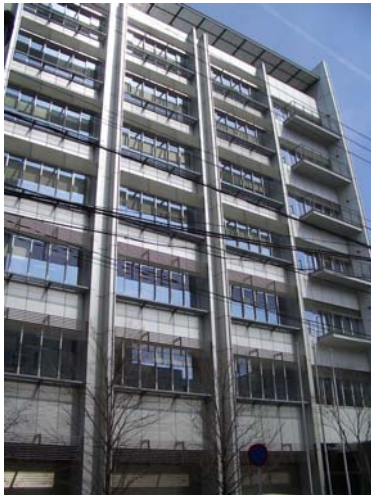
Photo 2 Appearance of Building C

Building C stands near the Kego fault. Photo 2 shows the appearance of the building, and Photo 3 shows the damage of the entrance area. It is considered that the damage which occurred on the tiles of the staircase because the clearance between upper and lower is small. The width of the damage on the staircase is approximately 25cm, and it is presumed that larger displacement than that occurred. An orbit drawn by the angle of an iron sheet placed on the access to a side door was found (Photo 4). Although no displacement orbit in the south side remains, the movements of the seismic isolated buildings were greater in the direction of south-north than east-west, and it reached a maximum of approximately 30cm. The observed acceleration was greater in the direction of south-north than east-west, and the maximum acceleration of 203gal was observed at 65m underground, 489gal at the basement of seismic isolation layer, 238gal on the 1<sup>st</sup> floor and 234gal on the highest floor (the 7<sup>th</sup> floor). The maximum response acceleration was damped by half against the input acceleration.

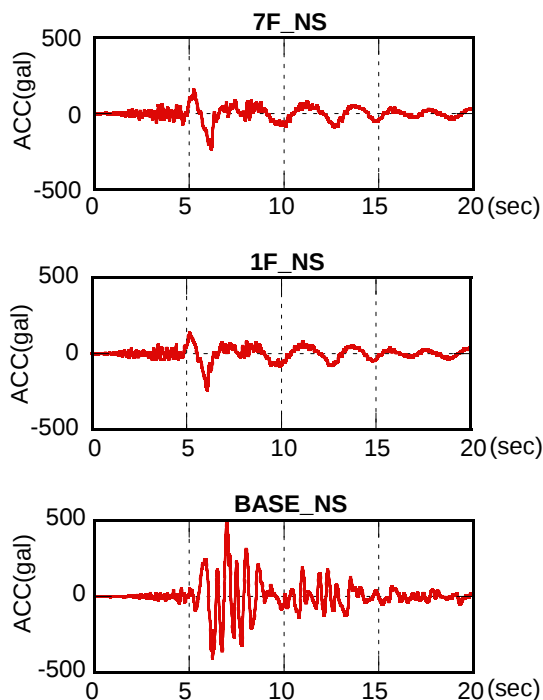
Figure 2 Acceleration Records of Building C(NS-dir.)

Seismic observations are performed at four locations such as 65m underground (above the foundation of  $V_s=500\text{m/s}$ ), at the basement of the seismic isolation layer (1.8m under the grounds surface), on the 1<sup>st</sup> floor and the 7<sup>th</sup> floor. Table 3 shows the observed maximum accelerations. From the observation record in the horizontal direction, the acceleration at the basement of seismic isolation was amplified to 2.5 times that at 65m underground, and the acceleration of the superstructure was damped to less than 1/2 of that at the basement. The acceleration in the vertical direction at the superstructure was damped to 1/1.3-1/1.5 against that at the basement. Generally speaking, the acceleration response in the vertical direction is amplified in a seismic isolation structure. However, according to this record, the seismic isolation also worked in a vertical direction to some extent. Figure 2 shows acceleration records in the direction of north-south. The records on the 1<sup>st</sup> floor and 7<sup>th</sup> floor were almost the same, which means that the superstructure swayed as a rigid body and the swaying period was approximately 3 seconds.

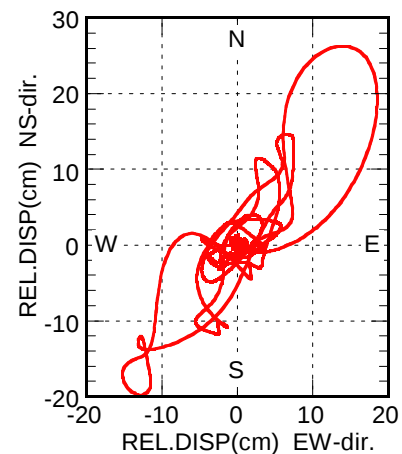
Figure 3 Relative Displacement of Seismic Isolation Layer of Building C

Figure 3 shows the relative displacement of the seismic isolation layer. An absolute displacement record was

calculated through integration of the acceleration data observed at the basement and in the flooring of the 1<sup>st</sup> floor. A relative displacement record of the seismic isolation layer was obtained from the difference between both response deformations. From comparison of this Figure 3 with Photo 4, although the maximum deformations on the north side were in approximate correspondence with each other, the orbits before and after these maximal deformations were drawn in different behaviors. It is presumably that because, as shown in Photo 4, the iron sheet was just placed, the motion before and after the maximum deformation was too fast to leave its orbit. The maximum deformation of the seismic isolation layer was 30cm, which shows that the seismic isolation layer was affected by the deformation to the extent of that predicted at the time of design. It also shows that the seismic isolation layer moved linearly in the direction of north-east.

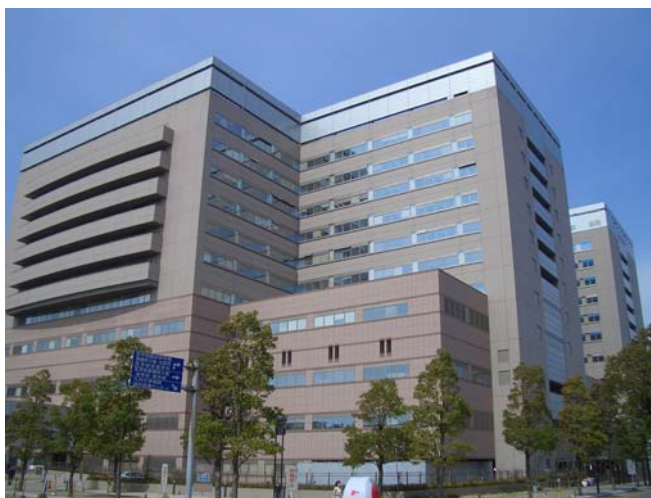
**Photo 5 Appearance of Building F**

As shown by the appearance of the building in Photo 5, this is a large-scale hospital. The entrance bridge of the southern side is an expansion structure. However, the expansion part of handrail did not work well during the earthquake, and as that result, the handrail and exterior wall were damaged (Photo 6). From the observed acceleration record at the time of the earthquake, it is judged that this did not affect the seismic isolation capability of the building. An inpatient on the 6<sup>th</sup> floor said that she noticed the slow horizontal motion during the earthquake, but there was no damage or overturning of shelves. In an adjacent hospital ward, which is an earthquake-proof building, bookshelves overturned and cracks were generated in the wall. Photo 7 shows a displacement orbit drawn by an orbiter installed in the seismic isolation layer. The deformation volume of the seismic isolation layer was larger in the direction of south-north than east-west, and the deformation was repeating in approximately two cycles with the amplitude within the maximum displacement of 15 cm.

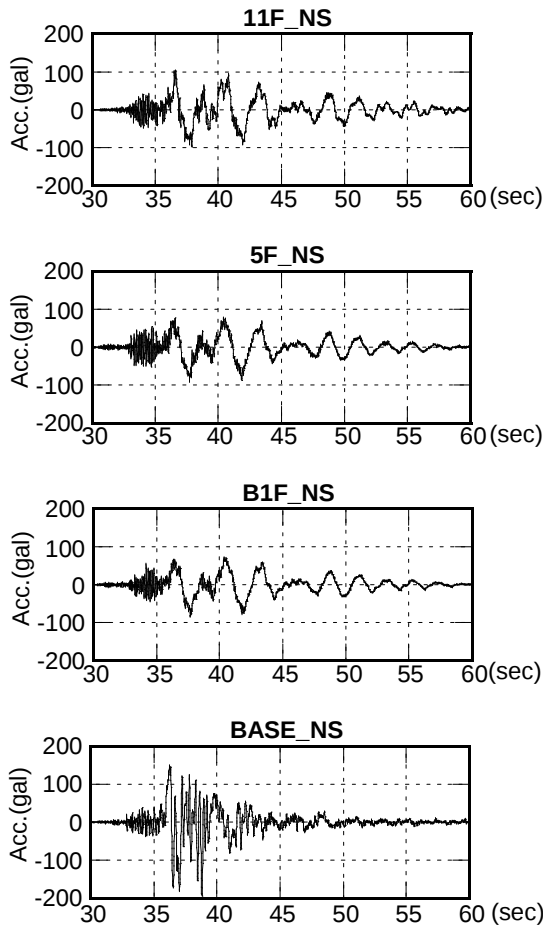
**Figure 4 Acceleration Records of Building F(NS-dir.)**

Figure 4 shows the acceleration record in the direction of north-south. The acceleration record remains as almost the same form in on each of B1-11 floors, which means that each floor moved slowly in the same behavior. From the response acceleration record, it can be perceived that the superstructure moved slowly.

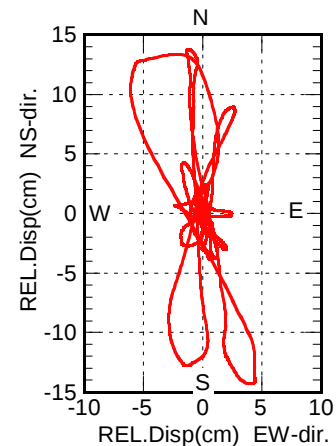
**Figure 5 Relative Displacement of Seismic Isolation Layer of Building F**

Figure 5 shows the relative deformation of the seismic isolation layer obtained by the acceleration record observed as in the case of Building C. The shockwaves of Building F moved in the direction of south-north, and it was revealed that deformations of approximately  $\pm 15\text{cm}$  occurred two or three times. This Figure 5 corresponds approximately to the orbit of Photo 7, and it was determined that the performance of the seismic isolation layer could be estimated from the integration of the acceleration record.

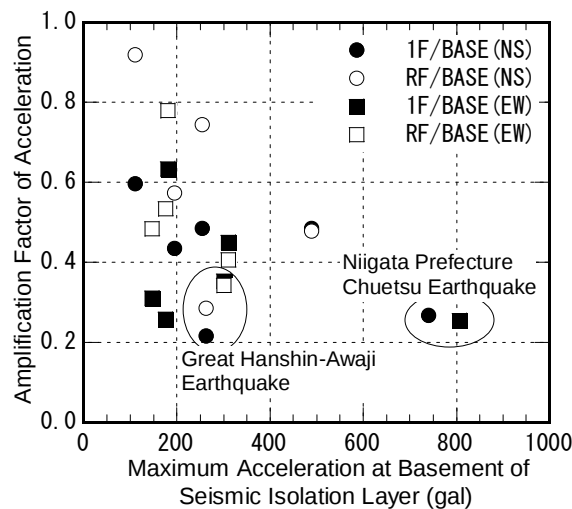
**Figure 6 Amplification Factor of Observed Acceleration of Seismic Isolated Buildings**

Figure 6 shows the maximum response accelerations observed in seismic isolated buildings. The horizontal axis shows the maximum acceleration at the basement of the seismic isolation layer and the vertical axis shows the ratio of the maximum accelerations (amplification factors) of the 1<sup>st</sup> floor (1FL) and the highest floor (RFL) against that of

the basement of the seismic isolation layer. Examples of observed results from each of the Niigata Prefecture Chuetsu Earthquake and the Great Hanshin-Awaji Earthquake are added to this Figure. From all observed results, it is revealed that the accelerations of the superstructure were more greatly damped than those of the basement (input acceleration) and that the larger the escalation of the basement, the greater the effect of seismic isolation becomes. It is very important to collect such basic observational data as it is necessary for the better development of seismic isolation structures.
