## PERUVIAN SEISMIC DESIGN PRACTICE PRODUCED UNDAMAGED BUILDINGS IN PERU'S LATEST EARTHQUAKES

J.R. Pique<sup>1</sup> and R. Salinas<sup>2</sup>

**The 14<sup>th</sup> World Conference on Earthquake Engineering**  
**October 12-17, 2008, Beijing, China**

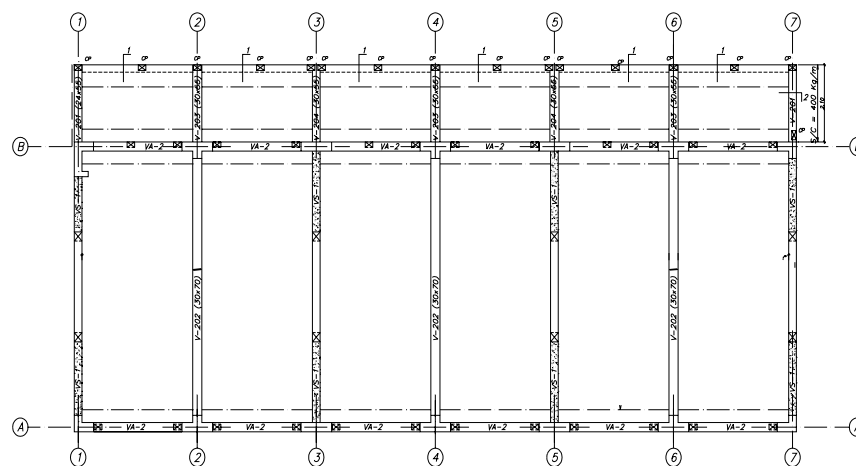
Figure 13- Typical school structure plan: Two or Three stories. Reinforced masonry in one direction. Wide concrete columns (small shear walls) in the other.

Figure 11 shows another hospital building, this from the social security and a school building, both designed with older standards and heavily damaged. On the other hand, in the same city of Pisco, new school buildings designed and built with 1997 and 2003 standards with no damage whatsoever.. Figure 13 shows a typical structural plan of these school buildings (Miranda et al, 2005). The structure is confined clay masonry in one direction and a frame with wide columns in the other. Older designs used slender columns which resulted in a flexible structure with large displacements. Because stringent limited displacements new designs had a need of more rigid columns which resulted in reduced displacements. These show excellent response.
