SEISMIC EVALUATION AND RETROFIT PLAN OF EXISTING REINFORCED CONCRETE BUILDINGS OF ALGIERS IN ALGERIA

Akira INOUE¹, Mehani YOUCEF²

¹OYO International Corporation, Tokyo, Japan, ²National Earthquake Engineering Research Center (CGS), Algiers, Algeria Email: inoue@oyointer.com

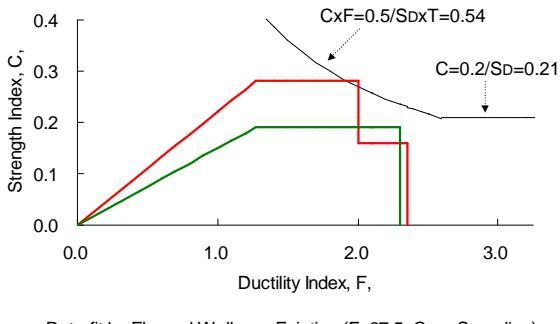
Figure 2 Ductility Index and Strength Index Relation

The method that providing RC walls for the 1^{st} storey to the 4^{th} storey was planned to increase strength, as shown in Figure 1. These were evaluated as flexural walls with the ductility index of 2.0. The value of *Is* of the 1st, 2nd, 3rd and 4th storey were increased to more than 0.50 as shown in Table 1. The relationship of the ductility index and the strength index at the 1st storey is shown in Figure 2. Typical detail for retrofit of reinforced concrete wall is shown in Figure 3.

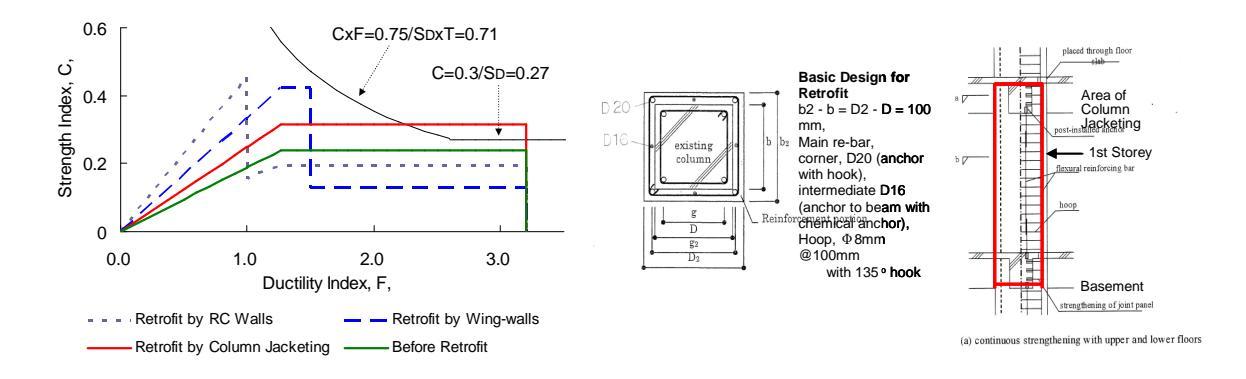
Figure 7 Ductility Index and Strength Index Relation

The value of *Is* for Case 1 was decreased because of the shear walls with the ductility index of 1.0. The value of *Is* for Case 2 was decreased because of the columns with wing-walls with the ductility index of 1.5. The value of Is for Case 3 was increased to 1.06 with maintaining the original ductility index. CTSD was increased to 0.35. The value of S_D has increased from 1.0 to 1.1 due to the stiffness increase for Case 3. The relationship of the strength index and the ductility index in the X direction of the 1st storey before and after the retrofit is shown for 3 Cases in Figure 7. The standard detail for the column jacketing is shown in Figure 8.
