## DYNAMIC BEHAVIOR OF ADOBE HOUSES IN CENTRAL MEXICO

### ABSTRACT:

Inside the towns of Zacatepec, Coyoacán and Tlayacapan exists adobe houses damaged by earthquakes. In Zacatepec typical adobe house was chosen in order to determine their dynamic behavior experimentally *in situ*. A reproduced model 1:10 was tested on vibration table, reproducing seismic ground motion caused by an earthquake at that period.

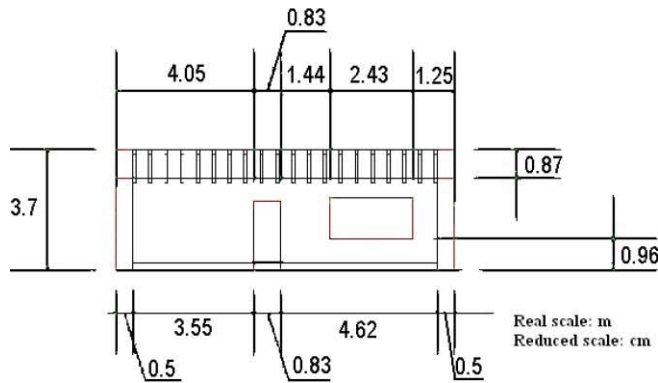
Fig. 1. Sketch of adobe house

In order to analyze a representative construction of the existing buildings of adobe a search was made in the municipalities close to Puebla City, Cholula and Huejotzingo. The selected house is located in *Santa Maria Zacatepec* at 15 km from Puebla City. Adobe house dimensions and its configuration are showed in figures 1 and 2.

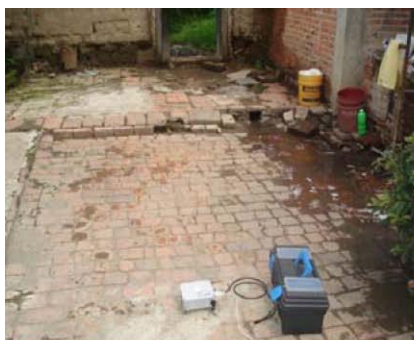
Environment vibration records were taken with Noise Tester SR04, 24 bit digitizer, SARA equipment. It has three orthogonal channels. We registered on the base and on the roof (fig. 3 and 4). Each record has approximately three minutes.

Fig. 3. Vibration records on the ground.

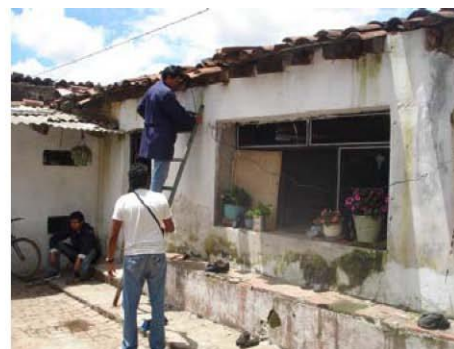
Fig. 4. Vibration records on the roof.

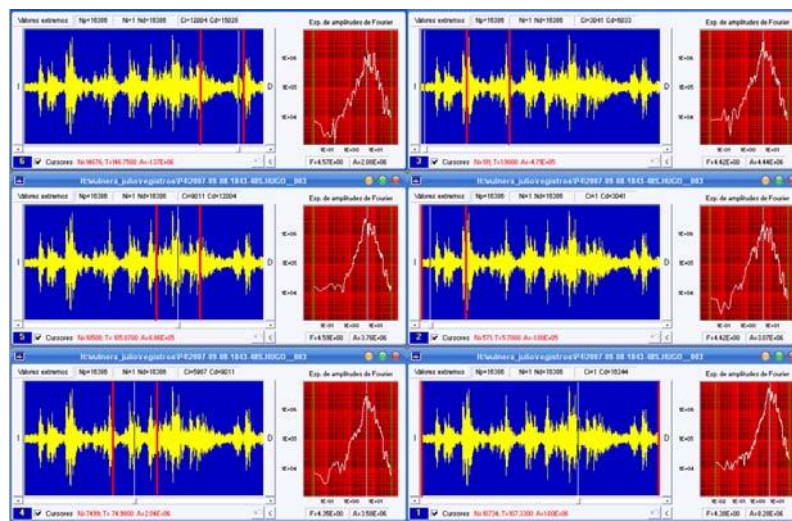
Fig. 5. Noise records and FFT graphics, N-S component.

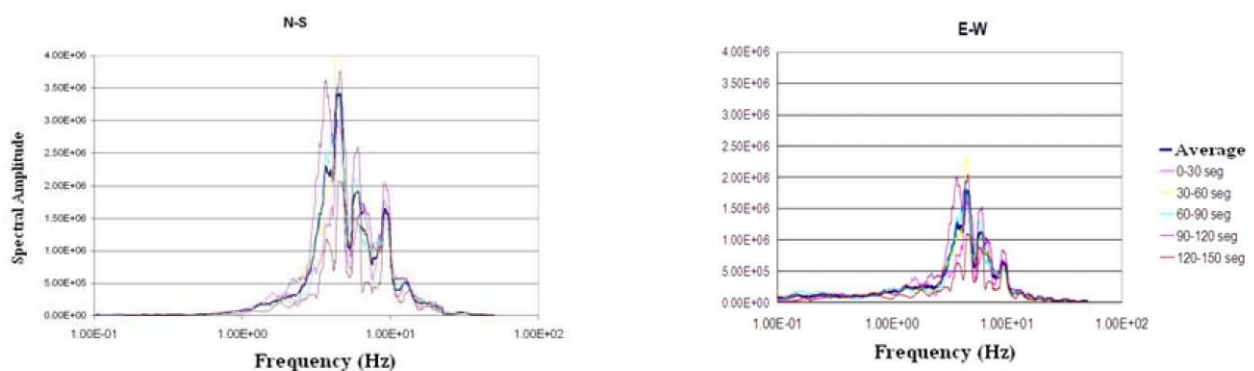
a) b)  
Fig. 6. FFT Average, a) N-S b) E-W.

The  $f_n$  is 4.42 Hertz (fig. 6) both directions (the North-South and the East-West) reason why its natural period is of 0.22 s.

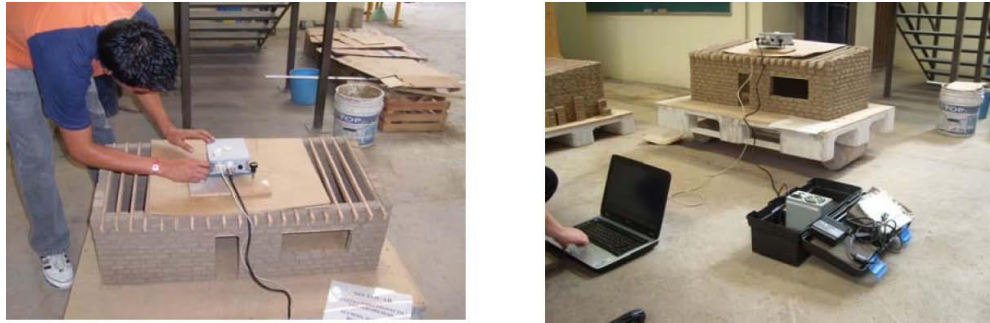
Fig. 7. Recording noise on the Scale model.

The seismic event was simulated on rollers in order to observe the damages that it would generate in the structure. Also environmental vibration registries were taken in the scale model (fig. 7) before and after the simulation to be able to observe in both cases the dominant periods with the same method previously seen.

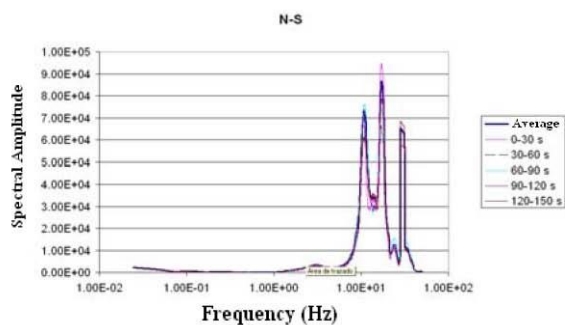
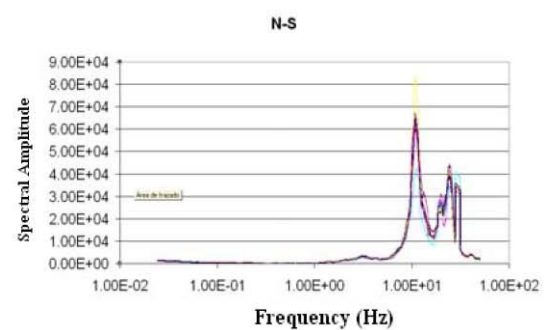
Fig. 8. FFT Average, N-S component, a) before the test b) after the test.

The  $f_n$  before the test was 10.9 Hertz (fig. 8 and 9) both directions (the East-West North-South and) reason why its natural period is of 0.09s, and after the test  $f_n$  is of 17.1 Hertz in both directions reason why its period after the test is of 0.056 s.

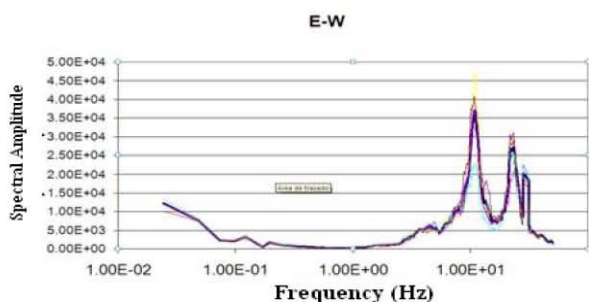
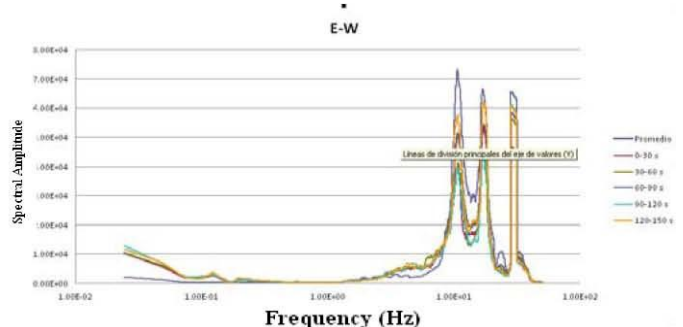
Fig. 9. FFT Average, E-W component, a) before the test b) after the test.
