# DESIGN LOAD EVALUATION FOR TSUNAMI SHELTERS BASED ON DAMAGE OBSERVATIONS AFTER INDIAN OCEAN TSUNAMI DISASTER DUE TO THE 2004 SUMATRA EARTHQUAKE

Y. Nakano<sup>1</sup>

## ABSTRACT :

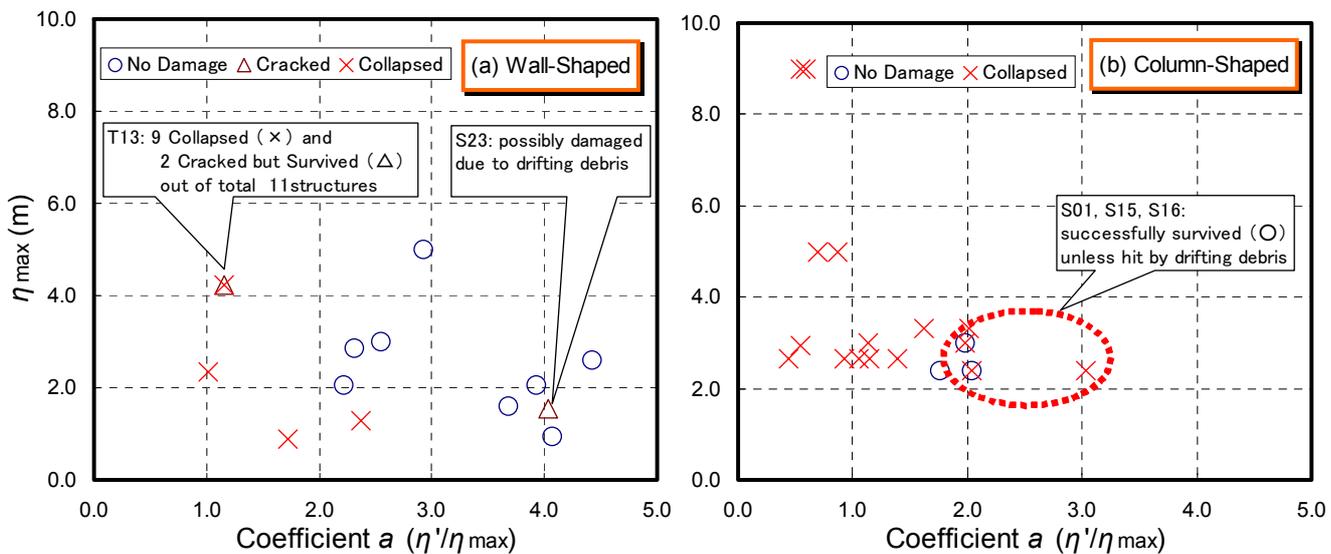
Figure 4 Computed Coefficient  $a$  vs. observed tsunami inundation depth  $\eta_{max}$   
 (Numerals in the figure denote ID Nos. in Table 1)

Table 1 shows the investigated tsunami inundation depth  $\eta_{max}$  and the computed coefficient  $a$ . Their relationship is shown in Figure 4(a) for wall-shaped structures such as fence walls and in Figure 4(b) for column-shaped structures such as cantilever RC columns, respectively, where the structure type is determined based on the shape of member on which the tsunami attacks. When the structures with identical structural properties have different failure patterns due to the effects of drifting debris or some other reasons, two marks corresponding to different failure patterns are plotted at the same point of the figure.

Figure 4(a) shows that structures with the value of  $a$  greater than 2.5 have no major damage except for the case S23 that may have been damaged due to drifting debris, and the value of 3 for the coefficient  $a$  proposed in the guidelines can be considered rational to avoid serious damage due to tsunami attack. It should be noted, however, that the structure (S23) having the coefficient  $a$  greater than 4 suffers wall cracking, and the coefficient of 3 may not be conservative if the load amplification due to drifting debris is taken into account, and countermeasures to protect structures from damage due to drifting debris need to be taken.

Figure 4(b) shows that the coefficient  $a$  for column-shaped structures to discriminate between damaged and survived may lie at around 2 when the effects of drifting debris are neglected, which is slightly lower than that for wall-shaped structures. This result implies that column-shaped structures have advantage in tsunami

resisting performance over wall-shaped structures on condition that both structures have enough seismic capacity to survive the ground shaking prior to the tsunami attack. It should also be noted, however, that the column-shaped structures can not be left undamaged at the coefficient  $a$  in the range of 2 to 3 as shown for the cases of S01, S15, and S16, and countermeasures against drifting debris need to be taken to protect structures as is the case of wall-shaped structures previously described.
