## CONSIDERATION OF DAM SAFETY AFTER WENCHUAN EARTHQUAKE IN CHINA<sup>1</sup>

Chen Houqun

In this paper in view of the dam safety some special features of the Wenchuan Earthquake on May 12, 2008 in China are noted. The damages and behavior of dams, especially for the 4 dams with a height over 100m, in the area affected by the earthquake are briefly described. The lessons concerning dam safety learnt from the devastating quake are preliminarily drawn. As the seismic safety of high dams during strong earthquake is the problem caused wide attention around the world, some critical problems related to the dam construction in China are considered and discussed after the Wenchuan earthquake, such as: “Why the dam construction is necessary in China as a seismic country?”, “How to evaluate the seismic safety of high dams built in the western region of China with seismogenic structures?”, “Whether the reservoir impounding of the Zipingpu and the Three Gorges Projects could trigger the Wenchuan Earthquake?”, “What is the major challenge has to be faced for Chinese dam engineers of seismic aspects?”. Finally, the corresponding tactics with response to the challenge are suggested.

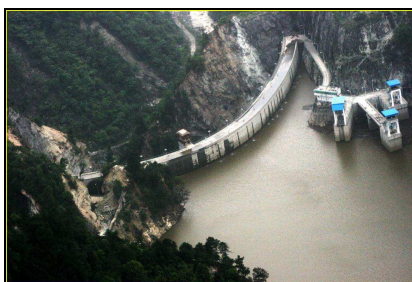
Fig.7 Aerial photo of Saipai dam

Saipai dam of 130 m high completed in 2006 is the world's highest RCC arch dam at that time. The dam is a three-center gravity arch structure having a crest length of 250.25m. It is 9.5m thick at the crest and 28m at the base. The dam is located 30km away from the epicenter and the reservoir kept its normal water level of 1866.0m during the quake. There are two contraction joints and two induced joints along the arch direction. The dam is founded on granite and granodiorite formations making up the relatively steep-walled and V shaped canyon. The dam abutments are supported by rock mass of class II without continued plane of weakness. The seismic design of the dam has been carried out with a design peak acceleration of 0.138g corresponding to a return period of about 500 years based on a special seismic hazard analysis for the dam site. The dynamic responses of the dam were checked both by dynamic trial method and finite element method. The dam site is still not accessible due to the road blockage by the landslides so far. However, base on the aerial photo and report from individual investigator entered by walking, it revealed that the dam including its anchored abutments is stable without evident damages (Figs.7-8). But the power plant has been inundated due to the collapse of the partial penstock being across the river.
