## NON-STRUCTURAL COMPONENT PERFORMANCE IN 4-STORY FRAME TESTED TO COLLAPSE

### ABSTRACT :

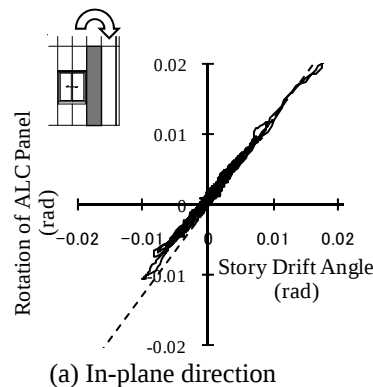
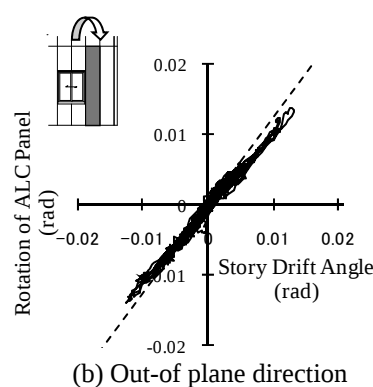
Figure4 Rotation behavior of the ALC panels at the 1st story by 0.6 Takatori records

Figure 4 shows an example of rotation behavior of the ALC panels under 0.6 times the Takatori records. The dotted line in this figure indicates that the story drift corresponds to the rotation of the ALC panel. So the results of the experiment almost behaved on this dotted line, it is understood that the ALC panels were accommodated to the story drift for both in-plane rotation and out-of-plane rotation. Similar relationships are confirmed under 0.2 and 0.4 times the Takatori records. The results of Figure 4 were provided from the hatching area in the figure. Similar measurement to the openings of the window or the adjacent ALC panels was performed, so the same relationships between the story drift and the rotation were obtained.

(a) In-plane direction

(b) Out-of plane direction

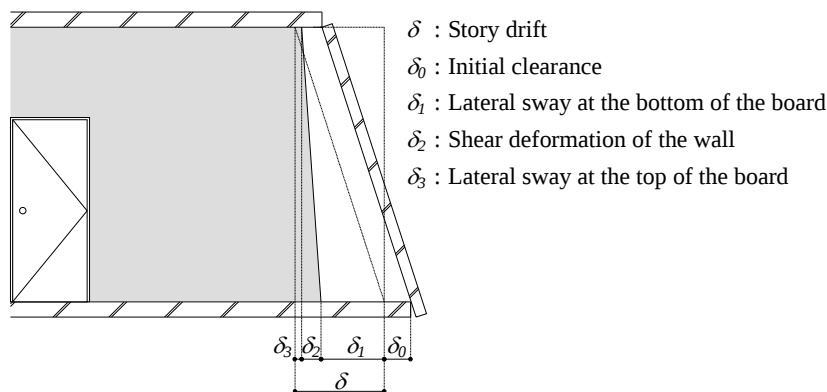
Figure8 Sway and deformation of the drywall partition

As shown in Figure 8, the story drift  $\delta$  is expected to correspond to the summation of three kind of displacement of the drywall partition. The first one is the lateral sway at the bottom of the board  $\delta_1$ , the second one is the shear deformation of the wall  $\delta_2$ , and the third one is the lateral sway at the top of the board  $\delta_3$ ; where  $\delta_2$  contains the deformation of the board, the metal-stud and the fastener. Figure 9 shows the relationships between the story drift and the lateral sway  $\delta_1$  or the shear deformation  $\delta_2$  of the drywall partition at the 3rd

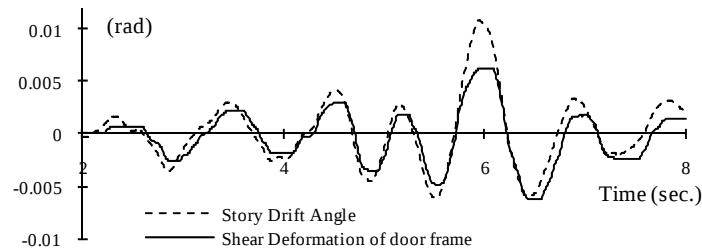
Figure10 Shear deformation of the door frame at 2nd floor by 0.4 Takatori records

The shear deformation angle of the door frame, which is the non-seismic type at each floor, was measured. Figure 10 shows the time history of the story drift and the shear deformation of the door frame at the 2nd story under 0.4 times the Takatori records. The two values almost corresponded when the story drift was less than 0.005 rad. However, when the story drift exceeded 0.005 rad, the shear deformation of the door frame was not accommodated to the story drift without increasing. It is expected that the reasons of this result are loosening of

the screw which fasten the vertical supporting frame of the door to the slab, and the local deformation of the reinforcing bar or the steel plates connecting the door frame and the supporting frame. Consequently, the shear deformation of the door frame did not become excessive. Despite of the maximum story drift of approximately 0.02 rad during the shake test, the door could be opened and closed.

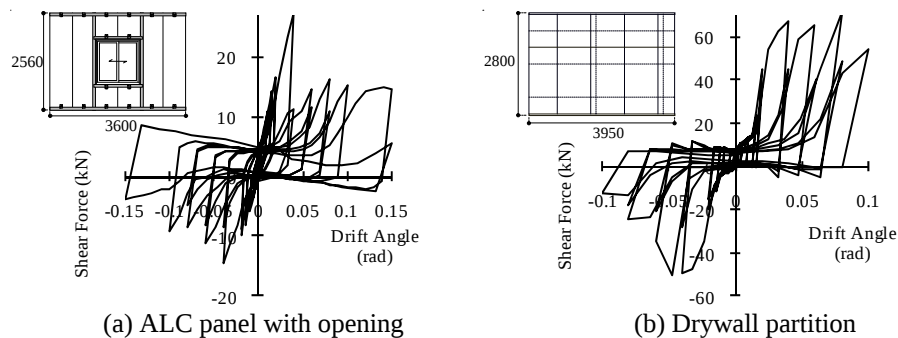
Figure11 Results of the element tests

The lateral resistance and the stiffness of the ALC panels and the drywall partitions of the test specimen are examined through the hysteretic characteristic obtained from the component tests of ALC panels (Matsuoka, et. al. 2007) and drywall partitions (Lee, et. al. 2007). Figure 11 show the hysteretic characteristic of the ALC panels with a single window, and partition wall without opening, respectively. The hysteretic characteristic of the ALC panel consists of (1) friction of joints, (2) compressive resistance at the corner of the ALC panel, (3) stiffness of the supporting frame of the sash, and (4) initial friction. The drywall partition are expected to resist the story drift by compressive action in the diagonal direction of the wall, when the gypsum board meet the columns, beams or the supporting frame of the door. Figure 12 shows the relationships between the lateral resistance per one story and the story drift. This lateral resistance was estimated from the results of the component tests considering the difference of the size of ALC panels and the drywall partitions between the component tests and the present shake tests.

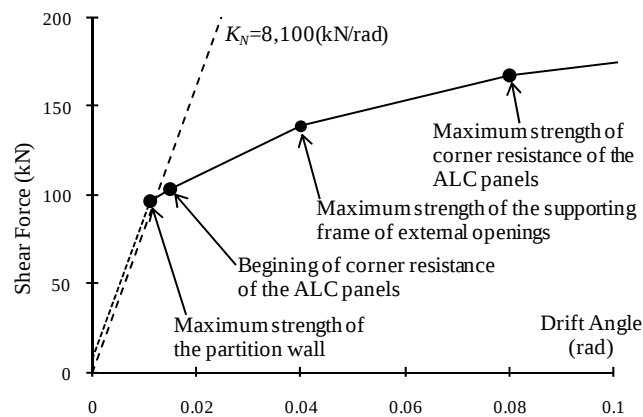
Figure12 Story shear of ALC panels and drywall partitions versus story drift at the 2nd and 3rd story in Y-direction

Under 0.4 times the Takatori records the maximum story drift reached 0.0011 rad at the 2nd story for Y direction. Then the story shear was 1,019 kN, and the summation of the column shear forces was 812 kN, so the difference  $Q_n=207$  kN of the two values is expected to be the lateral resistance of the non-structural components except the structural frame. It is obtained from Figure 12 that the lateral resistance of the ALC panels and the drywall partitions is 97 kN, which was 47% of  $Q_n$ . In the same way under 0.6 times the Takatori records, the maximum story drift was 0.017 rad, the story shear was 1,260 kN, the summation of the column shear force was 994kN, the difference  $Q_n$  was 266 kN, and the lateral resistance from Figure 12 was 108 kN, which was 41% of  $Q_n$ . These lateral resistances are 11 to 12% of the story shear carried by the structural frame. In the same way, the initial stiffness of the ALC panels and the drywall partitions is calculated from Figure 12. The stiffness is 8,100 kN/rad, which is 8% of the initial stiffness 100,000kN/rad at the 2nd story.
