CHARACTERISATION OF SLOPE FAILURES DURING THE 2004 NIIGATA-KEN CHUETSU AND THE 2007 NIIGATA-KEN CHUETSU-OKI EARTHQUAKE

H. Toyota¹ and A. Onoue²

ABSTRACT :

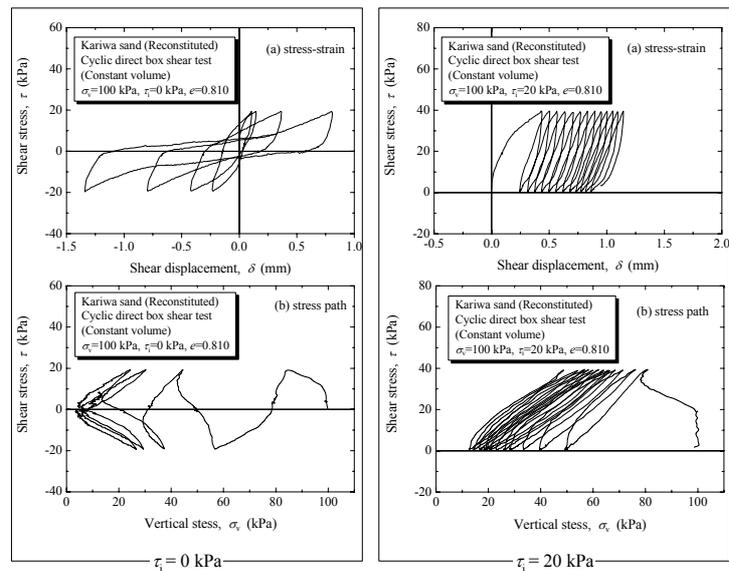
Figure 8 Effects of initial shear on cyclic shear behaviour in Kariwa sand

Figure 8 shows effects of initial shear on cyclic shear behaviour in Kariwa sand using direct (box) shear tests. In the case of no initial shear, similar cyclic behaviour with that of cyclic undrained triaxial tests is obtained in direct (box) shear tests. When the initial shear is applied, although amplitude of shear displacement does not exceed that without initial shear, large residual displacement occurred in the direction of initial shear. Important factor for estimating liquefaction damage is not only double amplitude of shear strain (displacement) but also residual shear strain (displacement). Figure 9 (a) shows the comparison of liquefaction resistance between Kariwa sand and Toyoura sand using the results of cyclic undrained triaxial tests. The relative density of Kariwa sand was set at about 46% that is close to the relative density of real ground. For liquefaction judgement, double amplitude of axial strain of 1% is used for cyclic undrained triaxial tests. It is understood that the ground composed from Kariwa sand is very liquefiable because the liquefaction resistance of $D_r=46\%$ Kariwa sand lies between those of $D_r=44\%$ Toyoura sand and $D_r=55\%$ Toyoura sand. Figure 9 (b) shows effects of initial shear on liquefaction resistance of Kariwa sand using the results of cyclic direct (box) shear tests under constant volume condition. The relative density of Kariwa sand was set to be close that of real ground. The relative density of Kariwa sand before shearing ($D_r=49 - 52\%$) in the direct shear test was slightly higher than the average $D_r=46\%$ before shearing in the triaxial test. The slope behind the houses of Kariwa is about 10° (Fig. 7 (b)). The initial shear of 10 kPa and 20 kPa were applied to the specimen under vertical stress of 100 kPa. Occurrence of liquefaction is judged when double amplitude of shear or residual shear displacement reaches a

certain value. Double amplitude of shear displacement or residual shear displacement of 0.5 mm is applied for liquefaction judgement in the case of cyclic constant volume direct (box) shear tests. Ishihara et al. (1977) demonstrated that liquefaction strength depended on the effective mean principal stress. Comparing Figs 9 (a) and (b), although the effective mean principal stress of the direct shear test is smaller than that of the triaxial test, cyclic strength of direct (box) shear tests is slightly higher than that of cyclic undrained triaxial tests. The reasons of this are that there may be the effects of the difference specimen's density and stress conditions. When the initial shear is high ($\tau=20\text{kPa}$), liquefaction resistance is stronger than that of no initial shear. When the cyclic stress amplitude is small, liquefaction resistance is stronger than that of no initial shear in the case of initial shear of $\tau=10\text{kPa}$. However, liquefaction resistance becomes weaker than that of no initial shear as the cyclic stress amplitude becomes larger. From this result, it will be necessary for softening and large deformation during cyclic loading that the cyclic shear stress develops to the reverse direction with the initial shear. This means that lateral displacement induced by liquefaction is increased in gentle slope comparing level ground when a strong shake due to earthquakes apply to the ground.
