ZONING FOR LIQUEFACTION AND DAMAGE TO STRUCTURES DURING THE 2005 FUKUOKA-KEN SEIHO-OKI EARTHQUAKE

ABSTRACT :

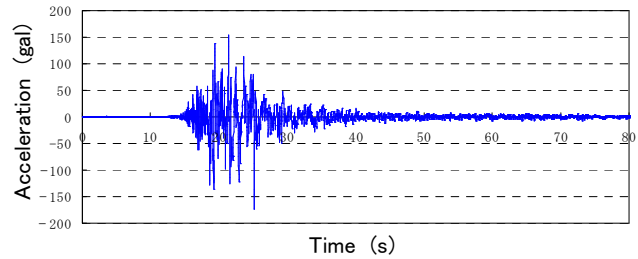
Figure 5 Wave form used for one-dimensional seismic response analysis

2) The seismic waveform for the analysis was obtained from a modification involving a conversion of the seismic record of the EW component measured on the ground surface at the Fukuoka public hall into that for the basement layer using the “SHAKE” program. Figure 5 shows the seismic waveform for the analysis. The maximum acceleration is 174.911 gal.

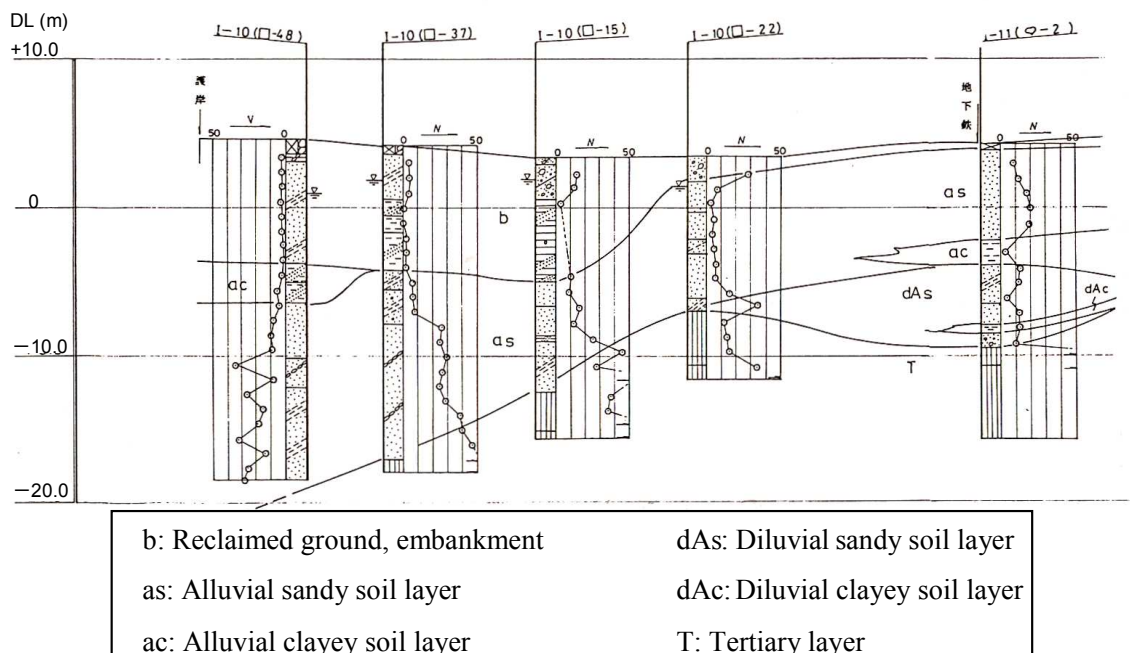
Figure 6 Soil boring logs for liquefaction analysis

5) The soil boring logs used in the analysis are shown in Figure 6. This soil profile was investigated in Jigyohama by the Water Works Bureau of Fukuoka City (1988).
