## ANALYSIS OF STAIRWELLS PERFORMANCE AND DAMAGE DURING WENCHUAN EARTHQUAKE

**ABSTRACT:** A large number of stairwells damage took place in various buildings during the 8.0 magnitude earthquake that struck northwestern Sichuan on May 12, 2008. For these special structural elements, a post-earthquake survey was carried out in Dujiangyan and different modes of failure of the stairwells were observed. Many structural deficiencies were highlighted by the earthquake damage. It is concluded that when buildings were mainly subjected to horizontal seismic forces in the transversal direction, the types of damage of stairwells included: 1) flexural damage in staircase treads, 2) shear damage at construction interface of staircase treads (initiating at the intersection between the treads and the risers), 3) shear failure in landing beams, and 4) crushing failure in the connections between the staircase treads and the landing beams. On the other hand, when the buildings were mainly subjected to horizontal seismic forces in the longitudinal direction, the type of damage of stairwells was mainly plastic hinging in the joints of the landing beams and columns or only in the columns.

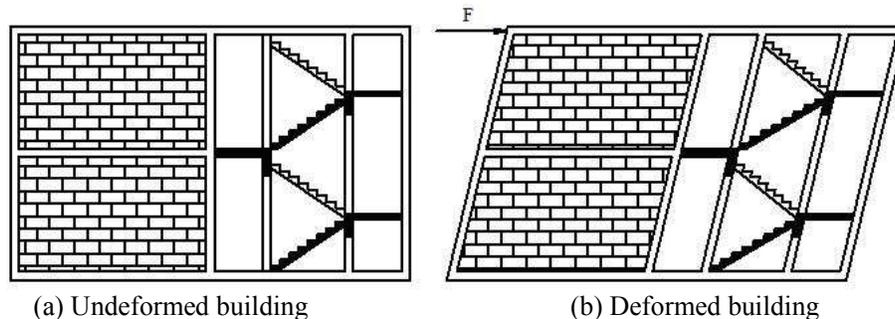
Figure 1 shows a building subjected to horizontal seismic force in the transverse direction. The staircase treads are diagonally placed on a landing beam, functioning as bracing to help resisting horizontal seismic loads. In this loading orientation and based on the observations from Wenchuan earthquake, the stairwell damages included: 1) flexural damage in staircase treads, 2) shear damage at construction interface of staircase treads (initiating at the intersection between the treads and the risers), 3) shear failure in landing beams, and 4) crushing failure in connections between the staircase treads and the landing beams.

Figure 1 Schematics of a transverse section elevation of a typical building

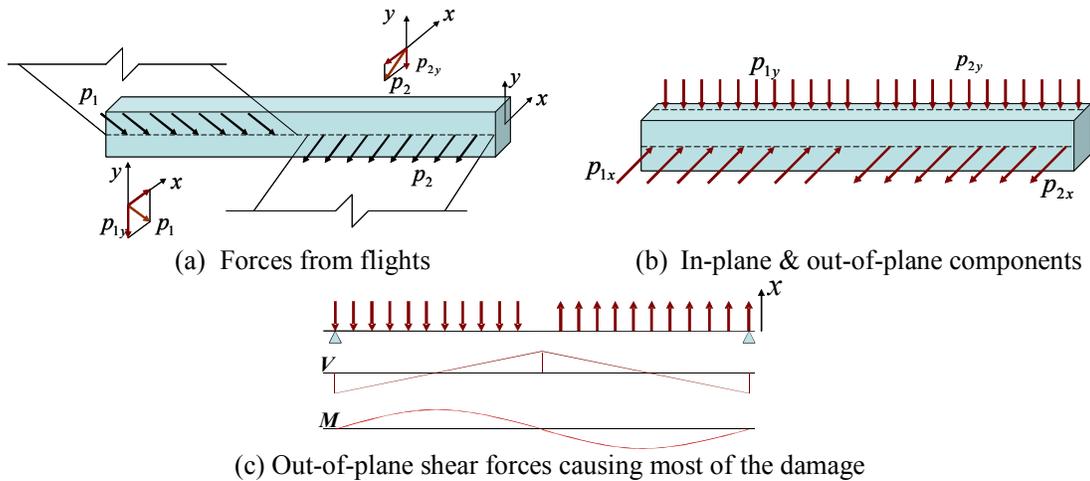
The damage in the landing beams was mostly caused by horizontal seismic forces in the transverse direction. During the earthquake, the beams were subjected to cyclic diagonal tension and compression from the staircase treads in two parts, as shown in Figure 5(a), where  $p_1$  is the compression coming from one staircase tread,  $p_2$  is the tension coming from the other staircase tread with  $p_{1x}$ ,  $p_{1y}$  and  $p_{2x}$ ,  $p_{2y}$  are the components of  $p_1$  and  $p_2$ , in the  $x$  and  $y$  directions, respectively, Figure 5(b). Accordingly, landing beam shear force in the  $x$  direction reached the maximum value at mid-span and possibly at the ends as well, Figure 5(c), causing the observed damages after Wenchuan earthquake. Since typically the mid-span sections are designed without or with very little shear reinforcement due to action of gravity load only, earthquake damage was mostly concentrated at mid-span. In other cases, as shown in Figures 6(a) to (c), landing beams experienced a mix of shear and bending damages near their two ends during Wenchuan earthquake.

Figure 5 Interaction of flights and landing beam causing mid-span shear failures

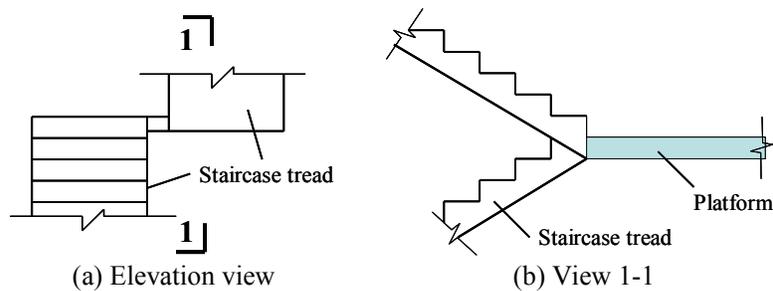
Figure 7 shows an L-shaped stair slab (according to the shape in the plan view) where, in the shown case, there is no landing beam. Figures 8(a) to (c) illustrate several cases of cracking in the stair slab where the two flights meeting with the slab in L-shaped stair. Crushed concrete (mainly at the connections between the landings and the stair flights) was observed after the Wenchuan earthquake in Figures 8(d) and (e). It is to be noted that Figures 8(d) and (e) demonstrate cases of inadequate embedment length of the flight longitudinal reinforcing bars into the landing slab. Figures 8(f) to (h) show crushing of concrete in the corner of L-shaped slabs caused by the reinforcing bars developed straight.

Figure 7 L-shape stair slab
