THE OVERVIEW OF SEISMIC DAMAGE AND THE ANALYSIS OF THE REASONS OF DIFFERENT STRUCTURES IN YINGXIU TOWN –THE HEAVY DISASTER AREAS OF WENCHUAN 8.0 EARTHQUAKE

SUN Bai-tao^{1,2} YAN Pei-lei²

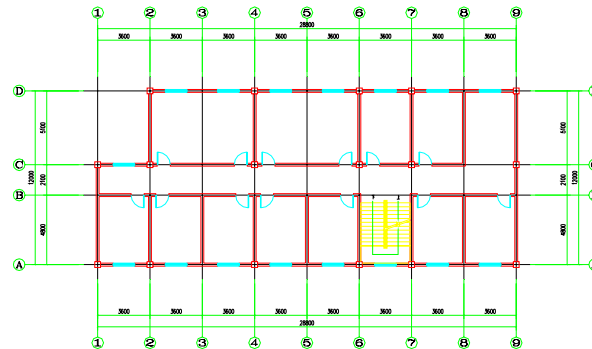
Fig1. the plane sketch of the office building of the Yingxiu secondary school

The two frames building are used for the office, the bay is relatively smaller. In the earthquake, the main structure of the framework are basically undamaged; the back of the office building are serious damage by the collision with the complex building that collapsed; shear cracks appear in filling wall serious on each floor; parapet partial collapse; the prominent wall of the appearance partial collapse. The building belongs to the middle damage, local serious damage is caused by collision.

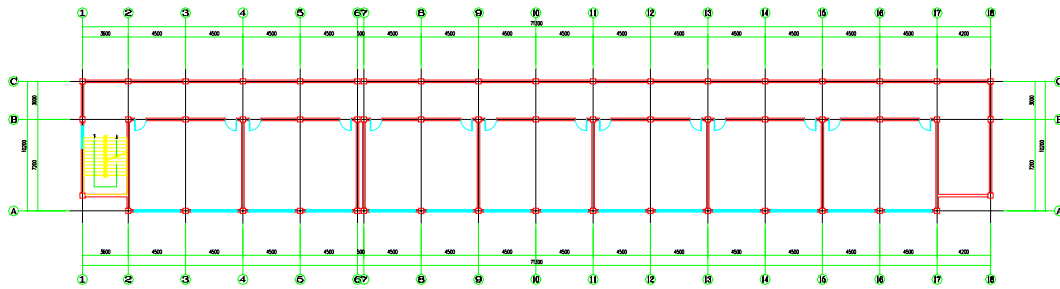
Fig4. the plane sketch of the complex building of the Yingxiu secondary school

The two frames building is composed of two parts with a seismic joints in the middle. It is mainly use for classrooms. the bay is relatively larger. In Fig5, the right portion of the building is destroyed completely, the left portion of the building inclines to the right portion and serious deform, the disappearance of the first floor. On the second floor , the concrete peels off and the reinforced bar leaks out the top of the column ; The filling wall of second floor partially collapsed, lots of perforative and permeate oblique crack appear in window belly wall. A large number of external decoration fall. The building is already destroyed.

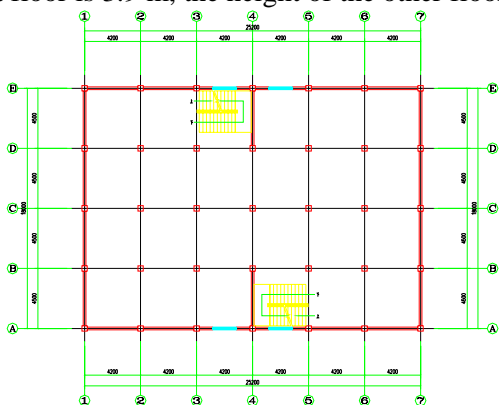
Fig7. the plane sketch of the Aba tobacco company warehouse

The concrete is crashed, reinforced serious bend even broken or larger shift The filling wall of second floor partially collapse. The building has a severely damaged.

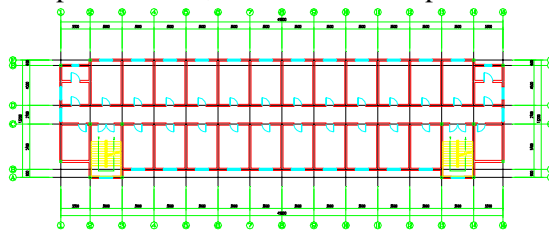
Fig9.the plane sketch of the student dormitory of the Yingxiu secondary school

Lots of perforative oblique crack and crossed crack appear in window belly wall, spandrel wall; serious shear cracks appear in some bearing wall, partly collapse of the outstanding roof structure, the disappearance of the

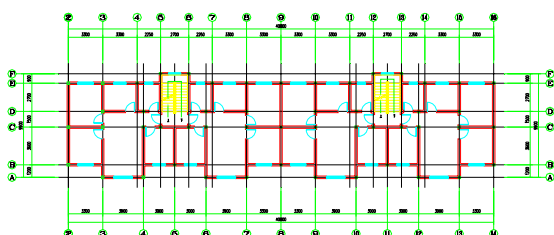
Fig11.the plane sketch of the teachers residential building of the Yingxiu secondary school

Serious shear cracks appear in some bearing wall of the first floor and the second floor . lots of perforative oblique cracks and crossed cracks appear in window belly wall、 spandrel wall. The building has a severely damaged.

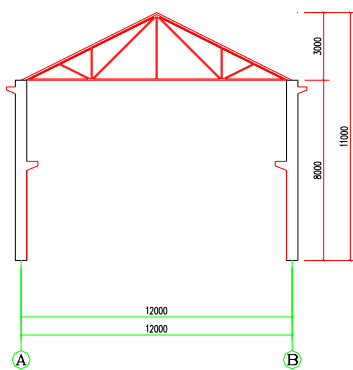
Fig18. the profile of factory building 1

The factory building 1 is a single frame structure. The length is 42m, the width is 12m, the height is 11m. The factory building is consisted by reinforced concrete column, steel roof truss and large roof board. The section of the column is 600mm × 500mm. Concrete grade: C30, reinforced: HPB235. The thickness of the exterior wall is 240 mm. There is no inner partition in factory building 1.
