## STRATEGIES FOR SEISMIC PREVENTION IN SCHOLAR'S BUILDINGS

## Strategies for Seismic Prevention In Scholar Buildings Bernardino Rivadavia School

Facade  
Strategies for Seismic Prevention In Scholar Buildings  
Bernardino Rivadavia School

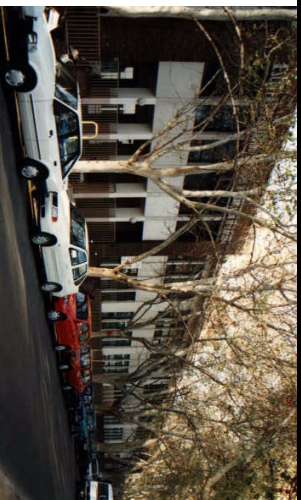
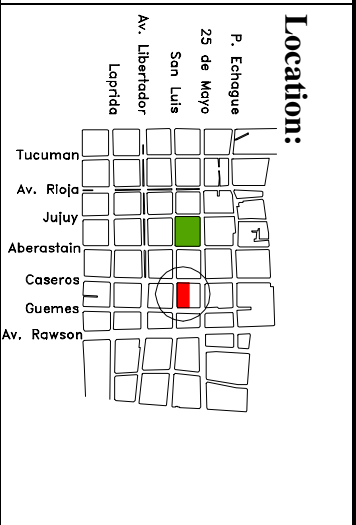
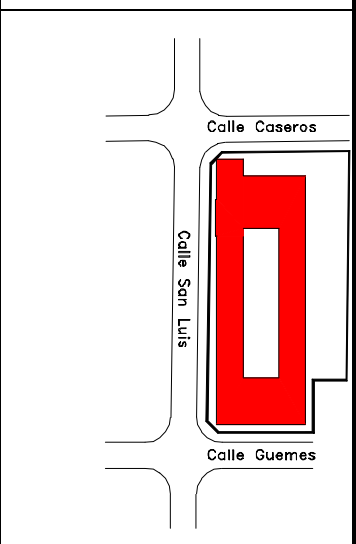
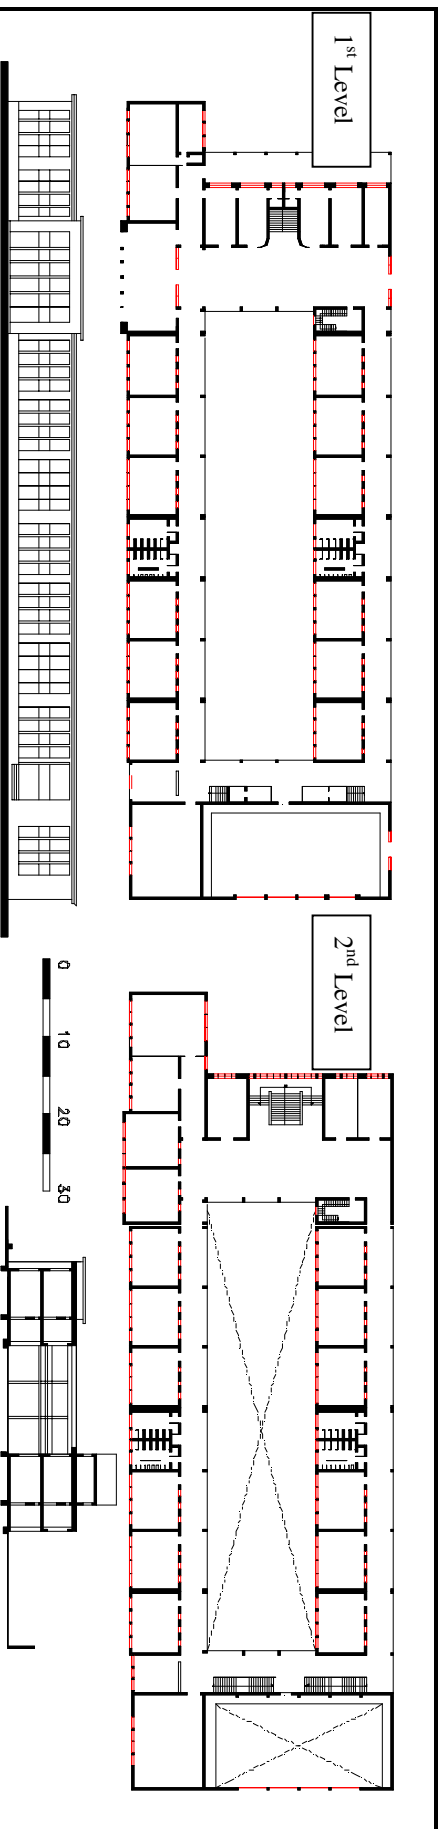
VALUATION
Electric installation	Good Condition. There isn't security interrupter 0.5
Water and sewer installation	Good Condition 1
Gas installation	Outside installation without security valve. 0
Glasses dimensions	(2.8x1.5) m 0
Library and Video room equipment.	There isn't 1
