DETAILED INVESTIGATION OF PILES DAMAGED BY HYOGOKEN NAMBU EARTHQUAKE

Kenichi HORIKOSHI¹, Akira TATEISHI² And Hiroyasu OHTSU³

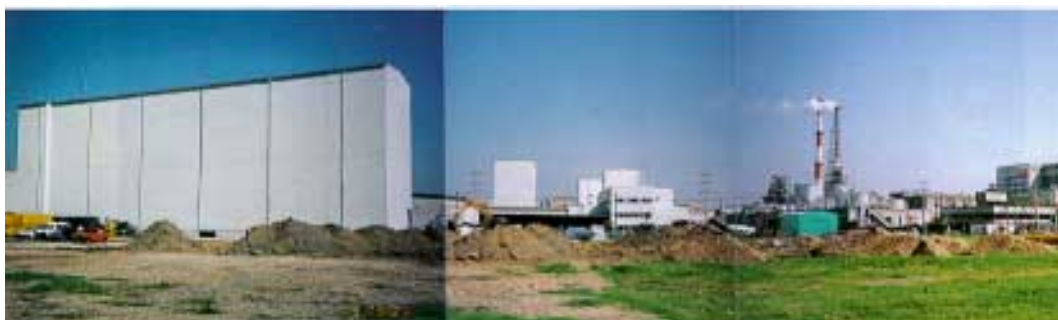
Figure 2: Photograph of the investigation site in Kobe.

Figure 2 shows an overview of the investigation site. In the photograph, the pile tops are below the soil surface at a depth of about 1 - 2 m in the area where excavated soil can be seen. The excavation was conducted to expose the pile top which was necessary for conducting the investigation.

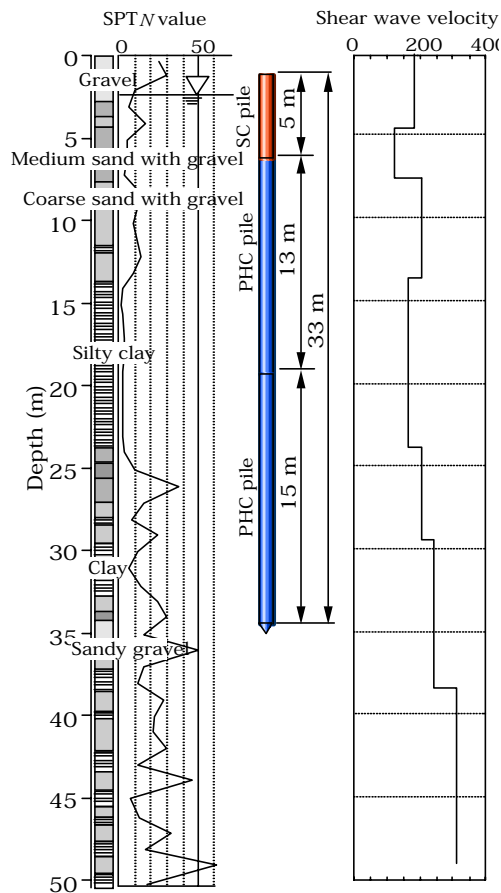
Figure 5: Soil profiles obtained after the earthquake

In Figure 5, the ground up to a depth of about 13 m below the surface is reclaimed soil which is called ‘Masado’ (consisting of decomposed granite). The reclaimed soil at the site consists of three layers, i.e. gravel at the soil surface, medium sand with gravel and coarse sand with gravel, and their SPT N values and the shear wave velocities are slightly different. It should be noted that there was a slight change in SPT values and shear wave velocity at the boundary between the medium sand with gravel and coarse sand with gravel. The ground water level was at about 2.25 m below the soil surface.

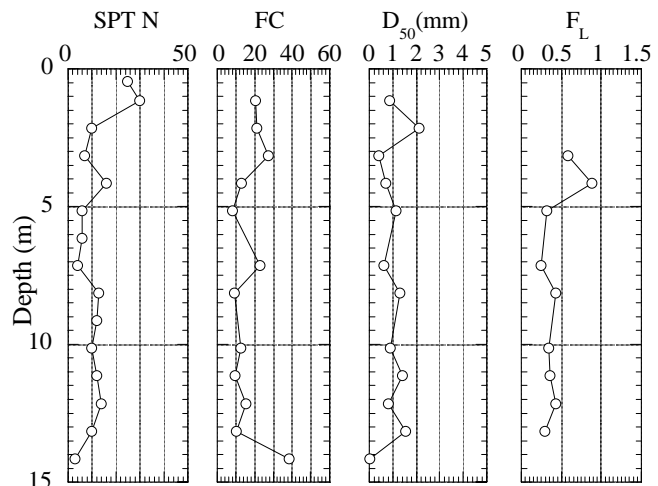
Figure 6: F_L value estimated from soil profiles

The F_L value, i.e. liquefaction safety factor, was estimated from the soil profiles based on the Japanese Standard for Highway Bridges [2]. In the estimation, the correction factor for area, c_z , was assumed to be unity, and the seismic intensity for the ground was set at $k_{hc} = 0.6$. The calculated distribution of the F_L value is shown in Figure 6 together with other soil profiles such as mean grain size and fine contents. The results show that the F_L values were below 0.5 throughout most of the reclaimed soil.

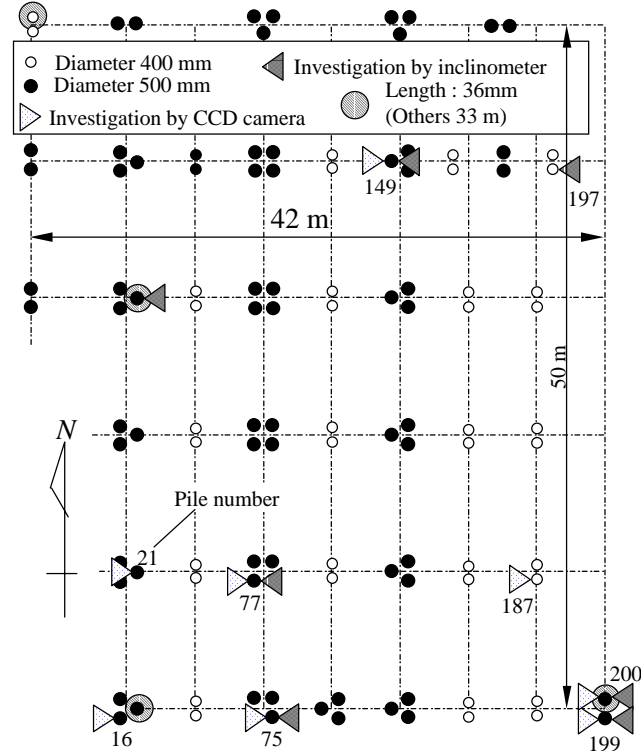
Figure 7: Plan of pile arrangements and investigation

The outside diameter of the piles was either 400 mm or 500 mm, and the inside diameter of the piles was 200 mm and 315 mm, respectively. The length of the piles was either 33 m or 36 m (see Figure 7). Each pile had two joints along its length. The upper segment of the pile is the so called SC pile, concrete pile covered by steel pipe and the middle and the lower segments are pre-stressed concrete piles (PHC piles). The tips of the piles were shaped as pencil tops and thud the pile tips were closed.
