REPAIRS ON POWER HOUSE AND BOILER SUPPORT STRUCTURE DAMAGED BY
1965 EARTHQUAKE. VENTANAS 115 MW STEAM ELECTRIC STATION (CHILE)

By: Santiago Arias (I), Víctor Arze (II) and Jaime Bauzá (III).

**VENTANAS STEAM ELECTRIC STATION
SEISMIC ANALYSIS**

1965 Earthquake Damage

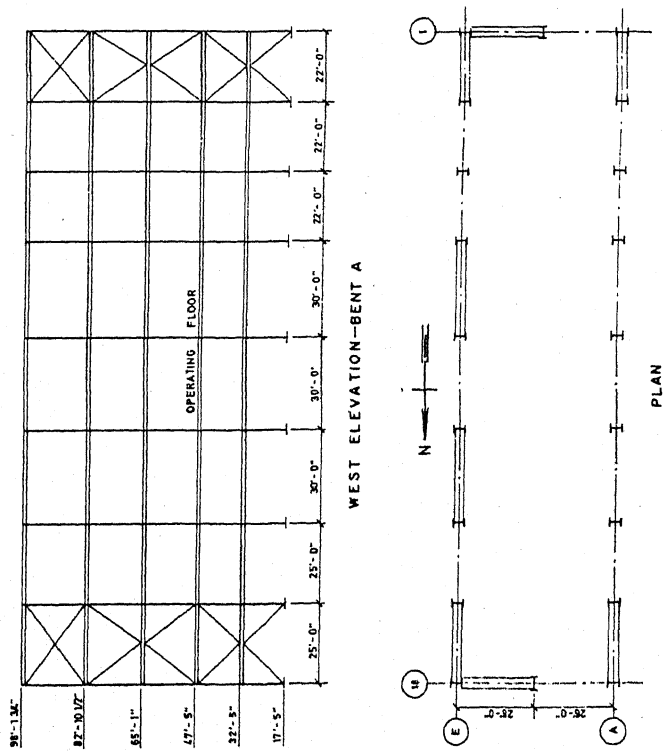
**POWER HOUSE
FRAMING ARRANGEMENT AND DIMENSIONS
(Fig. 1)**

The Power House is a 5-level steel structure, 25 m high, with 4,000 tons total weight, including electrical and mechanical equipment. It has a 63 x 20 m rectangular plan, formed by a system of perimetral columns and girders. Horizontal loads are resisted by a triangular diagonal system. Fig. Nº 1 gives a sketch and Photograph Nº 1 shows a general view of this building.

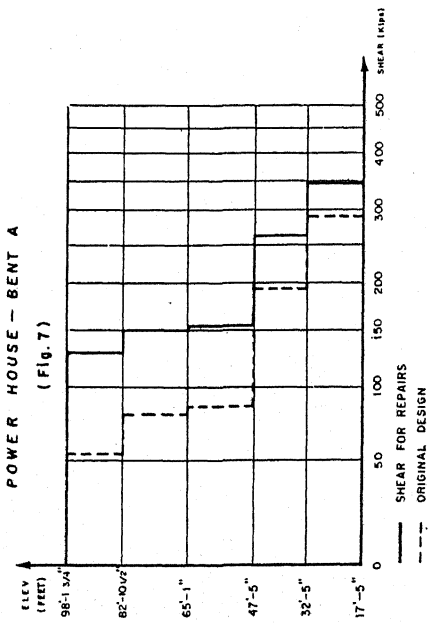
SHEAR DIAGRAMS FOR STRUCTURE REPAIRS

Two of these typical diagrams are shown in Figs. N° 7 and N° 8.

5.1 Repair Design Shear Envelope. Damage repair has been designed to provide more than a simple return to the original safety factor, in order to improve earthquake-resistance conditions so as to avoid similar damages in future earthquakes, which may occur due to the zone's high seismicity.

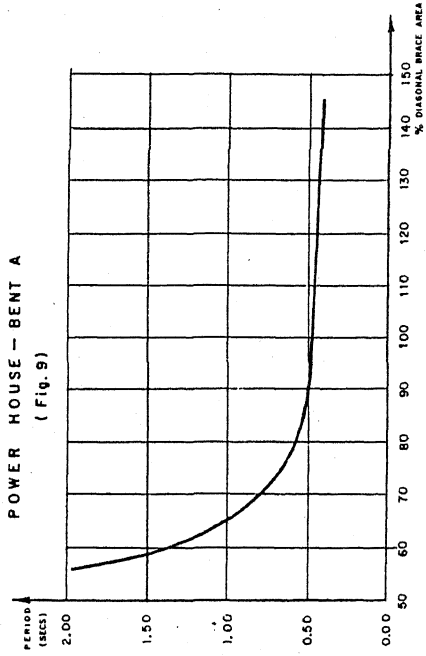
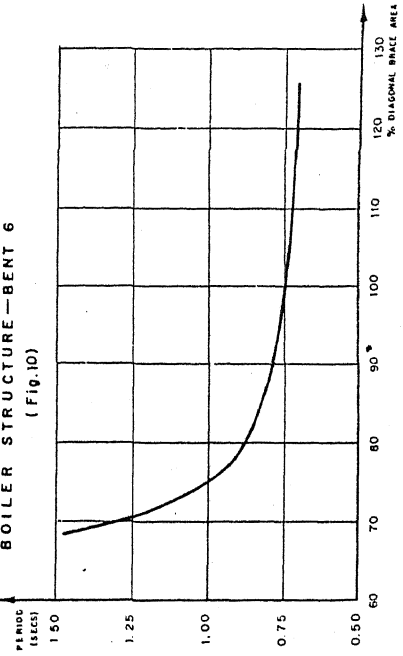
BOILER STRUCTURE - BENT 6 (Fig. 10)

2) In the structures studied in this paper, it was observed that the planned strengthening's rigidizing effect did not produce an important increase in earthquake-force magnitudes.

STRUCTURE STIFFENING DUE TO DIAGONAL BRACE STRENGTHENING

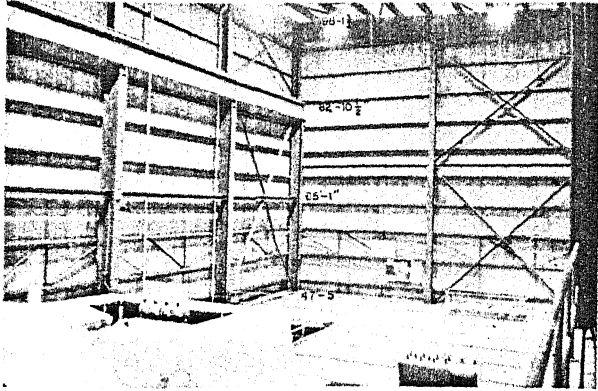
Photograph No 1 Inside view of Power House at Operating

Floor level. The typical bracing system
 arrangement can be seen.

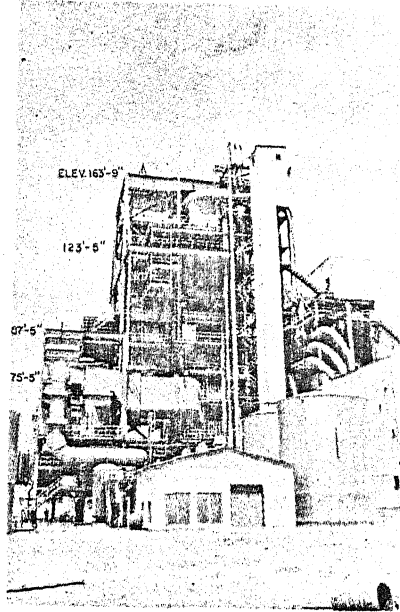
Photograph No 2 Boiler Structure North Elevation. The

3 main steam pipes are at far right.

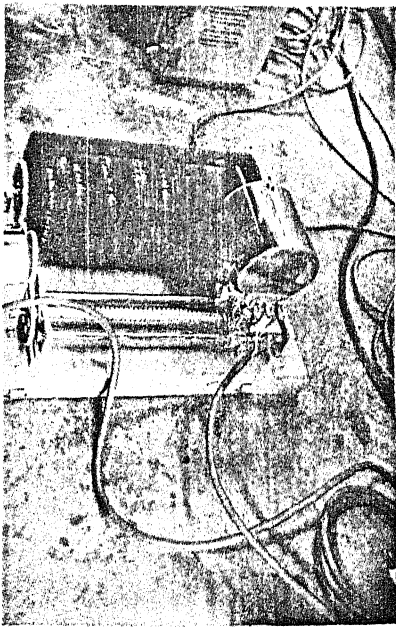
Photograph No 7

Photographs № 7 and № 8 show some aspects of the tests.

Oscillation recorder used for experimental measurements. Some recorded vibrations can be seen.
