Observation of Damages of Industrial Firms in Niigata Earthquake

The authors report the damages of plants and factories in Niigata Earthquake 1964. They refer to the important design consideration which were obtained through their observation.

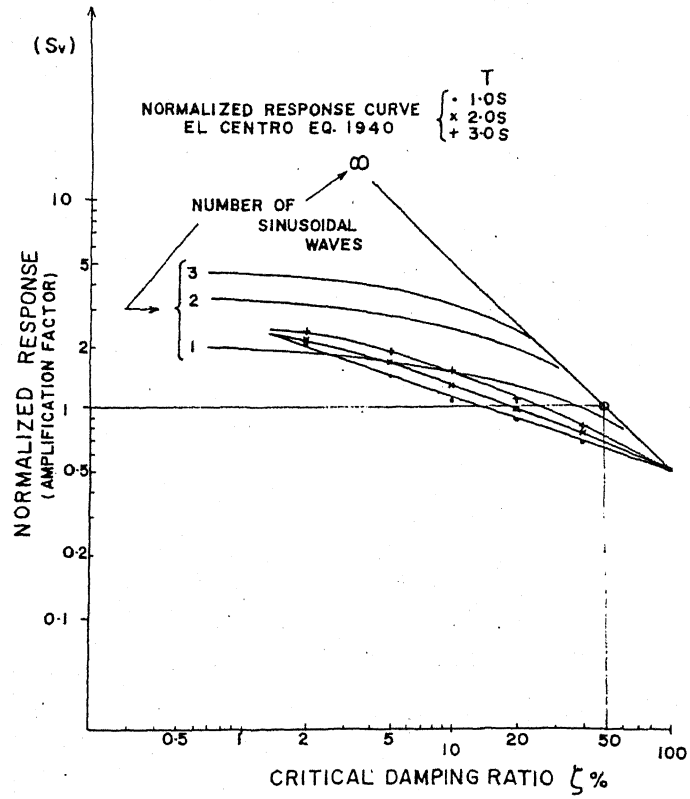
FIG. 6 NORMALIZED TRANSIENT RESPONSE (AMPLIFICATION FACTOR) VS. CRITICAL DAMPING RATIO. FOR $\zeta_p = 50\%$, AMPLIFICATION FACTOR IS EQUAL TO UNITY.

The authors obtained the response curves for the design of oil storage by using an analog computer. Those curves are summarized to a chart (in fig. 6). This chart shows the relation of transient amplification factors to the critical damping ratio. Parameters on the top group of curves show the number of waves after the first shock. The lower group of curves are the normalized velocity responses to El Centro Earthquake 1940 by Professor Housner (4). For the top group the relation of the period of the system to that of earthquake motion is fixed to be equal each other. In the case of Housner response, the authors choose the periods of the system as 1.0, 2.0 and 3.0 seconds.

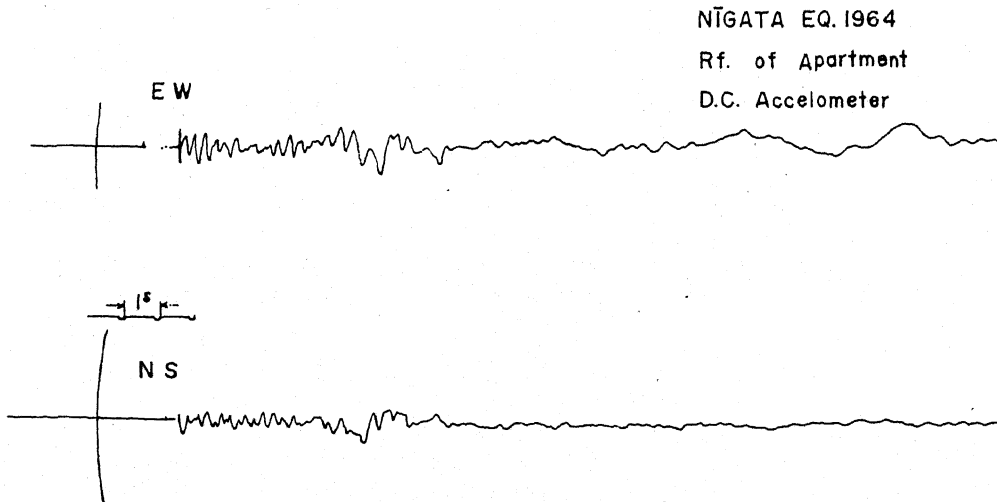
FIG. 5 AN EXAMPLE OF RECORDS OF ACCELERATION WAVES IN NIIGATA EARTHQUAKE.

On the inside wall of the storage (A), 5,000 kl, the scratched trace by the roof edge was remained. The displacement of the roof can be estimated as 1.5 meter from the trace. On the other-hand, the record of an accelometer (for example, fig. 5) shows that the ground motion became very slow 10 seconds after the first shock. In this phase, the dominant period was approximately 6 seconds and the amplitude of its accelogram was 58.8 Gal. So the displacement X might be 54 cm, if the motion could be assumed as sinusoidal wave.
