BEHAVIOUR OF TALL BUILDINGS DURING  
THE CARACAS EARTHQUAKE OF 1967

Synopsis

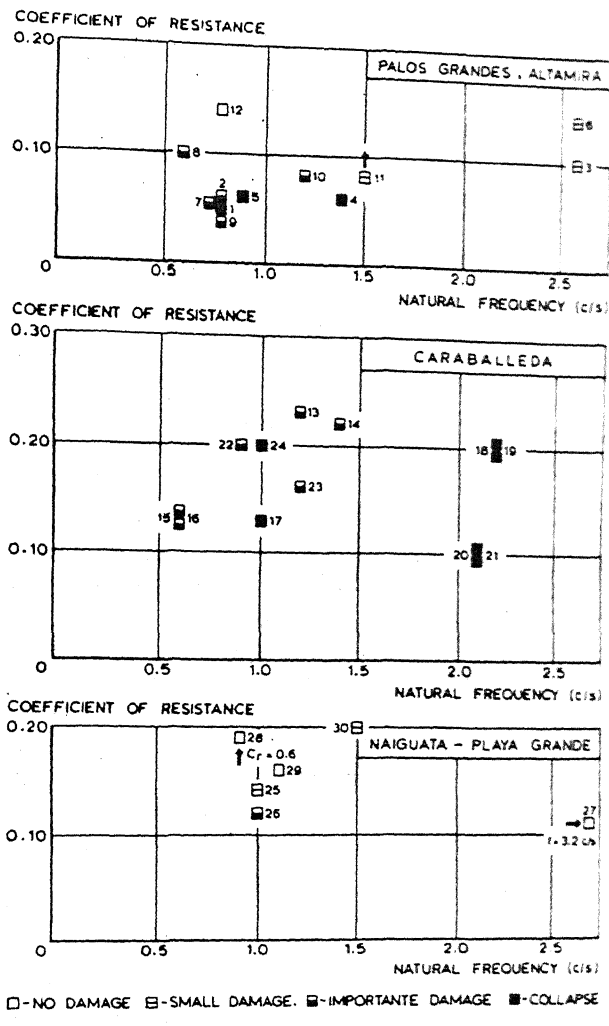
Fig. 14 - Relation between amount of damage coefficient of resistance and computed natural frequency

Fig. 14 compares the importance of damage, the coefficients of resistance and the computed natural frequencies at the Palos Grandes-Altamira area and at Caraballeda, Naiguatá and Playa Grande.

Fig. 14 shows that at Palos Grandes and Altamira area the buildings that collapsed or suffered important damages had coefficients of resistance below about 0.08.

The influence of the natural frequency on the amount of damage is not directly apparent in fig. 14. This may be due to the relatively small range of natural frequencies in the structures and also to the fact that the influence of this factor is not as important as indicated by the proportionality between seismic coefficient and natural frequency.

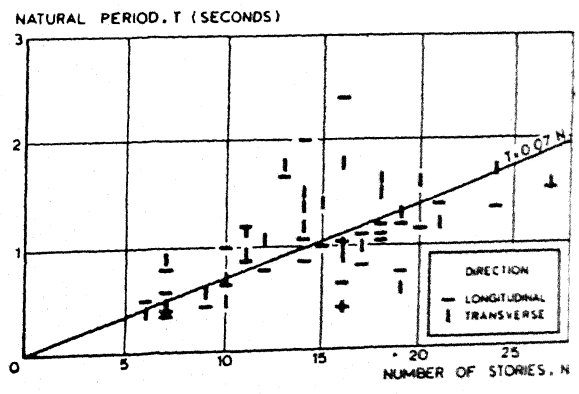
Fig. 15 - Measured periods

Fig. 15 relates the natural periods measured in longitudinal and transverse directions to the number of stories.

Fig. 15 relates the measured natural periods, T, in longitudinal and transverse directions to the number of stories, N. The mean value of T/N is 0.07 for the 64 cases considered, the coefficient of variation, V, being 35%.
