IMPLICATIONS ON SEISMIC STRUCTURAL DESIGN  
OF THE EVALUATION OF DAMAGE TO THE SHERATON-MACUTO

M. A. Sozen, N. M. Newmark, G. W. Housner

An analysis of the causes of damage to the Sheraton-Macuto Hotel in Caraballeda during the Caracas Earthquake of 29 July 1967. The paper evaluates the strength of the structure to resist lateral loads and discusses a possible sequence of events leading to the failure of the main columns.

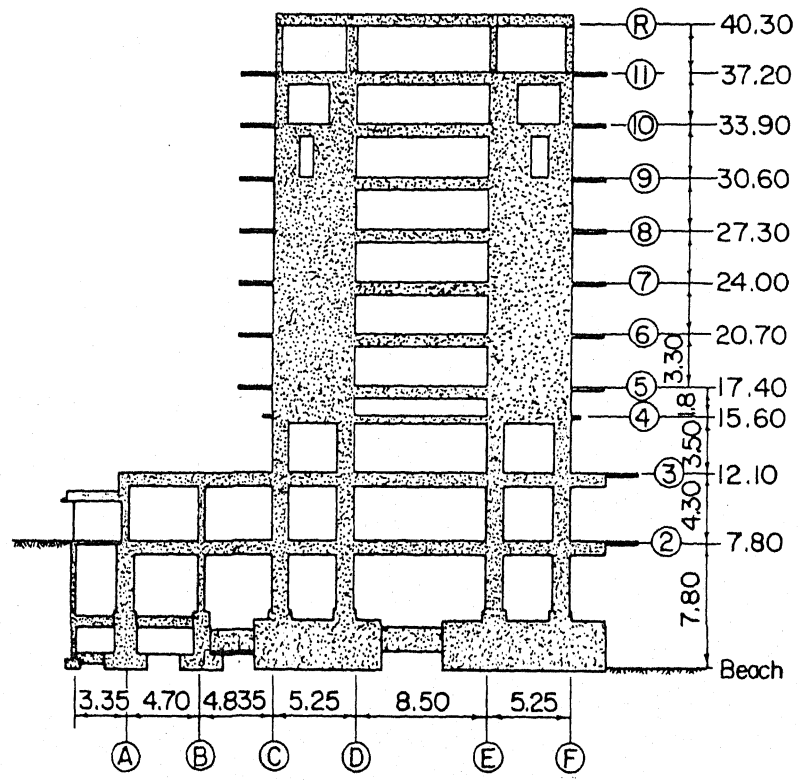
FIG. 1 COLUMN LAYOUT AT LEVEL 3, MAIN BUILDING, SHERATON-MACUTO

- △ \*Severely damaged columns at level 3
- X Damaged beams at level 3
- Damaged beams at level 2
