CARACAS, VENEZUELA EARTHQUAKE OF

JULY 29, 1967

Soil Engineering and Engineering Geology Observations

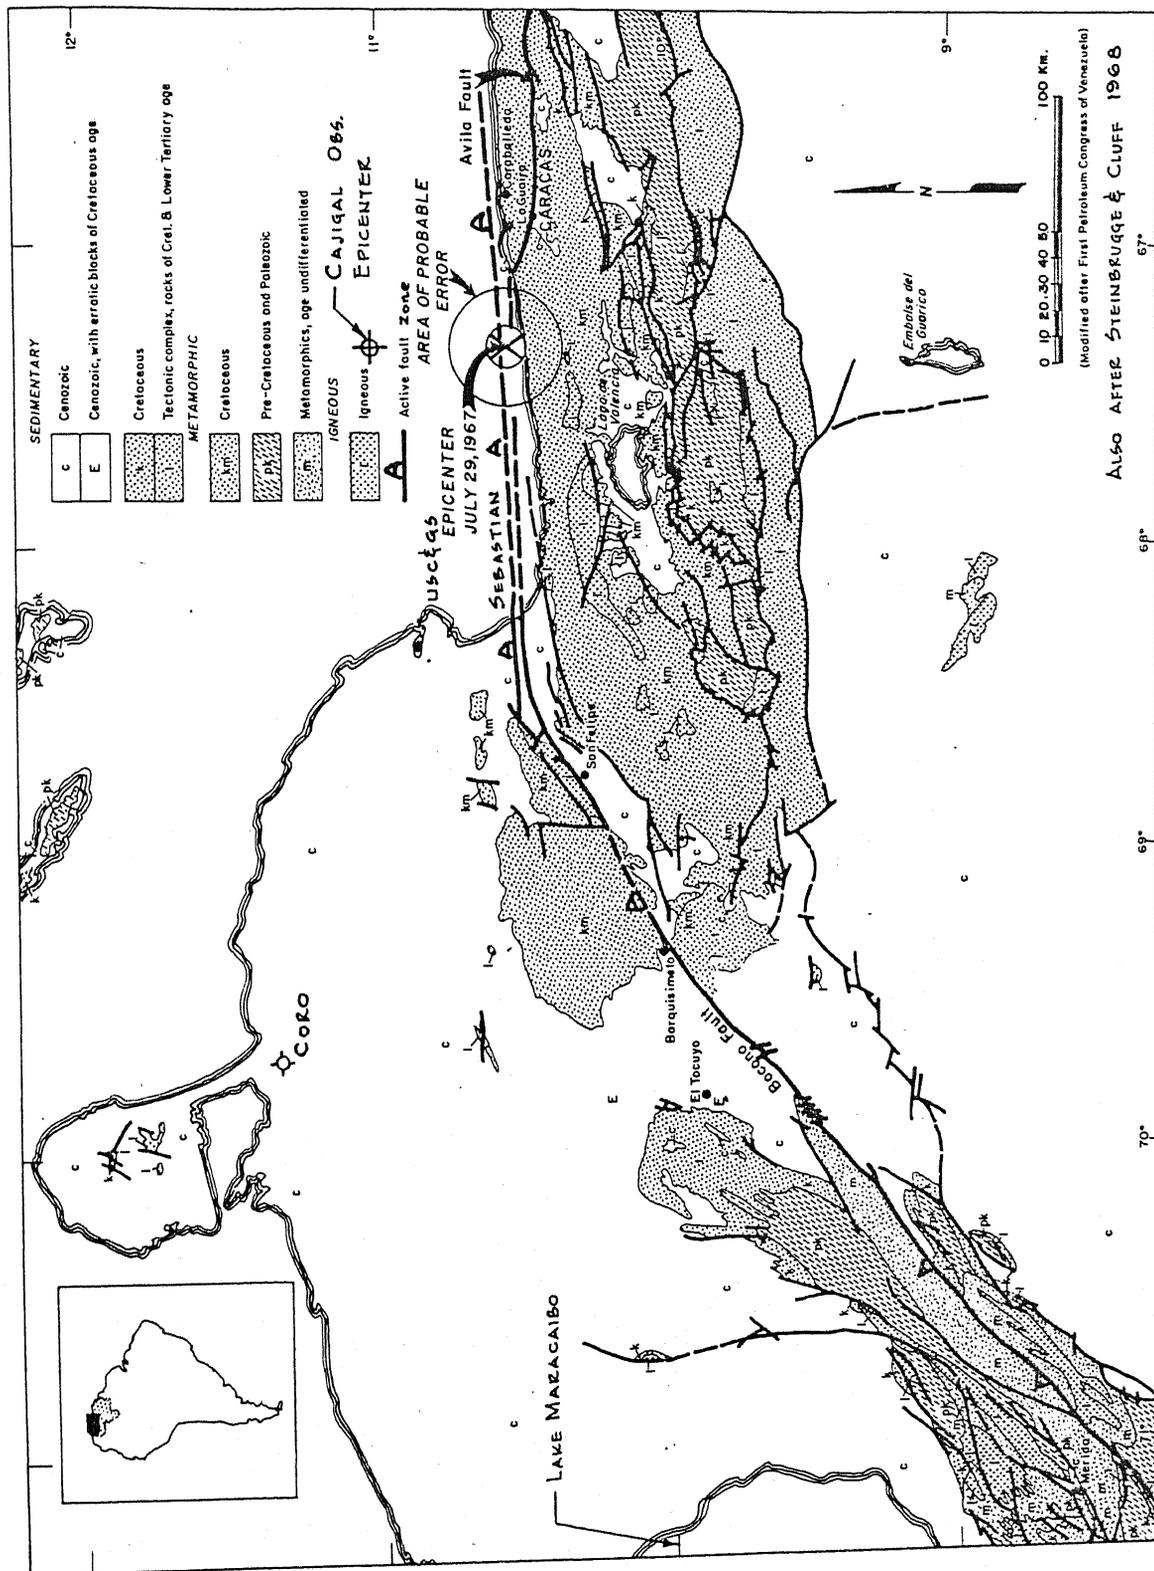
FIGURE: 1

Data received from the Cajigal Observatory in Caracas located the epicenter at the following coordinates: longitude $67^{\circ} 25'$ W., latitude $11^{\circ} 00'$ N., and distance to the Caracas Observatory, 62 kilometers. Depth of focus 28 ± 3 kilometers. According to the Cajigal Observatory the duration of greatest intensity was of 20 seconds, the magnitude was of 6.3 on the Richter Scale. The intensity on the modified Mercalli Scale was of VI - VII in Caracas and VIII or more at Los Palos Grandes and Caraballeda. Information received from the U.S. Coast and Geodetic Survey regarding the details of the earthquake are as follows: Epicenter location at longitude 67.3° W., latitude 10.6° N., with a probable error of + 19 kilometers. Depth of focus estimated 10 to 15 kilometers. Richter Magnitude 6.5. Both the Cajigal and USC & GS epicenters are shown on Figure 1.

Active earthquake faults near Caracas include the San Sebastian fault zone (probably an extension of the Bocono fault) located along the coast-line north of Caracas and the Avila fault located at the foot of the steep mountain range north of the Caracas Valley. The general geology and fault systems of Northern Venezuela are shown on Figures 1 and 3.

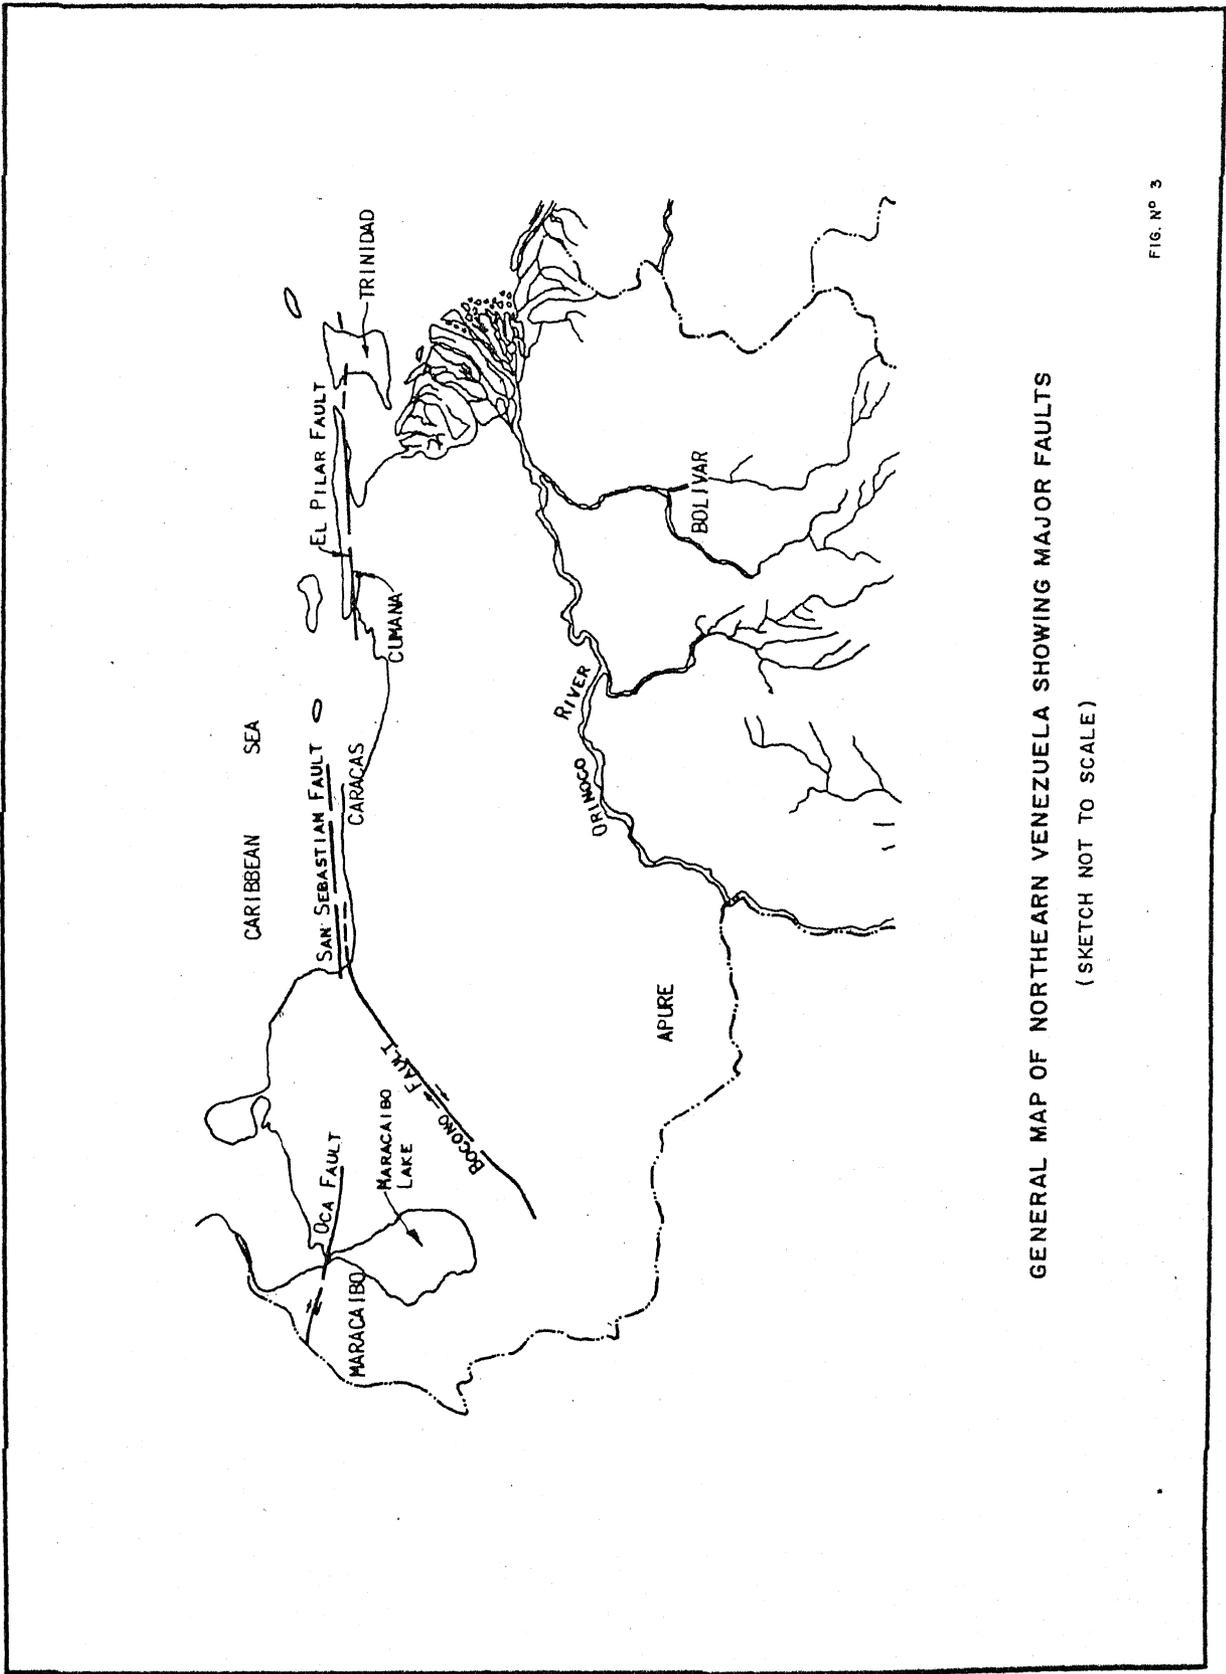
FIG. Nº 3

GENERAL MAP OF NORTHEARN VENEZUELA SHOWING MAJOR FAULTS
 (SKETCH NOT TO SCALE)
