THE JULY 29, 1967 VENEZUELA EARTHQUAKE  
LESSONS FOR THE STRUCTURAL ENGINEER

Henry J. Degenkolb (I) and Robert D. Hanson (II)

ABSTRACT

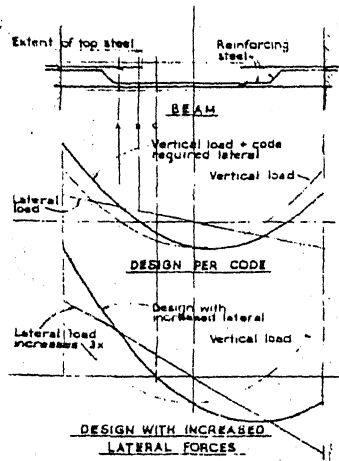
Fig. 8 - Moment Diagram

Figure 8 shows a typical concrete beam in a frame designed to resist earthquake forces, and the moment diagram that may be used to determine the required extension of the top reinforcing steel. In the upper moment diagram, the dashed line is the design vertical load moment diagram. If there were no lateral load, the top reinforcing steel in the beam could end slightly to the right of "A". When the code required lateral forces are added, the design moments of vertical and lateral are added, and the bars must be extended to slightly beyond Point "B". Many engineers, especially those trained to design for specific forces and with maximum economy, end all top bars at this point. The lower set of moment curves illustrates the fallacy of this attitude. If the lateral force moments are several times greater - shown in the diagram as about three times greater than code requirements - the combined moment curve indicates that top reinforcing steel is required up to Point "C". Since there is no required reinforcing steel at this point, the beam would collapse. This design is in full conformance to all current building codes. In the United States, there is often, but not always, a reserve strength. Our spans are quite long, our slabs are fairly thick, and we have appreciable shrinkage and temperature stresses, so there is usually some slab reinforcing steel parallel and adjacent to the girder or beam. This helps to reinforce the top of the beam and give it at least some minimal strength. However,

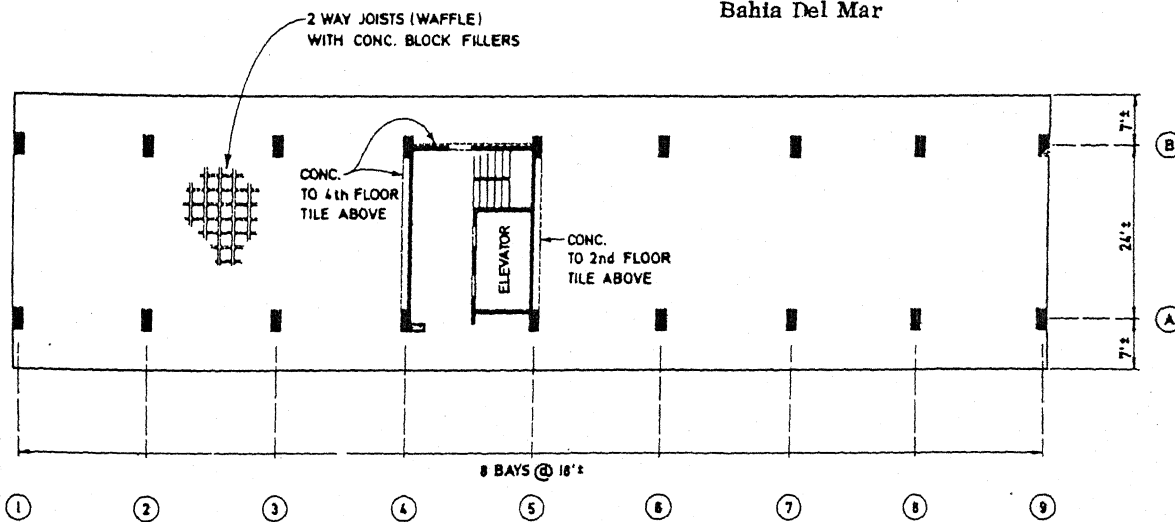
Fig. 19 - Typical Floor Plan, Bahia Del Mar

Figure 19 shows the typical floor plan of the thirteen story Bahia Del Mar, with the core shear wall extended to the fifth floor. Figure 20 shows the "tear" in the slab near Line 5 where the longitudinal forces generated in the right half of the building pulled the slab away from the shear wall. This type of failure has been observed before, but seems to have been overlooked by many engineers.
