RESPONSE OF THE OLIVE VIEW MEDICAL CENTER MAIN BUILDING
DURING THE SAN FERNANDO EARTHQUAKE

SYNOPSIS

Dynamic response of the main building of the Olive View Medical Center, damaged beyond repair during the 1971 San Fernando earthquake, is analyzed and the principal cause of the severe damage identified.

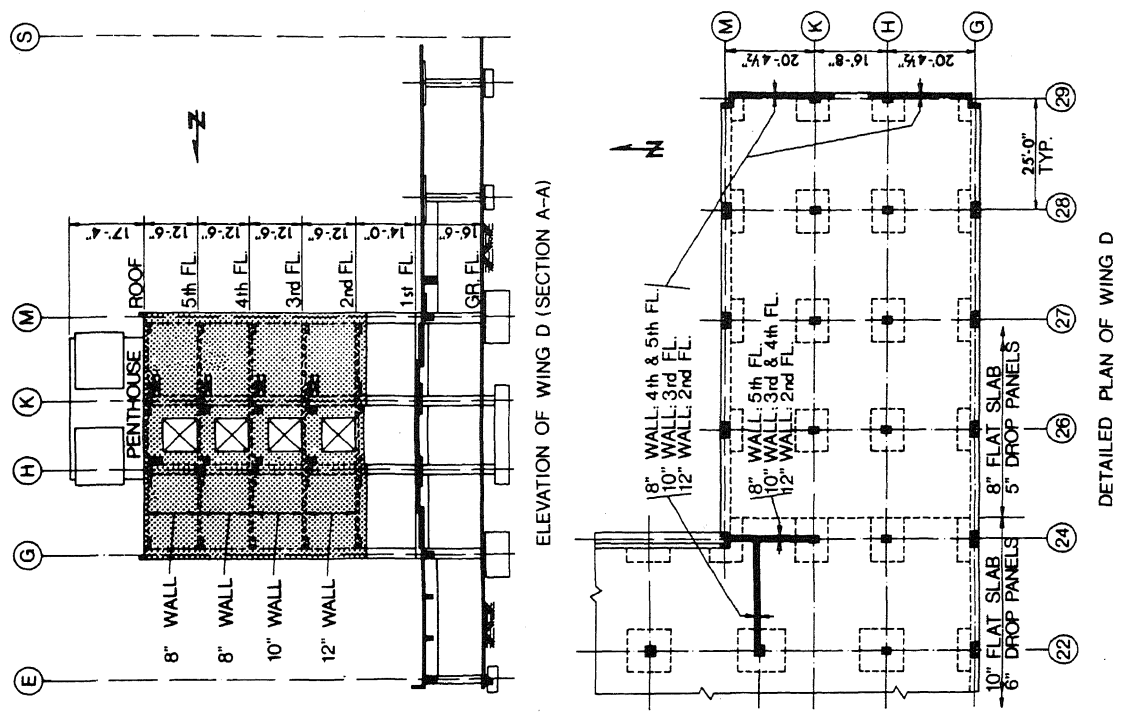
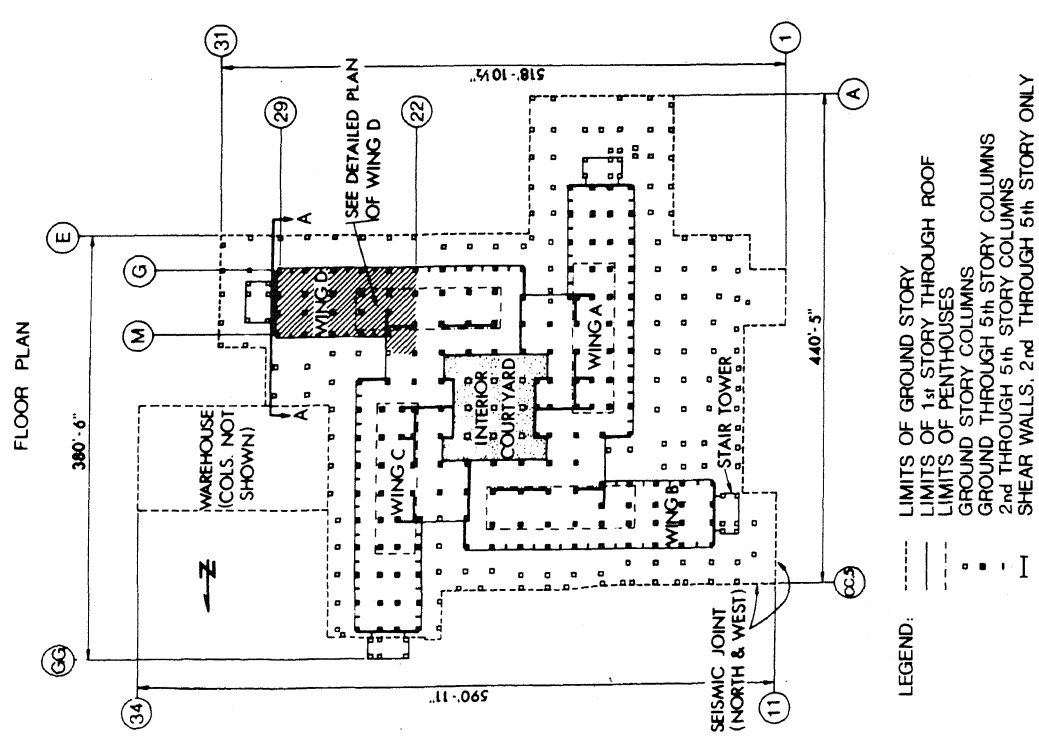
FIG.1: MAIN BUILDING.

The plan of the upper five stories of this reinforced concrete building is composed of four wings intersecting each other at right angles, having an open courtyard in the center (Fig. 1). The ground story extends in plan beyond the upper stories, is underground on the north and west sides, and separated from the retaining wall by a 2-4 in. space (seismic joint). The structure is made up primarily of a flat slab-column system with drop panels at the columns. The columns used were of two types: tied and spirally reinforced. Shear walls were provided in the upper four stories but not in the ground and first stories (Fig. 1). The stiffness and strength of the lower stories were therefore smaller than the upper four stories resulting in a system with two 'soft' stories.

The structural system considered consists of frames 24, 26, 27, 28 and 29 in Wing D (Fig. 1), with frame 24 separated from the rest of the building along column line M. Preliminary analyses indicated that the terrace canopy, extending outside column lines G and M, failed very early in the earthquake at a drift of about 0.3 in.; it is therefore not included in the frames. Damage observations indicated that plastic hinges developed near the base of the ground story columns; the columns are therefore assumed as fixed at the ground floor level.

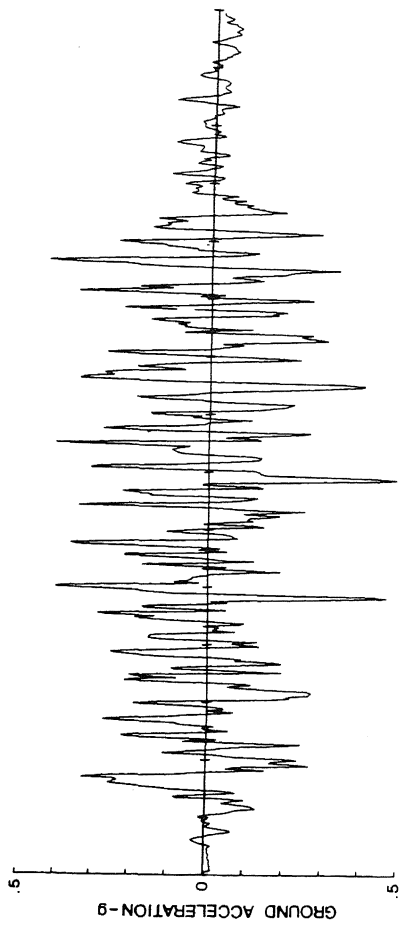
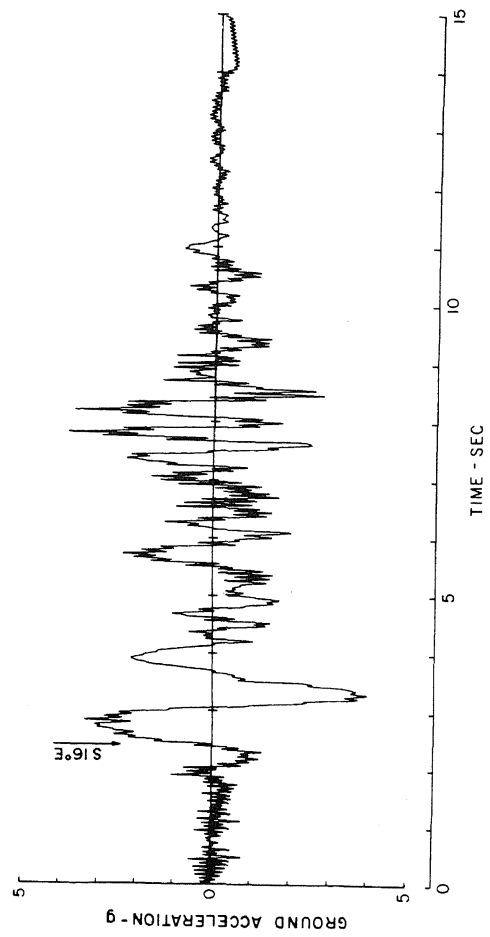
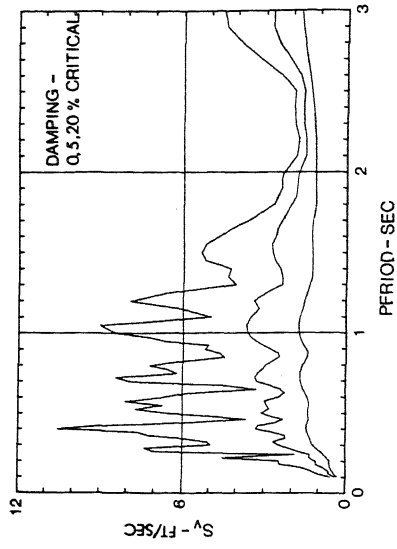
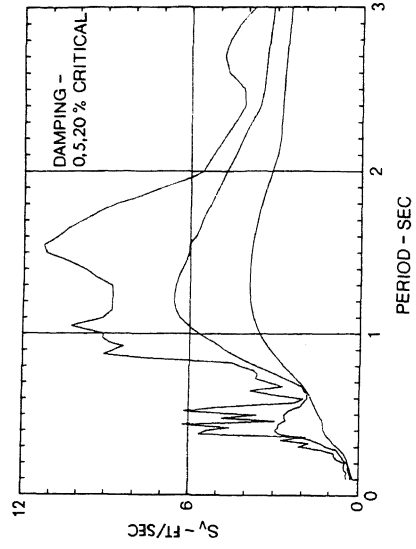
FIG.2: GROUND MOTIONS AND VELOCITY RESPONSE SPECTRA.

In general, except for the Pacoima accelerogram, the strong motion records were similar to the usual California earthquake records. In simulating ground motion for this site from a filtered white noise process, it is therefore appropriate to choose the filter frequency as 2.5 cps and damping 60% of critical⁽³⁾. The filtered signal is multiplied by an intensity function of time, the shape and duration of which is selected to be similar to that for other records during the earthquake. The peak acceleration is estimated to be 0.5 g. The simulated ground motion and its response spectrum are presented in Fig. 2. The spectrum intensity for 20% damping is about 150% of that of the El Centro 1940 motion.

A very recent analysis⁽⁴⁾ of Pacoima Dam including foundation and abutment rock has led to a derivation of the motion on firm rock near the base of the dam from the recorded motion at the instrument site. This computed Pacoima Dam base rock motion is possibly representative of the most intense ground shaking during the earthquake. A very unusual feature of this motion are three acceleration pulses each of 2/3 to 1 sec. duration which leads to largest spectral values in the one to two second period range (Fig. 2)

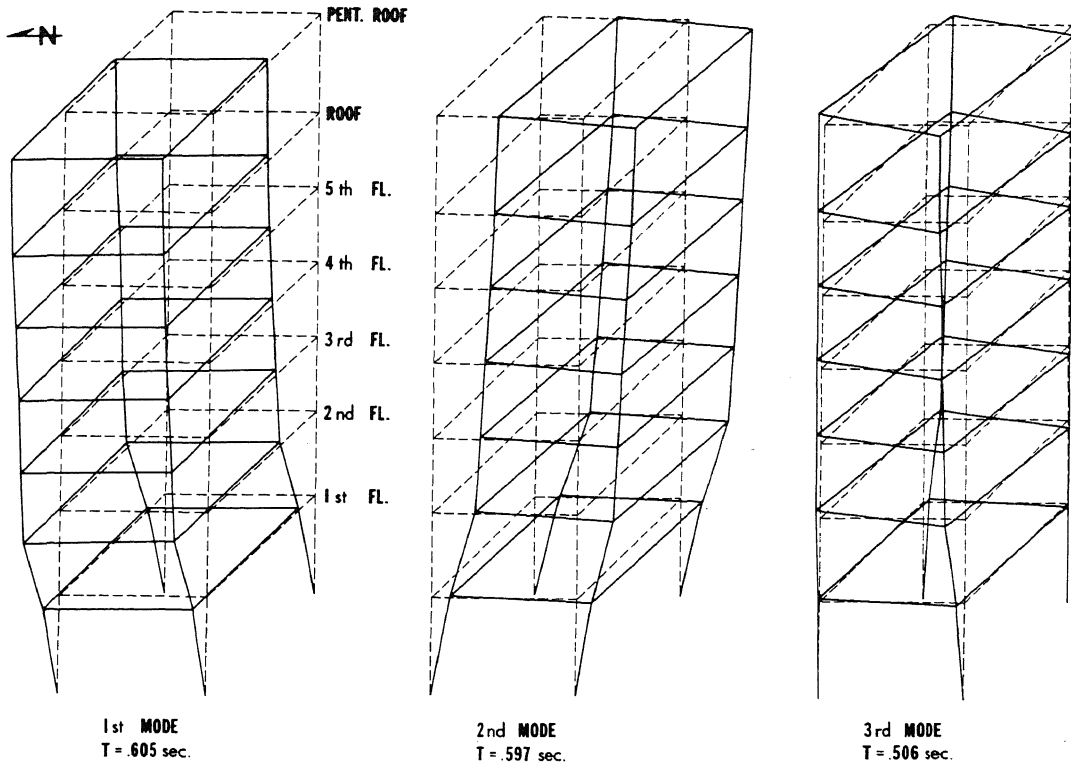
FIG.3: PERIODS AND MODE SHAPES OF ENTIRE STRUCTURE.

The validity of this Wing D model is established by comparing its periods and mode shapes of vibration with those for the complete building. The first three modes of the complete building, obtained using the computer program TABS⁽⁵⁾, are presented in Fig. 3. The closeness of the translational and torsional periods indicates that neglect of torsion can result in considerable under-estimation of the response. The first two translational modes of the Wing D model are compared with the north-south components of the corresponding (2nd and 6th) modes of the complete building; the agreement is satisfactory. It should be noted that the triangular first mode implied in the code is not appropriate for this building (Fig. 4).
