# REPAIR OF BUILDINGS DAMAGED BY THE 1969 BOLAND EARTHQUAKE

C.J. THOMPSON<sup>I</sup>

On the 29th September, 1969, at 10.00 p.m., the Western Cape in South Africa was severely shaken by an earthquake which caused damage estimated at R15 million (\$18 million). This paper provides a general description of the damage caused to masonry structures near the epicentre, describes repair techniques and methods of surveying the damage and specifying the repair details.

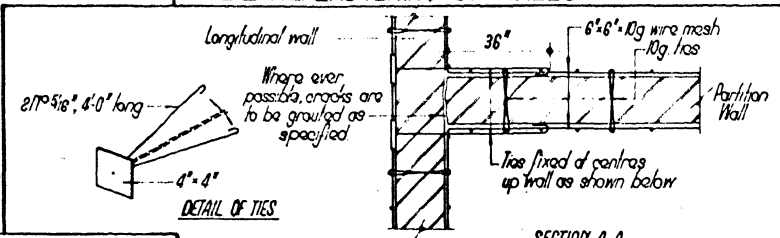
**TYPE II-REPLASTERING OF WALLS**

Note: Type II repairs refer to walls which originally were plastered with coats of mud and lime plaster and which have been loosened over large areas of the walls while the brickwork is stable and lightly cracked. This may also apply to baked brick walls where either the same type of plaster as above has been used or the plasterwork shows extensive crack formations.

1. Chip down plasterwork over whole wall.
2. Fix 6"x6" walled wire mesh to walls using 1/2" tie wires, through predrilled holes in wall of approximately 4"x4" in both ways.
3. Apply 2 coats plaster using Mix A or B for baked and unbaked bricks respectively.

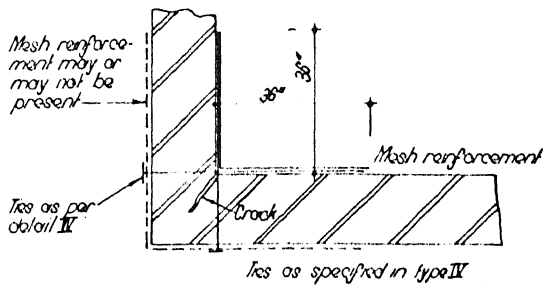
Note This type of repair is to be used when there are minor cracks apparent on inside of wall, but not visible on external face

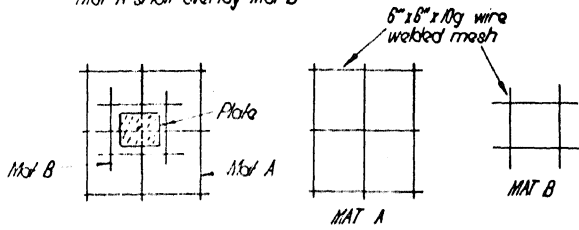
Note In the event of there being no reinforcement on the outside face plaster shall be removed over an area of 12" x 12" at each tie position and mats A and B shall be used. Mat A shall overlay Mat B
