DEFORMATION OF THE VAN NORMAN RESERVOIRS AREA,
NORTHERN SAN FERNANDO VALLEY, CALIFORNIA^I

R. F. Yerkes^{II}, T. L. Youd^{III}, and J. N. Alt^{II}

SYNOPSIS

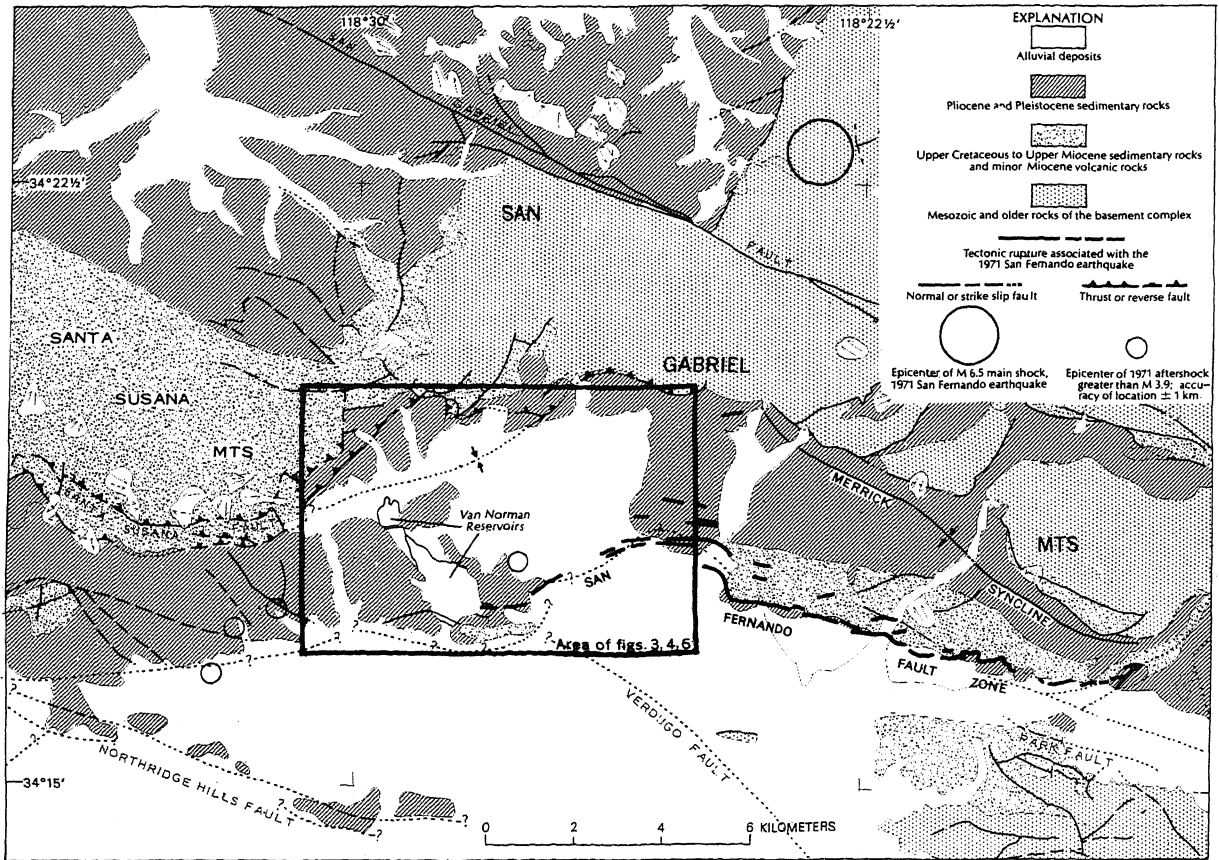
Bedrock in the reservoir area is poorly to moderately indurated pebbly sandstone, conglomerate, and mudstone of Pliocene and Pleistocene age. The reservoir area is on the steep south limb of a northeast-trending syncline (fig. 2); the south limb is truncated by the zone of faults along which the 1971 ruptures occurred. An inferred zone of ancient faults at least 1 km wide extends from the mountain-front fault zone east of the lower reservoir northwestward through the site of the proposed replacement dam, into the abutments of the upper dam (fig. 3). The pronounced angular unconformity at the bedrock-surficial deposits contact, of late Pleistocene age, locally has been displaced by prehistoric movement on faults in the proposed dam site; these faults also are considered active.

FIGURE 2.--Generalized geologic map of northern San Fernando Valley and western San Gabriel Mountains showing the Van Norman reservoirs, epicenters of the 1971 San Fernando earthquake and selected aftershocks, and the associated zone of tectonic ruptures. Unpatterned areas with half-arrows represent landslides. Adapted from Yerkes and Wentworth^{4/}.
