GUATEMALA EARTHQUAKE OF FEBRUARY 4th , 1976. DESCRIPTION AND ANALYSIS  
OF DAMAGES CAUSED ON BUILDINGS

by  
José Herrera Cano \*

SUMMARY

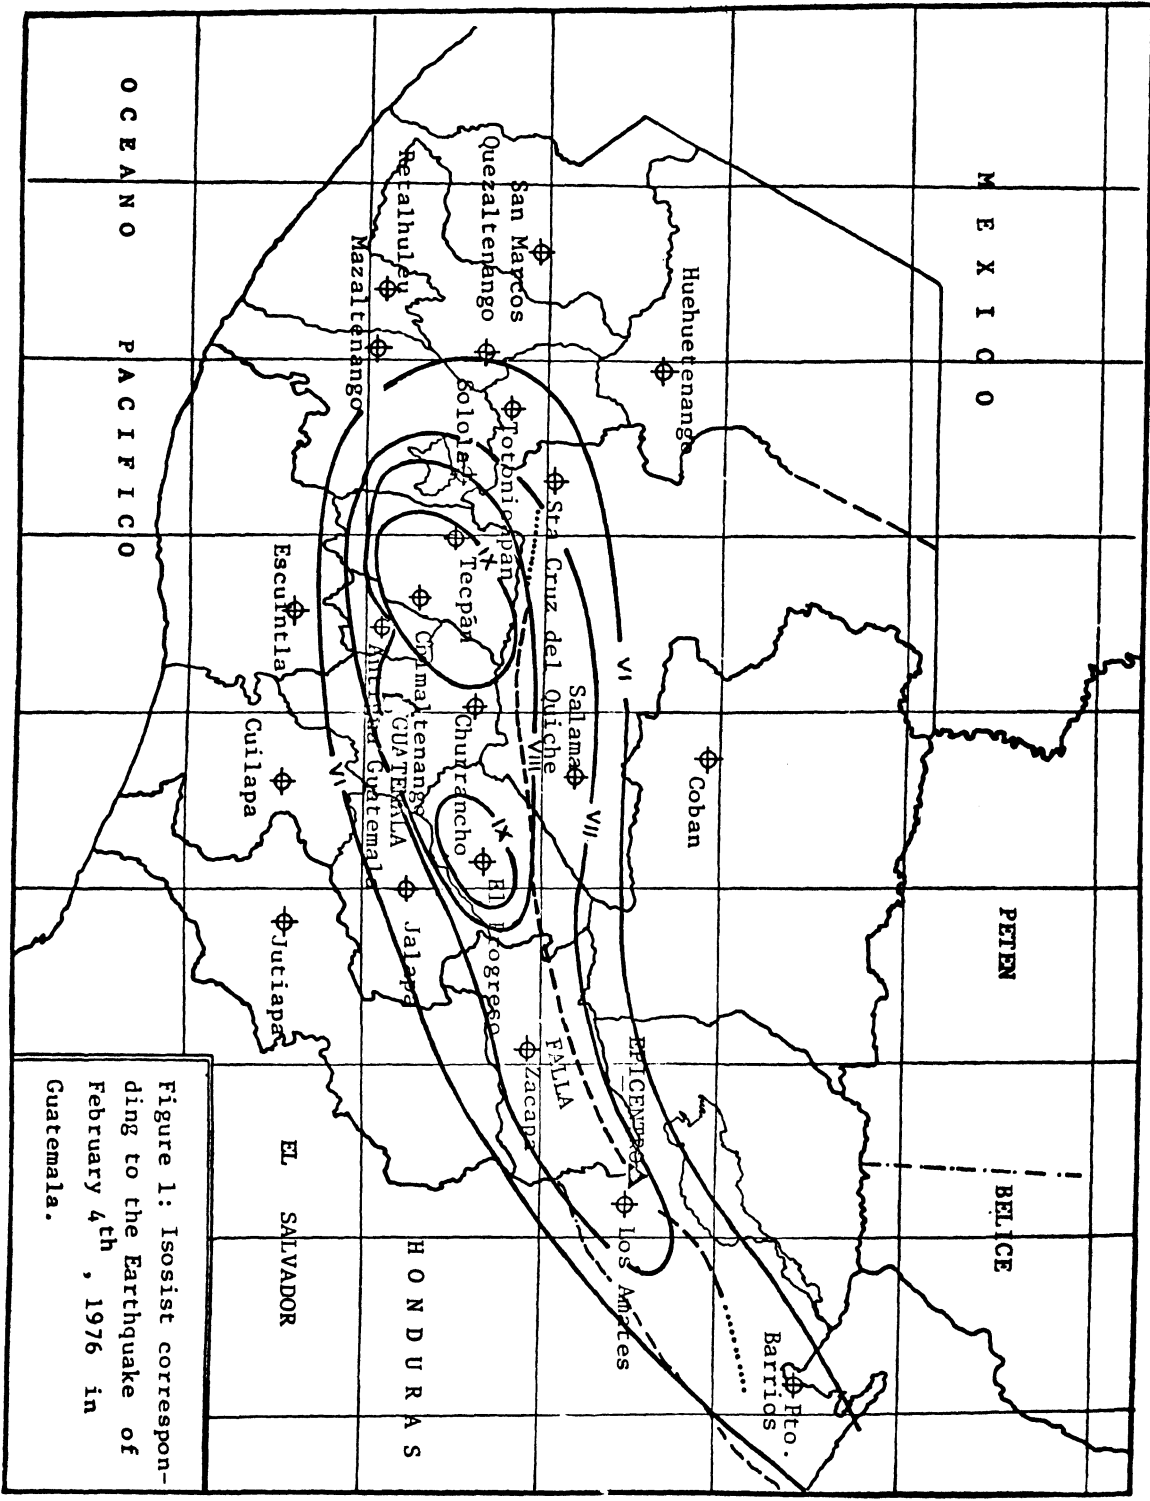
The towns where damages were of greater importance are located in the Districts of Chimaltenango, El Progreso, Baja Verapaz and Zacapa, amounting between 70 and 100% (intensity IX Modified Mercalli). Damages ranging between 20 and 70% were observed in the Districts of Sacatepéques, Quiché, Izabal, Guatemala and Totonicapán (intensity VIII MM) Figure 1.

Figure 1: Isosist corresponding to the Earthquake of February 4<sup>th</sup>, 1976 in Guatemala.
