AN INVESTIGATION OF MECHANICAL RELIABILITY OF SHEAR WALL  
REPAIRED WITH EPOXY MORTAR

SYNOPSIS

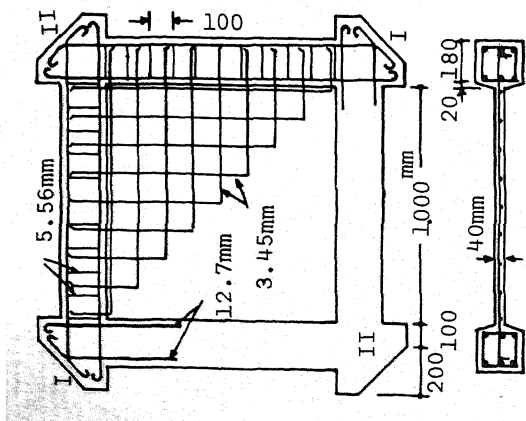
Fig. 1 Specimen  
(in CASE RCW-A)

As shown in Fig.1, reinforced concrete walls were subjected to alternately increasing load between I and I and between II and II points, such as  $0 \rightarrow 5 \rightarrow 0 \rightarrow -5 \rightarrow 0 \rightarrow 10 \dots$  in ton, and plain concrete walls were loaded repeatedly only in one direction such as  $0 \rightarrow 5 \rightarrow 0 \rightarrow 10 \dots$  in ton. Deformation of the frame was measured at eight positions between I and II points. Strain in vertical and horizontal bars at the central part of the wall was measured at two points, respectively. Strain on the concrete surface before repair was measured at nine points in the quarter part of the inside wall.

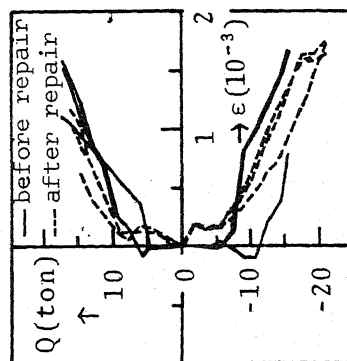
Fig.3 Stress of Bars (in CASE RCW-A-II)

Before repair, the strain in the reinforcing bars in the widely cracked zones must exceed the proportional limit strain of  $2.35 \times 10^{-3}$ , though the average normal strain of the wall denoted by  $R/2$  is less than the value of the proportional strain. Except for the case RCW-A-II, the strain in the bars of the walls before and after repair were almost the same and naught until the load level of initial crack. The strain in the bars of CASE RCW-A-II is shown in Fig.3 as an example. In this case after repair, considerably large tensile strain developed in the bar even for low loading level. This may be because unrepaired cracks existed.

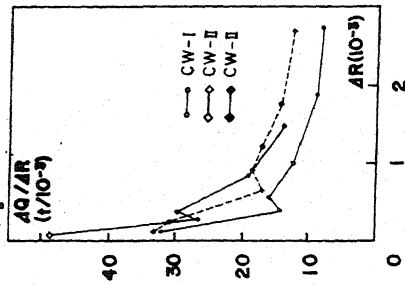
Fig. 4 Stiffness vs. Deformation

(1) Stiffness. In the case of reinforced concrete wall specimens, since stiffness obtained in this test is a little different under the loading in two directions, it is presented as the equivalent stiffness as shown in Fig. 5. The results are shown in Fig.3. The ratio of stiffness after repair to that before repair are represented in Table 2. After all, stiffness change by the repair is summarized as follows:

(2) The repaired walls showed a remarkable drop in the initial stiffness. But regarding the rigidity in the extensive range of subsequent large deformation, there was no significant difference between the repaired and original ones.

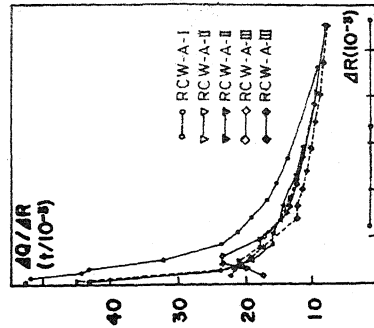
Fig. Equivalent Stiffness and damping

(4) At the range of the large shear deformation ( $>1.0 \times 10^{-3}$ ), both the repaired and the original walls showed good coincidence in the capability of energy absorption. The equivalent viscous damping factor for these walls was obtained as nearly 9%.

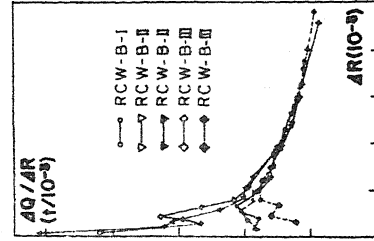
Table 3 Variation of Damping

(5) The repaired wall with larger amount of reinforcement shows comparatively larger reduction in initial stiffness and in damping factor, though this tendency is related to imperfection of repair.

h(%)	ΔR(10 <sup>-3</sup> )	A-II	A-III	B-II	B-III
1.0	8.6	9.6	8.6	8.6	6.6
1.5	8.6	8.8	8.4	7.6	6.7
2.0	8.6	8.6	8.6	6.7	6.7
h'/h	1.01	1.09	1.08	1.07	0.67

h'/h: Ratio of h of repaired to that before repair.
