## LESSONS FROM STRUCTURAL DAMAGES OBSERVED IN RECENT EARTHQUAKES

Vitelmo V. Bertero<sup>I</sup>, Stephen A. Mahin<sup>II</sup>, and James A. Axley<sup>III</sup>

### SUMMARY

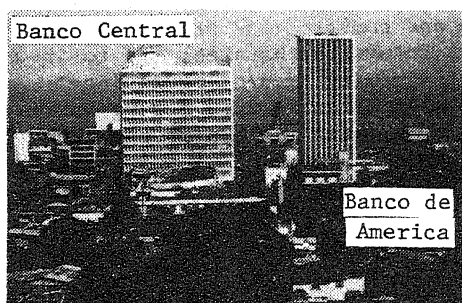
1972 Managua, Nicaragua, Earthquake. Two reinforced concrete buildings, the 15-story Banco Central and the 18-story Banco de America, were located on adjacent sites in Managua at the time of the earthquake (Fig. 1). Due to extensive earthquake damage, the top 12 stories of the Banco Central were demolished. However, only moderate structural repairs were required in the Banco de America. To determine the reasons for this difference in performance, a number of detailed dynamic analyses were performed [7,11,12]. Accelerograms from the Esso Refinery, about 5 km from the buildings, were used in these analyses.

FIG. 1. VIEW OF BANCO CENTRAL AND BANCO DE AMERICA, MANAGUA

The perimeter columns between the fourth and fifteenth story suffered extensive cracking. The walls around the elevator shafts suffered cracking and spalling of the concrete and buckling of the reinforcement in the fourth and fifth stories. Transverse cracks, sometimes wider than 10 mm, were observed

across all slabs above the third floor just to the east of the elevator shafts. Hollow clay tile infilled walls (located on the west face of the tower, beneath the windows on the other faces of the tower and around the stairwells) and other nonstructural elements suffered substantial damage.

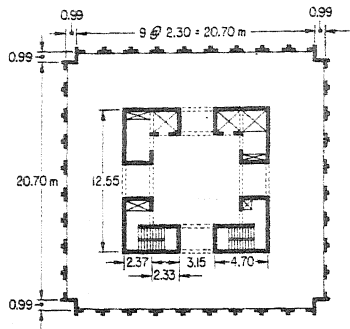
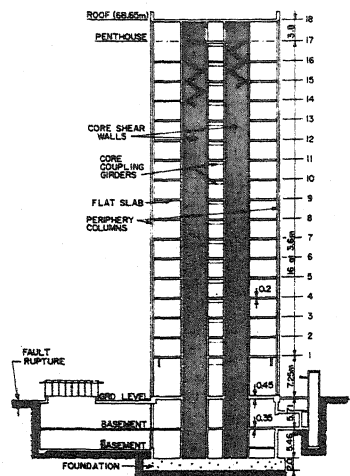
FIG. 4. PLAN AND ELEVATION OF BANCO DE AMERICA

Banco de America [7,12]. As indicated in Fig. 4, the structural system of the Banco de America is essentially symmetric. The primary lateral force resisting system consisted of four large L-shaped wall cores, symmetrically coupled by pairs of girders. Because of duct openings placed at the center of the coupling girders, their shear capacities were generally only about 35% of the values required to develop their flexural capacities. Shear failures in these girders were the primary structural damage observed in the building. Elastic three-dimensional analyses of the whole building and inelastic two-dimensional analyses of the coupled wall system indicate that (1) the symmetric structural configuration and relatively stiff and strong coupled wall system effectively limited displacements and drifts (Fig. 5) and prevented any significant torsional influence; (2) avoidance of long floor spans and masonry partitions reduced nonstructural damage; and (3) when coupling girder shear failures were accounted for, displacements significantly increased (Fig. 5) but were limited due to the considerable remaining lateral stiffness and strength provided by the walls.

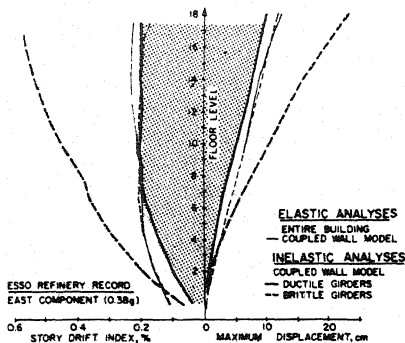
FIG. 5. ENVELOPES OF MAXIMUM FLOOR DISPLACEMENTS AND STORY DRIFTS--BANCO DE AMERICA

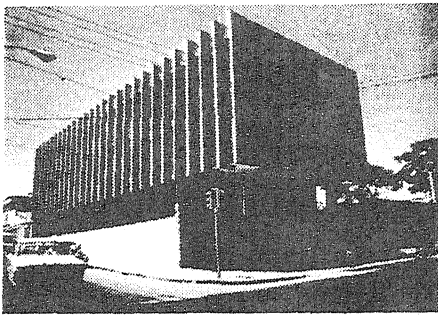
1976 Guatemalan Earthquake [9]. During this earthquake a relatively modern three-story reinforced concrete building, La Escuela De Niñeras (Nursery School) (Fig. 6), which utilized structural frames infilled with masonry, suffered seismic damage characteristic of this type of frame-infill construction, i.e., "captive column" failures due to infill panel restraint, "explosive" shear failures of infill panels, and masonry debris blocking exits and stairways (Fig. 7).

FIG. 6. VIEW OF ESCUELA DE NIÑERAS

dominant frequency content of the Guatemalan record. The highly irregular and asymmetric distribution of infills in the otherwise relatively regular and symmetric frame introduced significant torsional response and thus a concentration of (computed) stress in two of the seven transverse frames that correlated well with the observed damage. The constraint approach provided a sufficiently detailed estimation of member forces and local infill stresses to indicate the probable nature of failure of a critically damaged column (Fig. 8), insofar as the brittle nature of the building response allowed realistic modeling elastically. Furthermore, the combined evidence of the observed damage and analytically predicted behavior (1) suggested one probable failure mechanism for completely infilled frames, and (2) demonstrated a positive correlation between observed infill damage levels and predicted infill stress levels, encouraging consideration of a damage limit state based upon a parameter of infill stress (or strain) rather than drift.

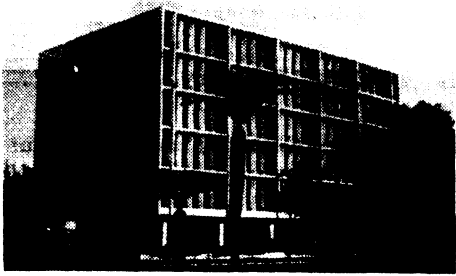
1979 Imperial Valley (California) Earthquake. As far as performance of structures is concerned, the main features of this earthquake were (1) significant damage to cylindrical liquid storage tanks, either ground supported or elevated, and (2) the recorded performance of the modern six-story Imperial County Services Building in El Centro (Fig. 10). Thirteen accelerograms recorded the motion at various locations in the building, which suffered significant structural damage. This six-story building is rectangular in plan (23 x 42 m). Lateral resistance is provided by moment-resisting frames in the longitudinal direction (EW), and shear walls were used in the transverse direction (NS). Shear walls in the upper five stories were provided for the full width of the building on its east and west faces. Four considerably narrower shear walls were asymmetrically placed in the first story. Damage to the building consisted of the failure of the four columns along the east side at the ground level (Fig. 11), spalling of concrete cover and buckling of longitudinal steel in other columns at the ground level, and cracking in slabs, beams, columns, and shear walls throughout the building. A detailed field survey of the damages and preliminary study of the design and detailing indicate that the observed failure of the columns was due to a combination of factors: (1) discontinuities in the

FIG. 10. VIEW OF THE IMPERIAL COUNTY SERVICES (ICS) BUILDING, EL CENTRO, CALIFORNIA
