VIBRATION TESTING OF AN EPOXY-REPAIRED
FULL-SCALE REINFORCED CONCRETE STRUCTURE

G. Norman Owen (I)
Roger E. Scholl (II)
Ike O. Egbuonye (III)

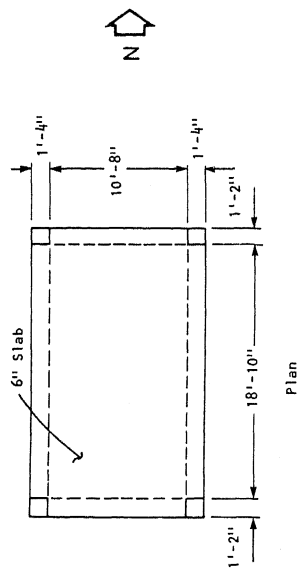
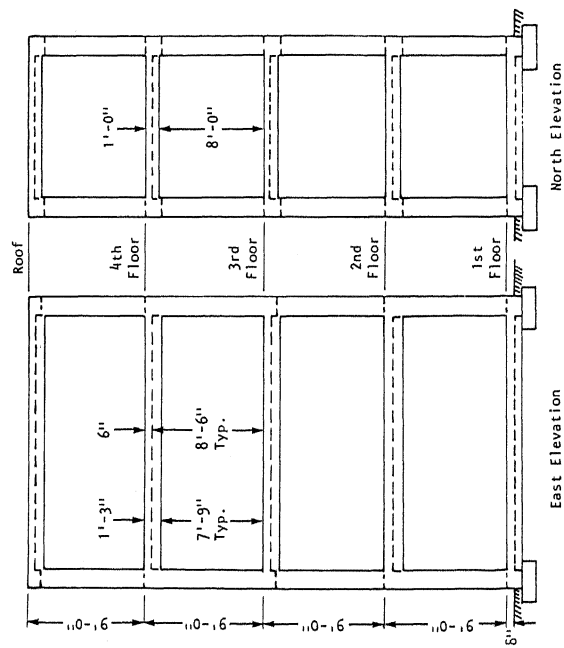
FIGURE 1 FOUR-STORY CONCRETE TEST STRUCTURE

In 1965 and 1966, two identical, full-scale, four-story reinforced concrete structures (see Figures 1 and 2) designed specifically for field investigation associated with a structural-response program conducted by URS/John A. Blume & Associates, Engineers (URS/Blume) for the U.S. Department of Energy

(DOE) were constructed at DOE's Nevada Test Site. Each test structure is 12 ft by 20 ft center to center in plan and has four 9-ft stories. There are four rectangularly tied corner columns, 16 in. by 14 in. Spandrel beams are 16 in. by 15 in. in the 20-ft direction and 14 in. by 12 in. in the 12-ft direction. The floor slabs are 6 in. thick and are reinforced for two-way action.

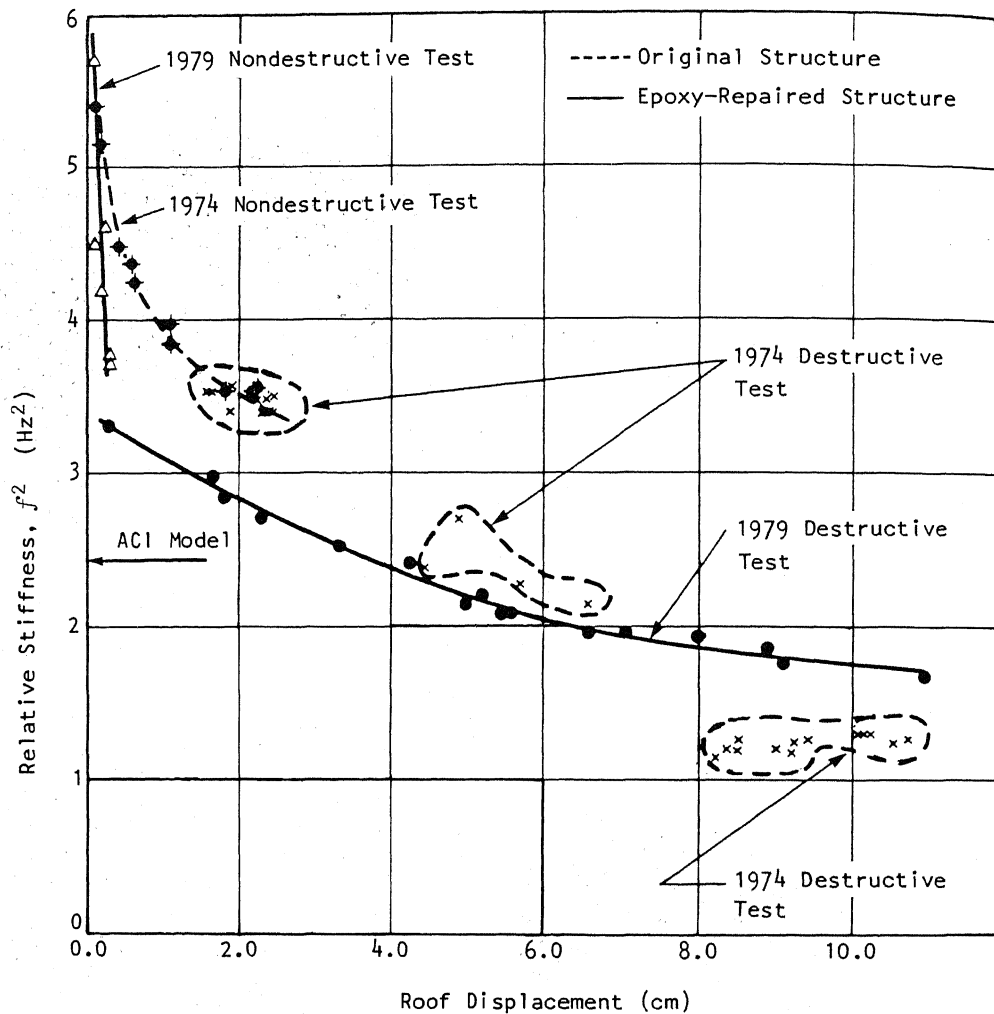
FIGURE 5 STIFFNESS VERSUS ROOF DISPLACEMENT FOR NONDESTRUCTIVE AND DESTRUCTIVE TESTS OF ORIGINAL AND EPOXY-REPAIRED STRUCTURES, FIRST MODE

The results of this study show that for low-amplitude motions the two structures had essentially the same stiffnesses at very low roof displacements, but the stiffness of the epoxy-repaired structure fell dramatically with respect to the original structural stiffness as the roof displacement increased (see Figure 5). This result was expected, however, because not all cracks could be repaired and because the epoxy that was used is less stiff than concrete. A plot of the destructive-test data shows that as the amplitude of the structure's response increased, the difference in stiffness between the epoxy-repaired structure and the original structure decreased. At a roof displacement of about 7 cm, the stiffness of the original structure underwent significant degradation; however, the epoxy-repaired structure continued to degrade in a very gradual fashion. This is further evidence that the epoxy-repaired structure had better beam-column connections than the original structure.

Several mathematical models were developed to represent the dynamic properties of the test structure in the longitudinal direction. One model was based on stiffness guidelines provided in Section 10.10.1 of the ACI 318-77 Commentary (Ref. 5) for frames that are free to sway. The stiffness of this model is indicated on Figure 5. When the stiffness of the epoxy-repaired structure corresponded to that of the model, the drift was approximately equal to the *Uniform Building Code (UBC)* drift limits of 0.5% of the story height.

However, when the original structure was at the same stiffness, the drift was about 50% greater than the *UBC* drift limits.
