EARTHQUAKE STABILITY OF  
INTERIOR NON-BEARING HOLLOW CLAY TILE PARTITIONS

Stanley H. Mendes (I)  
Presenting Author: Stanley H. Mendes

This paper presents findings of an earthquake strengthening study for an older building. This three story reinforced concrete frame building, constructed in Santa Barbara, California, in 1924, was damaged from nearby earthquakes in 1925, 1940, 1952, and 1978. As part of the study, in-place tests to destruction were performed on panels of plastered hollow clay tile partitions with static loads of 0.82G maximum applied normal to wall surface. Studies indicate that with conventional construction, these partitions have substantial inherent earthquake resistance, deflecting 4" to 5" at collapse, and they may not require strengthening if story drift is properly controlled.

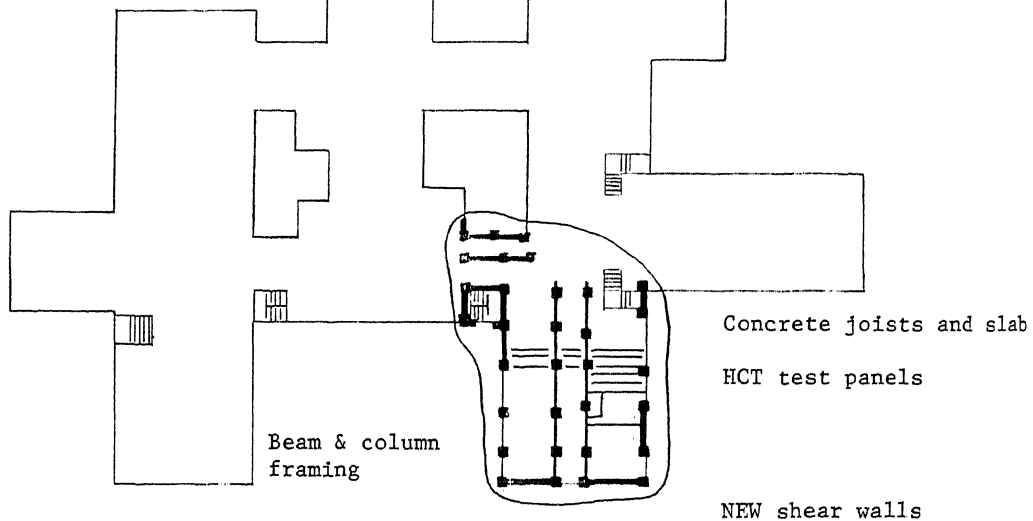
FIGURE 1

Discussion of the study will be limited to strengthening considerations and those aspects of the study directly related to hollow clay tile exterior walls and interior partitions. The building and framing details are shown in Figure 1.
