LOW INTENSITY EARTHQUAKES ON MULTI-STOREY R.C. BUILDINGS:  
RECORDS, IDENTIFICATION AND MODELLING

T. Sanò (I)  
E. Vitiello (II)  
Presenting Author: E. Vitiello

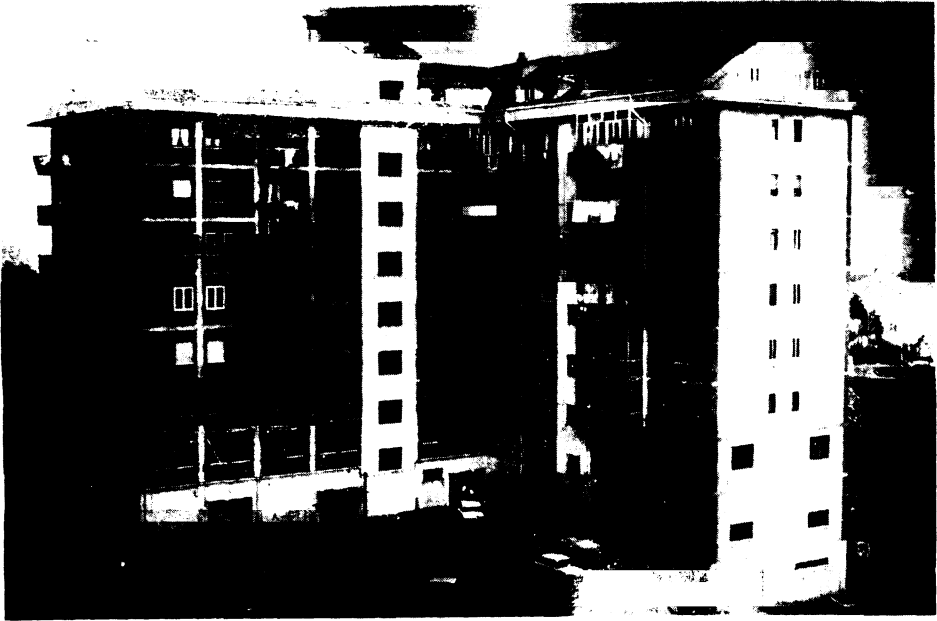
FIG. 1

Figs. 1 and 4 illustrate the elevation and plan of the building. It stands on a hill (slope of about 10%) of over-consolidated clay in Potenza.

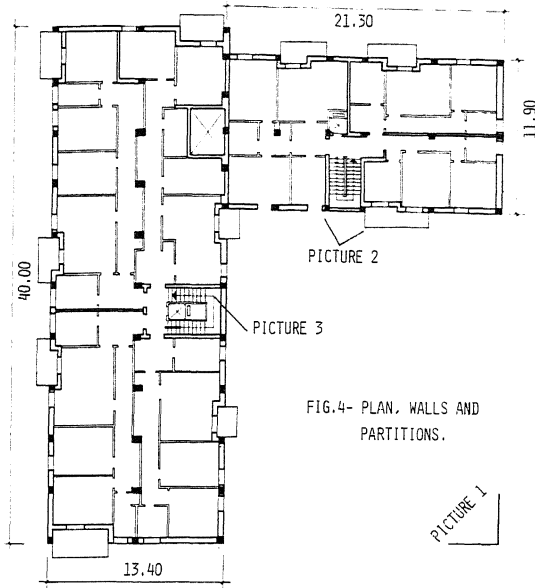
FIG. 4- PLAN, WALLS AND PARTITIONS.

On the basis of an examination of all the channels together and their phases at the peaks of fig. 8, an evaluation of the displacement of the roof in the first two modes is obtained, see fig. 9. Torsional effects, as expected in this kind of L-shaped building, are very evident. It is also clear that the building is less stiff in one direction (5 bay frames). This fact explains the damage in pictures 2 and 3 (see also plan 4) while the corresponding orthogonal elements (stair girders and walls) suffered no damage.

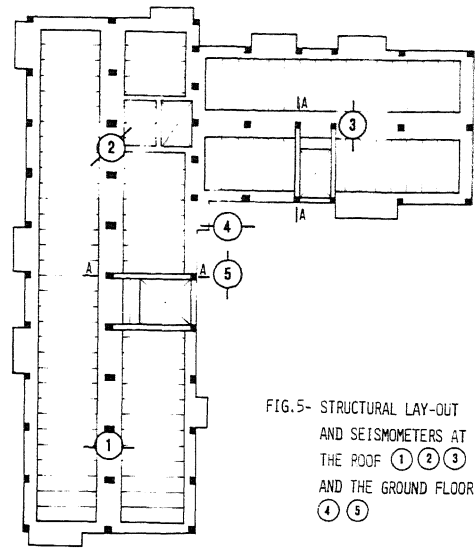
FIG. 5- STRUCTURAL LAY-OUT AND SEISMOMETERS AT THE ROOF ① ② ③ AND THE GROUND FLOOR ④ ⑤

The structural lay-out is described in fig. 5 (columns and main girders), showing that the main structure of the building has multi-bay frames in both orthogonal directions. Slabs are of r.c. joists and clay bricks. The stairs are supported by crooked r.c. girders (see fig. 7) that form a kind of bracing with excentric connexions around the stairs.

The positions of seismometers is given in fig. 5. The characteristics of the recording net is given in ref. (4): it was active for about two months, recording a) several after shocks with a close epicenter, b) the earthquake of Greece, Feb. 24, 1981 and c) a few wind storms. Details on the records are given in ref. (4): in the present paper only a few samples are given in order to explain the processing and to justify the conclusions.
