EVALUATION OF THE RESPONSE OF THE IMPERIAL COUNTY SERVICES BUILDING

M. E. Kreger (I)
Presenting Author: M. E. Kreger

This paper describes the Imperial County Services Building in El Centro, California, and the damage sustained by the structural system during the 15 October 1979 Imperial Valley earthquake. Recorded acceleration response of the structure and calculated base-shear and moment responses are presented and interpreted. The procedure used for determining how and when columns failed at ground level is described.

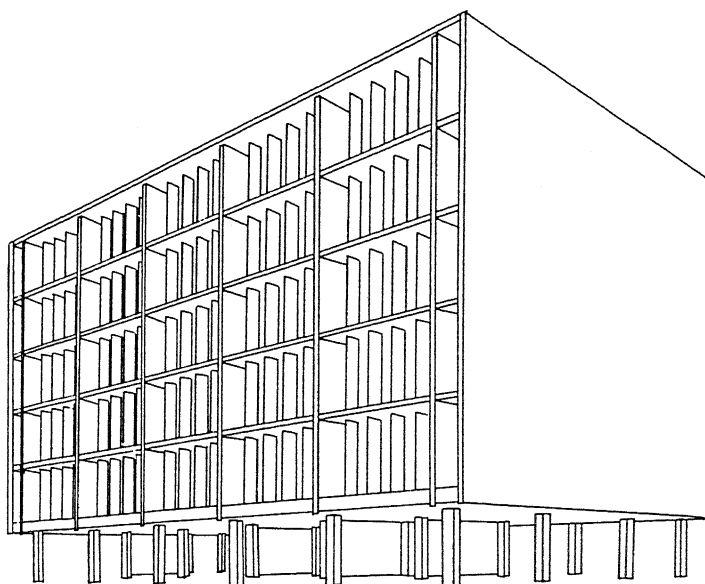
The Imperial County Services Building of El Centro, California (Fig. 1) was severely damaged during the 15 October 1979 Imperial Valley earthquake. The most significant damage sustained by the structure during the earthquake was the material failure of four east-end columns at ground level (Fig. 2). The event was unique because response of the structure as columns failed (during the earthquake) was recorded by a network of 13 strong-motion accelerographs.

The ICSB (Fig. 1) was a six-story, reinforced concrete building, 136 ft 10 in. (41.71 m) by 85 ft 4 in. (26.01 m) in plan. The perspective drawing of the structure illustrates the open nature of the first story. Nonstructural elements were omitted from the first story of Fig. 1 to make the location and number of structural walls evident.

Fig. 1 Perspective drawing of the Imperial County Services Building
