IMPLICATIONS OF DAMAGES TO THE IMPERIAL COUNTY SERVICES
BUILDING FOR EARTHQUAKE-RESISTANT DESIGN

Christos A. Zeris (I)
Rodrigo Altmann (II)
Presenting Author: Christos A. Zeris

SUMMARY

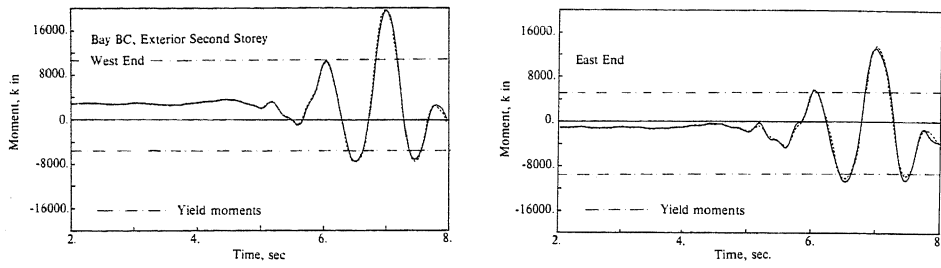
As illustrated in Fig.(10), the correlation of the recorded and the predicted displacements is satisfactory until 6.20 seconds, with minor deviations until the 6.90 sec., when a change in the recorded response is observed; subsequent peaks exceed the elastically predicted ones by a factor of two. By comparing the true member capacities with the predicted demands the sequence of failure is estimated to be: (a) separation of the "nonstructural" elements from the frames around 6.0 seconds and subsequent yielding of the exterior beams in bending at the second and third floor at 6.40 seconds (Fig.10). (b) Probable yielding of the interior second floor beams, between 6.40 and 6.90 seconds. (c) Yielding of the ground level columns at their base (Fig.12) and subsequent large displacements above the second story.

Fig.10 Comparison of Predicted and Recorded Displacements

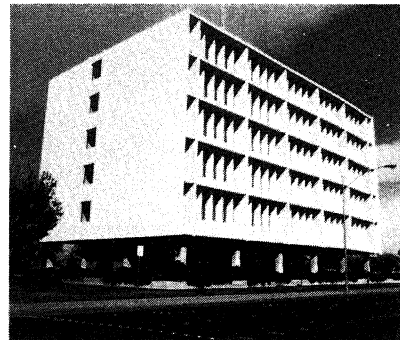
(d) The analysis revealed a prominent contribution of torsion, which due to the structural layout was coupled to the NS translational response. This torsional motion, together with the imposed rotational component of the ground motion induced in the East end ground walls higher shear forces than those at the West end (Fig.12), as well as significant biaxial bending to all four corner columns, reducing even further their resistance.

Fig. 13 Ground Walls Shear Force History
