A DESIGN ANALYSIS OF THE IMPERIAL COUNTY
SERVICES BUILDING

Slobodan Kojic (I)
James C. Anderson (II)
M. D. Trifunac (III)

SUMMARY

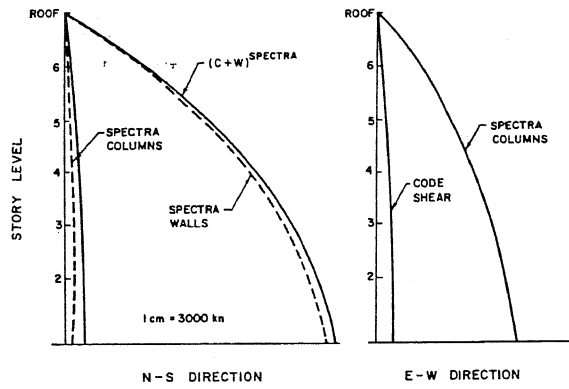
Fig. 10 Envelope of Story Shear Forces

The interaction diagram for the interior columns on column lines E and F is shown in Figure 9. Here the difference between axial failure and flexural failure becomes readily apparent. The columns on both column lines are overstressed, however, the columns on line F are once again above the balance point indicating a brittle, compressive failure mode. Conversely the columns on column line E are below the balance point indicating a more ductile, flexural failure mode. The columns experienced cracking and spalling of the concrete cover, but no disintegration of the concrete core and no buckling of the reinforcing steel. The envelope of story shears in the two principal directions are shown in Figure 10. In both cases the story shears calculated from the response spectra are compared with those obtained using the 1967 Edition of the Uniform Building Code. In the N-S direction the shear due to the response spectrum is separated into that taken by the columns and that taken by the shear walls. As might be expected, the shear taken by the columns is almost negligible and the combined spectrum shear is almost thirteen times larger than that specified by the code. In the E-W direction, all story shear is resisted by the columns of the moment frames. Here the spectrum shear is eight times greater than the code requirements.

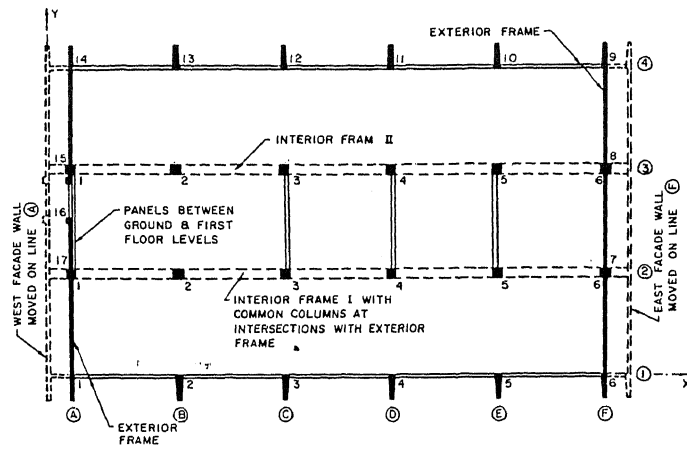
Fig. 5 Frame Layout for Analytical Model

In the analytical model, the building is represented by six different frames which are interconnected by the floor diaphragm which is assumed to be rigid in its own plane. The location of these frames is shown in Figure 5. The primary frame includes the beams and columns on column lines 1 and 4 and the shear walls at the east and west ends of the building. In order to facilitate the modeling of the structure, these walls were moved in to column lines A and F as shown in Figure 5. Hence the primary frame is a peripheral frame which has moment frames in the east-west direction and shear walls in the north-south direction. The two interior frames on column lines 2 and 3 are modeled as moment frames which "share" columns with the peripheral frame at locations F2, F3, A2 and A3. It should be noted that at these locations axial compatibility is not enforced between these three frames. The remaining three frames consist of the three shear walls between the first and second floor levels on column lines C, D, and E. Prior to subjecting the model to dynamic loading, static load checks were made using the model to insure that equilibrium was satisfied in both directions.

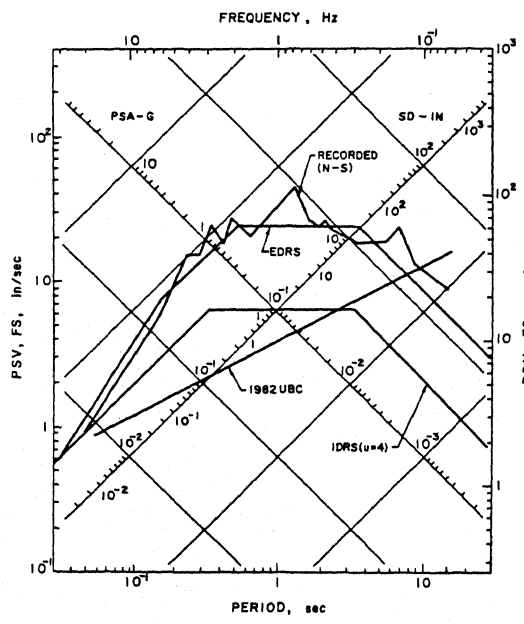
Fig. 6 Response Spectra, North-South

The seismic input for this phase of the investigation consisted of two response spectra developed from the strong motion acceleration data recorded on the base slab in the N-S and E-W directions. The recording instruments were located just west of the ground floor shear wall on column line E. These two spectra for five percent damping are shown in Figure 6 and Figure 7. The maximum recorded base acceleration in the N-S direction was .29g and the maximum in the E-W direction was .32g. Also shown on these figures for basis of comparison are the following three design spectra: (a) a Newmark-Hall spectrum (Ref. 6) based on the maximum ground acceleration and five percent damping, (b) a Newmark-Hall spectrum adjusted to reflect a design ductility of four and (c) the seismic coefficient, C, specified in the 1982 edition of the Uniform Building Code. The fundamental period of the County Services Building under ambient vibration was determined by Pardoen (Ref. 7) to be 0.65 seconds in the E-W direction and 0.44 seconds in the N-S direction. Results of the ETABS model gave 0.78 seconds in the E-W direction and 0.30 seconds in the N-S direction. In this period range it can be seen that there is a large difference between the spectral acceleration obtained from the recorded data and that specified by the code coefficient. On the other hand, the elastic design response spectrum (EDRS) suggested by Newmark and Hall gives a close approximation to the actual values. However, it is recognized that this criteria would result in predominantly elastic behavior and may be overly conservative. The Newmark-Hall inelastic design response spectrum (IDRS) with a design ductility of four gives values of spectral acceleration which are intermediate to the other two and may have resulted in a more adequate design.
