U.S.-JAPAN COOPERATIVE RESEARCH ON R/C FULL-SCALE BUILDING TEST

PART 3 INSTALLATION ON NONSTRUCTURAL ELEMENTS  
AND REPAIR WORKS, DAMAGE ASPECTS AND  
HYSTERESIS PROPERTIES AFTER REPAIR

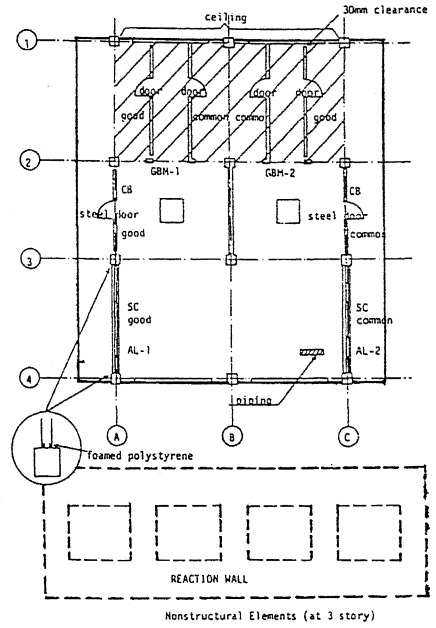
Fig.3.1 Installation of Partition

When the repair works were completed, nonstructural elements were placed in the test structure. The layout of the partitions is shown in Fig.3.1 and Table 3.1. The ceiling was also installed in a part of the third story.

- a) When the roof-level displacement was 1/1000, cracks occurred around the door openings of the partitions in the fifth story.
- b) When the roof-level displacement was 1/500, several doors could not be opened. Cracks were found on walls and around door openings of the partitions GBM-B, MSM-B and MSM-A.

- c) When the roof-level displacement was 1/250, many doors of the partition GBM lost their function. Mortar finishings and plaster finishings of partitions in the fifth story began to fall off and door jambs were separated from the partition. When the roof-level displacement was 1/125, boards were separated from furring frames, and the connection between the partition GBM in the third story and that perpendicular to it was damaged. Cracks became large and the separation of the boards was found.

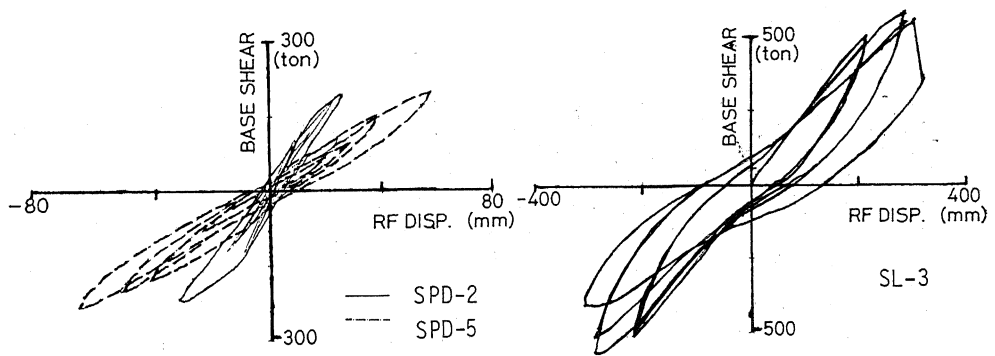
Fig.4.1 Responed Hysteresis Loops at Roof Floor

SL-3 was conducted by static loading under a uniform load distribution. This test was controlled by the top floor level displacement angle ( $R$ ); defined as horizontal displacement at the roof level divided by the total height of the test structure. During the load cycle of  $R=1/75$ , the first story shear wall suddenly failed in shear at the base shear force of 600 ton., then this final loading test terminated. At the final stage of this test, the main reinforcement was broken out, and the concrete was crushed along the full span of the first story shear wall. The hysteresis loops of roof displacements are shown in Fig.4.1.
